NIWA Project: ELF17208

20 December 2016

Background

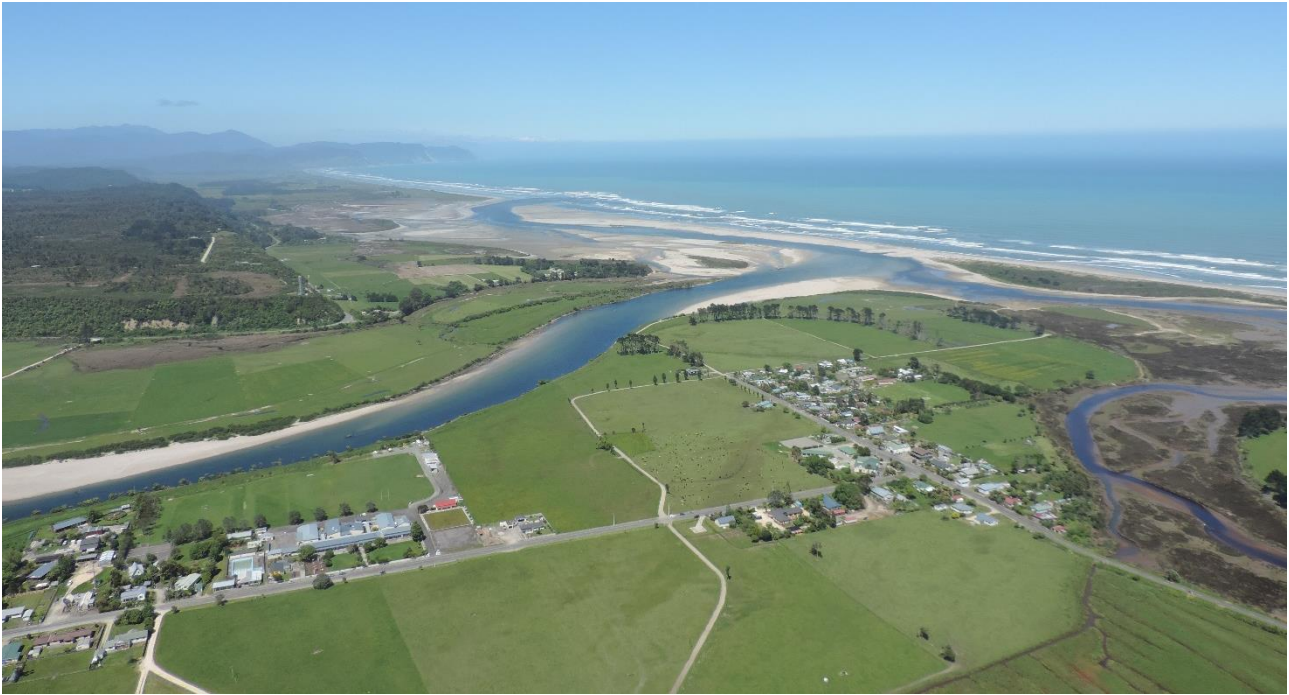
During the site inspection the Karamea River and Otumahana Estuary had a single opening to the sea positioned 1 km from the southern extent of the estuary (Figure 1).

Figure 1: Aerial oblique (view to southwest) of the Karamea River flowing past Karamea township (foreground), merging with the swamp overflow and Baker Creek (at right), before discharging into the Otumahana Estuary and exiting through the single southern opening to the Tasman Sea. [Source: M Allis, 22-11-2016]

The river’s present discharge point into the ocean is 3 km south from its most direct path to the sea (see Figure 1). This increases the flood risk to Karamea town because of the extra ‘head’ required for the river to flow the additional distance to the sea.

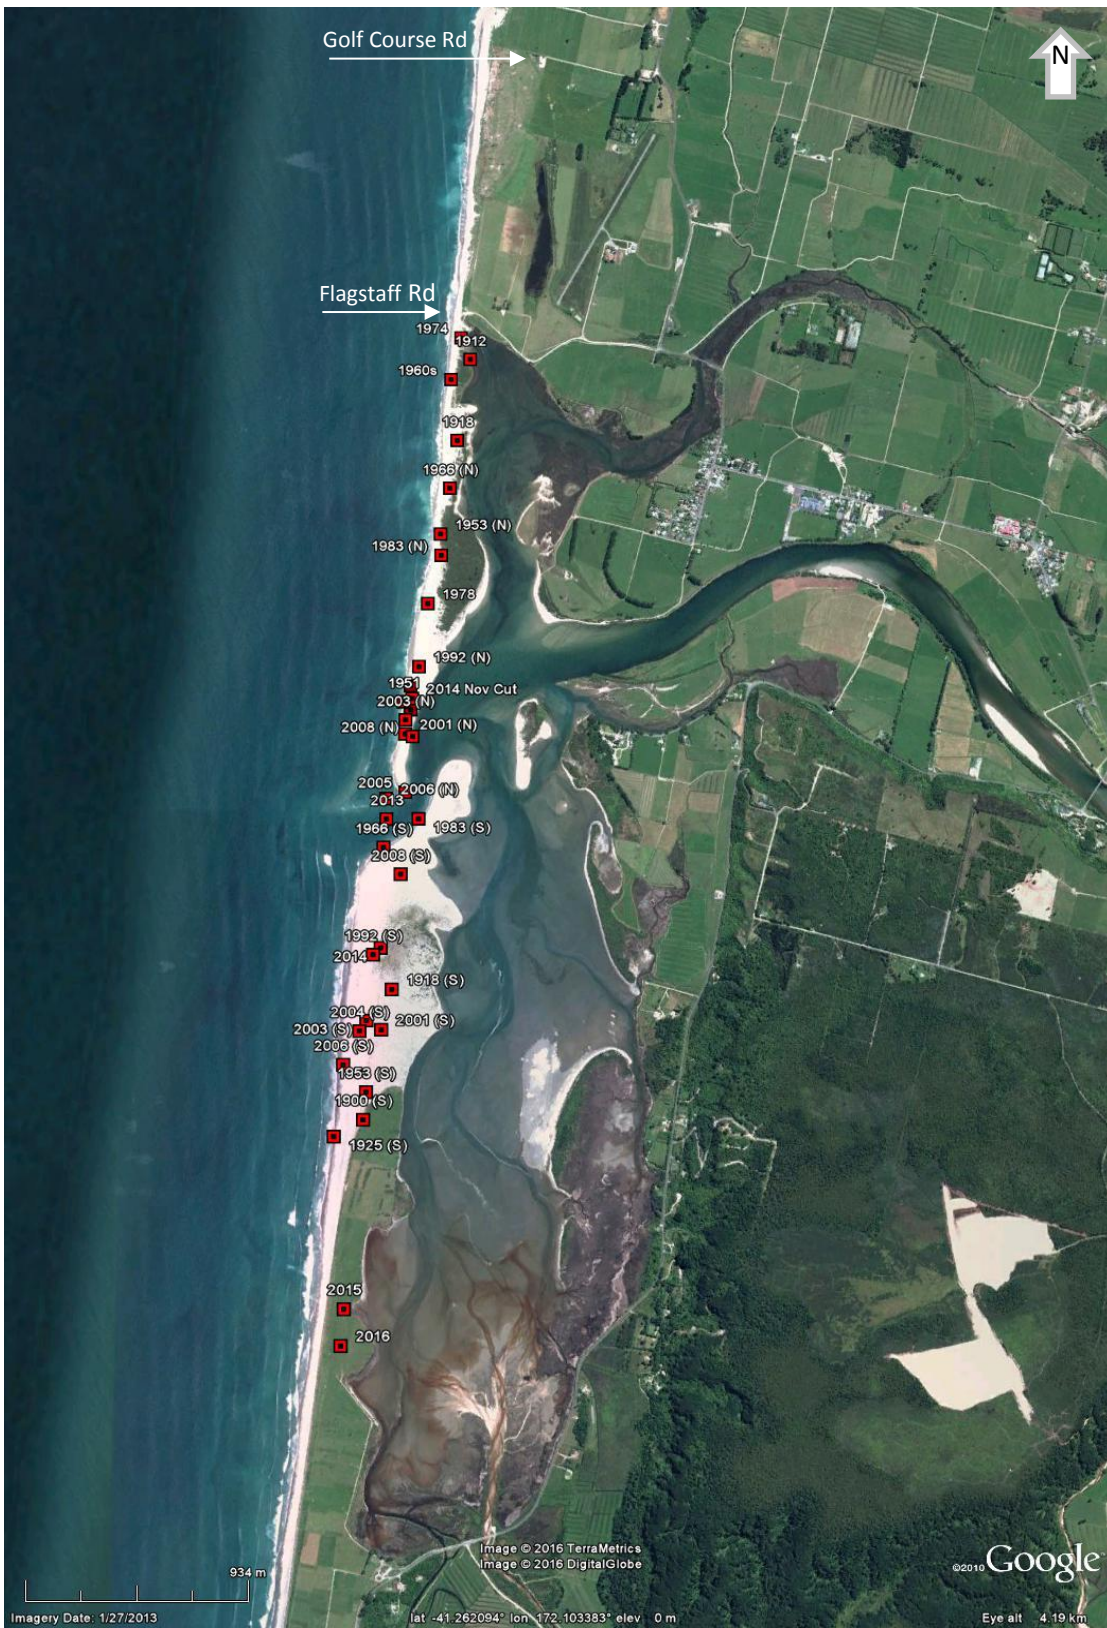
Figure 2: Location of known estuary openings. Year of observation with north (N) or south (S) shown if multiple openings visible. Symbols indicate approximate centreline of opening. [Source: Google Earth image Jan 2013].

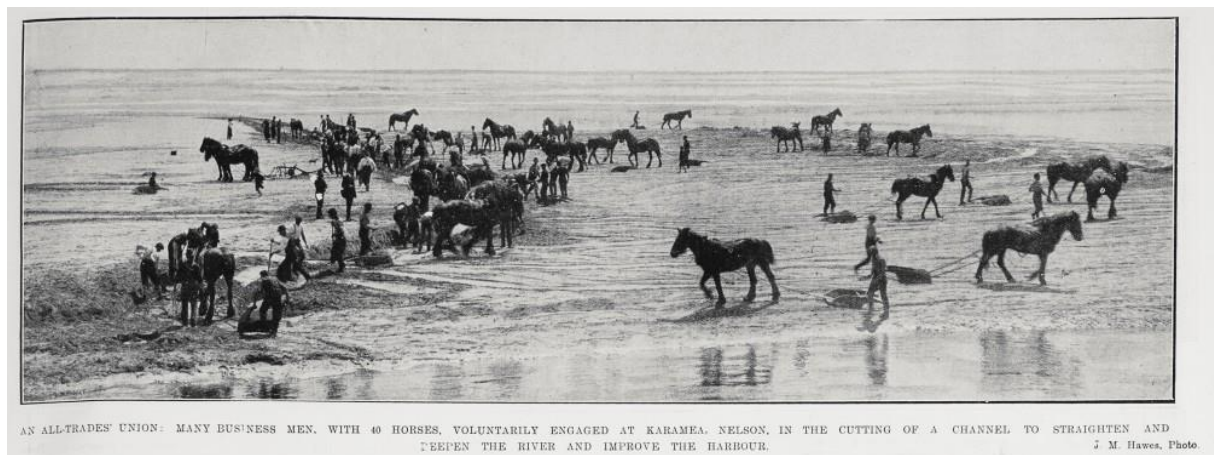
- Major changes to the river opening followed the 1929 Murchison M7.8 earthquake. A landslide is reported to have dammed the upper Karamea River for a short period, and when the dam burst it sent a minor flood downriver (Carr, 2004). However, this and the other multiple landslides continued to supply sediment to the river which progressively silted up the river mouth to an unnavigable state (Furkert, 1932). Manual dredging of the river mouth was attempted to facilitate coastal shipping in the 1930s (Figure 3).

Figure 3: Attempts to straighten and deepen the Karamea River mouth c1930. [Photographer: J.M. Hawes, Source: Te Ara Encyclopaedia]

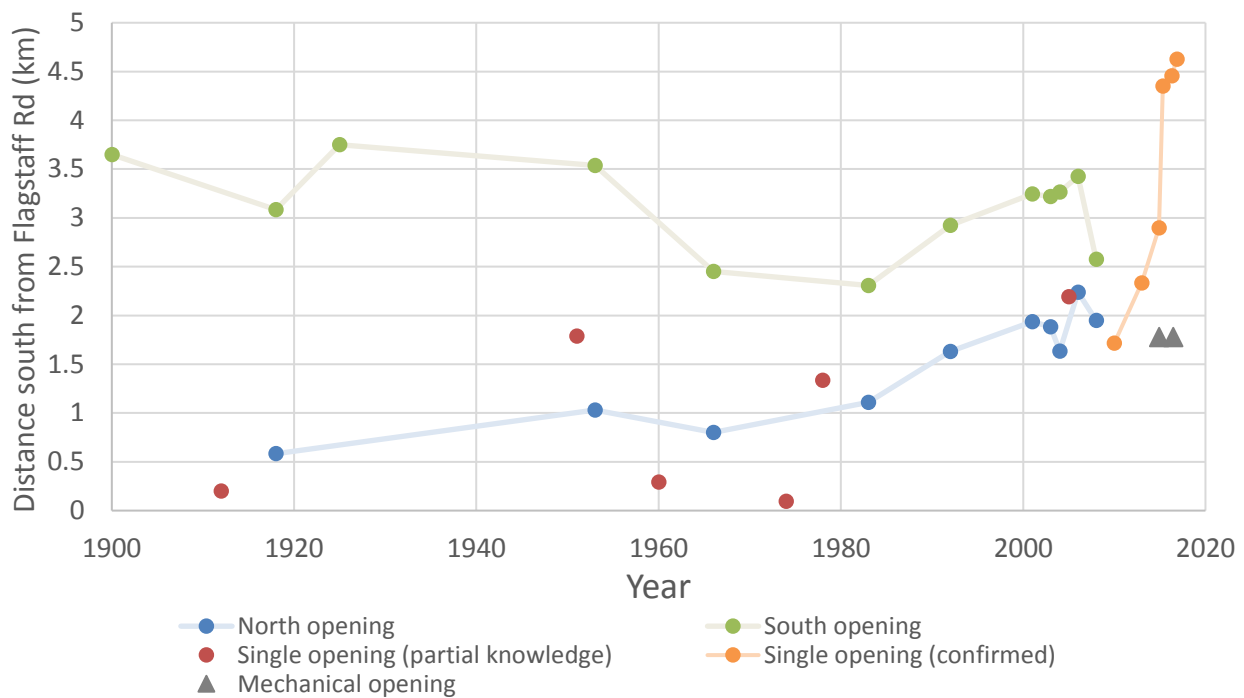
- During 2006 to 2008 the southern (estuary) opening migrated north and narrowed, while the northern (river) opening migrated south and widened. This indicates a further behaviour shift towards re-coupling of the river-estuary systems and preferential river and tidal discharge from the northern opening. The separation between openings was only 500 m in June 2008 (Figure 4).

- Between June 2008 and December 2010 the two estuary openings merged into a single opening for the first recorded time. The single opening was wider than historic openings (approximately 700 m wide) and was located at the site of the usual northern opening, with a direct (shortest path) outlet for the Karamea River (Figure 4).

- There was a brief period (several months) with two openings from November 2014. This was facilitated by mechanical excavation of a channel across the spit at the location of the previous northern opening (in line with township, 1.77 km from Flagstaff Rd – see Figure 4) and was followed by a 6.8 year ARI flood (2690 m³/s). The new northerly opening was naturally infilled and closed in early 2015, probably because of a lack of summer flood flows to sustain the opening against wave-driven sand deposition.

- The present location of the opening, at 4.5 km from Flagstaff Road, is the southernmost position that has been observed. A further 1.5 km of southerly migration will begin to encroach on Kongahu village.

Figure 4: History of estuary opening locations as distance south from Flagstaff Road.

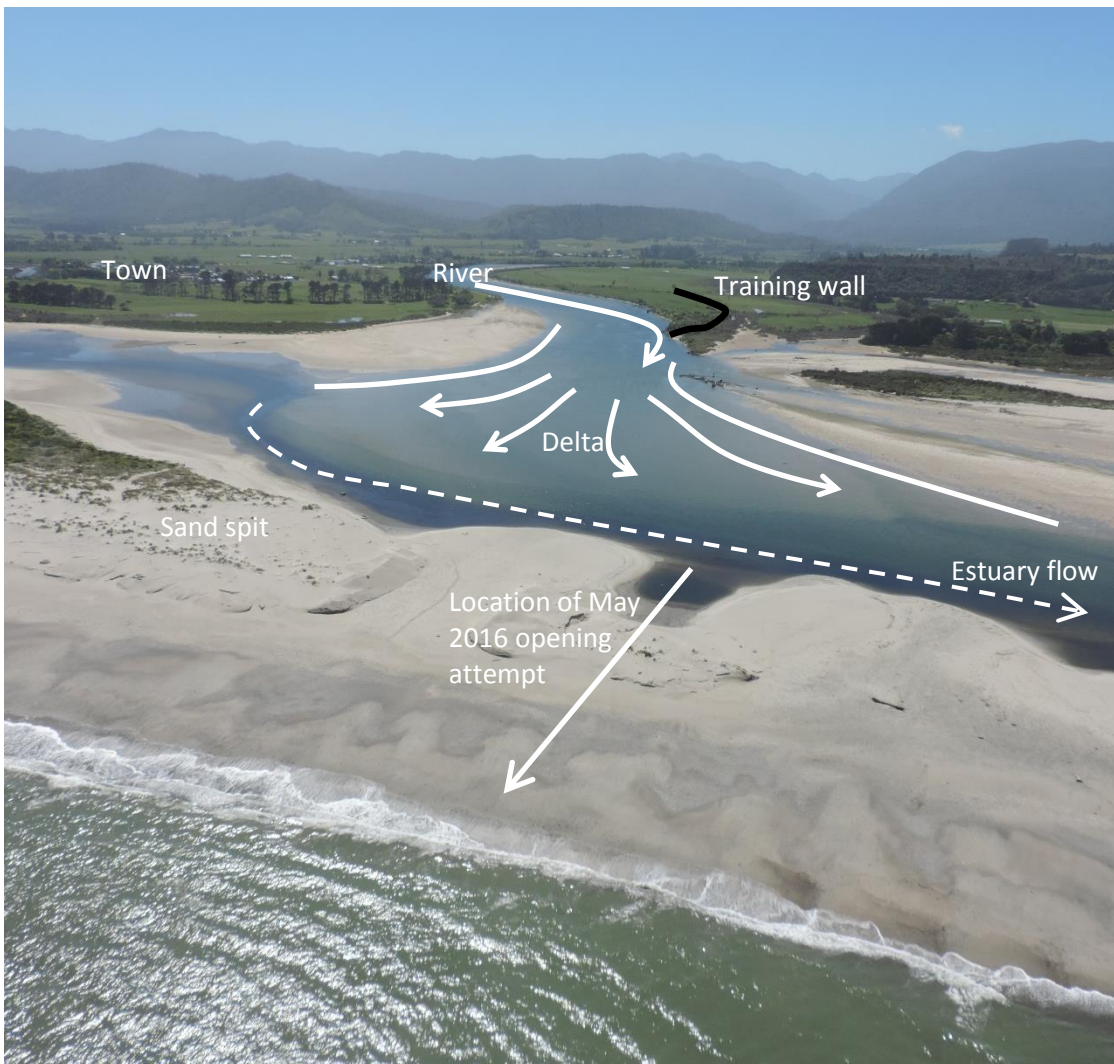
The present configuration of the river-estuary system has the Karamea River, guided by a rock training wall near Maori Point, spilling over a small estuarine delta into the Otumahana Estuary and being swept south behind the sand-spit (Figure 5). As the river flows over the delta it does not have a clear incised channel, indicating loss of current speed, allowing development of the delta through sedimentation processes. At the base of the delta the river collects into the southerly flowing estuary channel (Bakers Creek and the Overflow) behind the sand spit and follows a circuitous route for 3 km to the outlet near Kongahu.

The notch excavated during the May 2016 attempted mechanical opening remains (Figure 5), but shows evidence of infilling from both wave overwash and river sands. At its narrowest the spit separating the river and estuary is only 100 m wide with no vegetation.

Figure 5: Aerial oblique (view to east, upriver) of Karamea River discharging into Otumahana Estuary over an estuarine delta, merging with the swamp overflow and Baker Creek (from left), before flowing south behind the sand spit (foreground). [Source: M Allis, 22-11-2016]

The largest river discharge in the present configuration was 2300 m³/s, with three separate smaller events with flows >1500 m³/s. These have been unable to breach the sand spit at this location – even with mechanical assistance weakening the barrier (Figure 5).

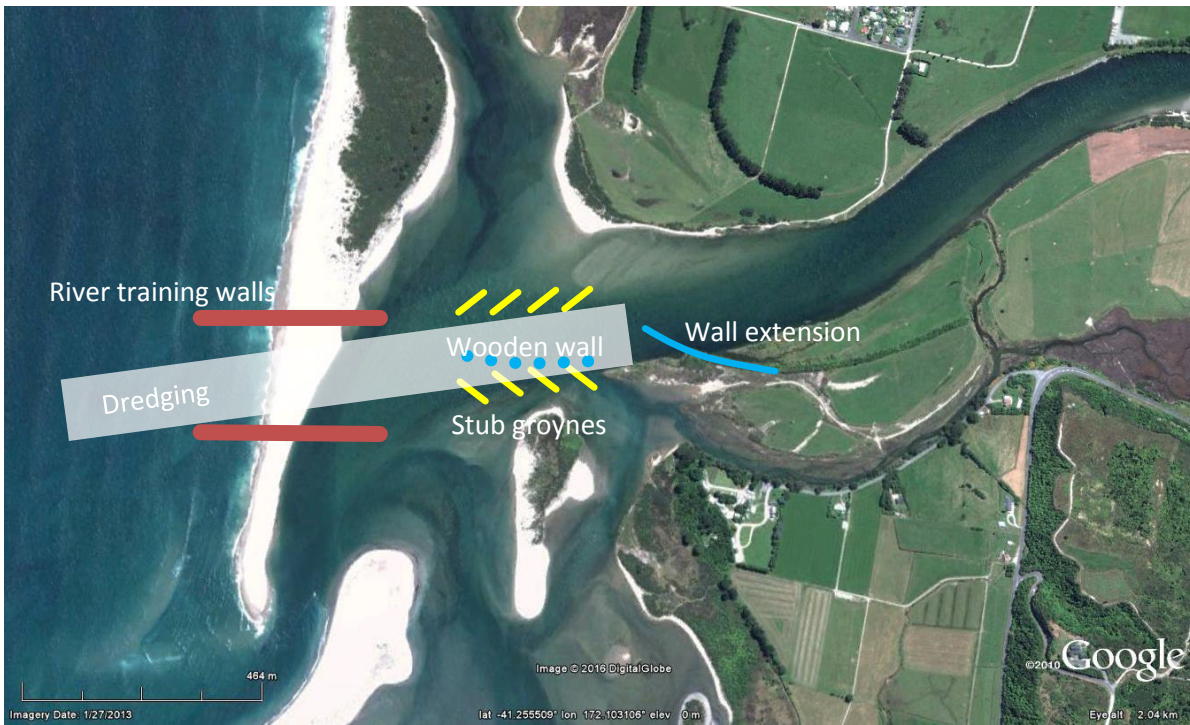
Figure 6: Major engineering options at Karamea. [Background image: Google Earth, 2013]

Major engineering works have been employed in Karamea and the Otumahana Estuary since the 1920s, and there is a range of engineered interventions to assist the natural spit-breach process. These options are sketched in Figure 6 and include:

- Constructing river mouth training walls (as at Westport and Greymouth) to disconnect the river from the estuary and discharge straight to sea. This exercise would be very costly, with large scale changes to the estuary and beach, and would require a substantial dredging programme to maintain the entrance during non-flood conditions.

- Extend the existing left-bank stopbank/training wall which currently guides the river to its present location. However, this stopbank/wall previously extended approximately 50m from its current end point and was subsequently shortened by both the river (scour, collapse) and engineers because of the constriction and backing-up of flood flows. Re-extending the training wall would cause the same problem.

- Construct a series of short stub-groynes at 45 degrees to the river flow direction to enhance river channelization across the present estuarine delta during low flows, and therefore direct the force of the river discharge directly into, and hopefully through, the sand spit. This would require smaller rock quantities than a large scale training walls, but would act to slow floodwaters and potentially increase flooding hazard through the backing-up of water prior to the sea outlet.

- Construct permeable and temporary (25 year lifespan) wooden training walls to partially direct the flow through the estuarine delta in a more direct path to the sea, in essence extending the present training wall arc. This would be relatively costly, with similar drawbacks to other engineering measures, but could be removed more easily if unintended consequences eventuate.

- Dredging a new channel through the estuarine delta and spit. This would only be a temporary measure as the river base flows are unable to maintain a northern opening.

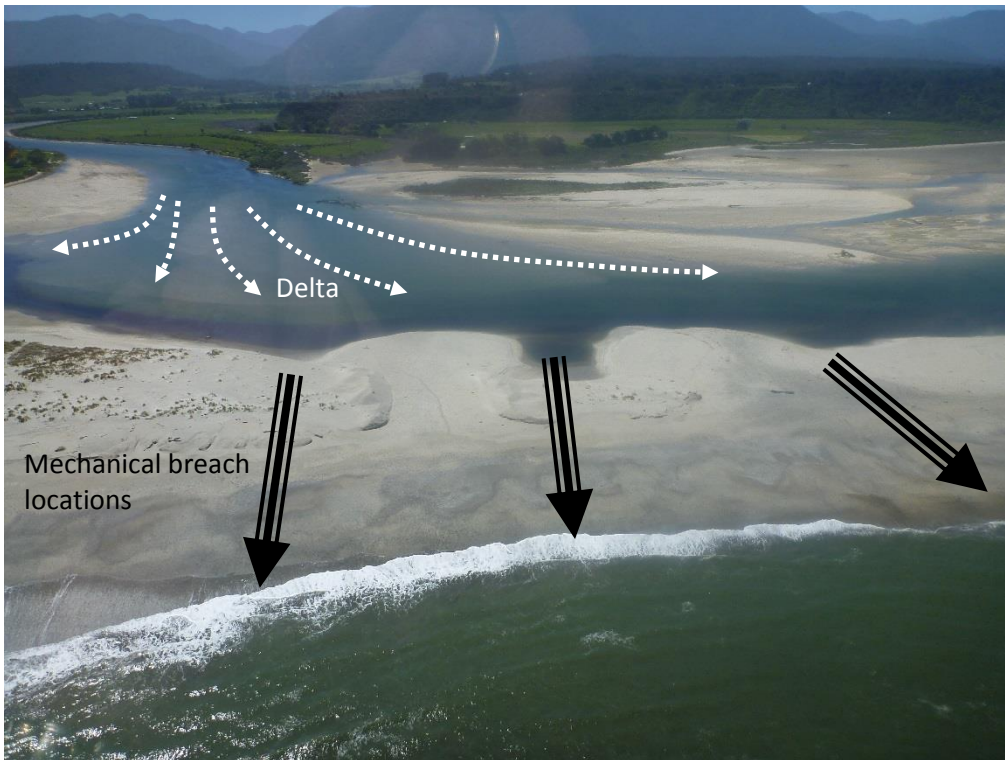
Figure 7: Mechanical channel breach locations for Karamea River.

We recommend to mechanically excavate a breach channel for the floodwater to overwhelm and widen the opening. We recommend to prepare in readiness and maintain 2 or 3 channels through the sand spit at similar locations as the historic river mouth openings, oriented as shown in Figure 7. The prepared breach channels should be maintained after each minor unsuccessful flood event to ensure viability after flood/wave/wind sand deposits infilling. The key concept is to await a major river flood to push the river through the pre-weakened spit breaches. It is expected that a flood discharge greater than 2300 m³/s (approximately a 5 year ARI flood event) will be required to breach the pre-weakened openings. The preparation of multiple channels is a reflection of the uncertainty of how/where the river will scour a channel through the estuarine delta during flood flows, and therefore ensures that the spit is pre-weakened in several locations to increase the chances of a major breach and a more permanent opening eventuating.

This new opening is expected to close up again unless a sequence of flood flows maintain and deepen the new channel opening. Shortly after the closure next occurs, the spit should again be excavated in several locations in preparation for the next flood to breach the spit. If this occurs repeatedly, a detailed investigation may be required to refine configuration and position of the excavated channel and to predict the longevity of the opening.
