WEST COAST
REGIONAL COUNCIL

Meeting of Infrastructure Governance Committee
(Te Huinga Tu)

Tuesday, 7 May 2024

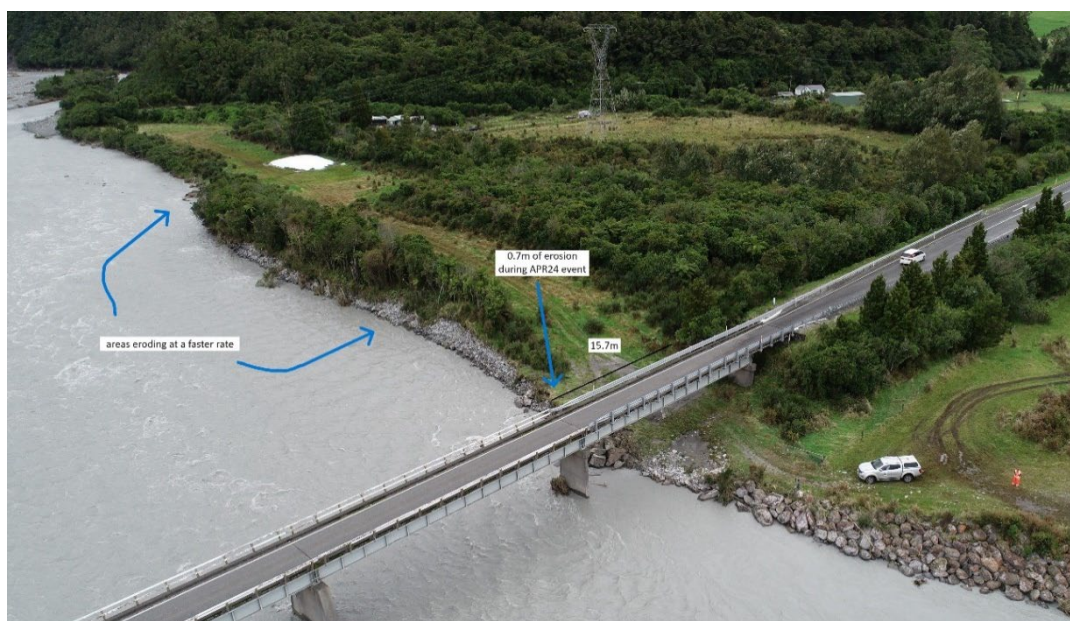
Figure 1: Areas being monitored for erosions Wanganui River

During the flood event, engineers conducted regular patrols, visiting key areas of the flood defences approximately every 2 hours. They began at the SH6 Bridge, assessing any changes in flow before completing their loop. Observations revealed that the natural bank below/upstream of the true left abutment eroded by <0.7 metres during the event. To track erosion over time in this location, a reference point using a fence post to the edge of the berm has been established. Upstream of this point, erosion has been more severe, possibly exceeding 1.5-3 metres over the span of the event (Figure 1).

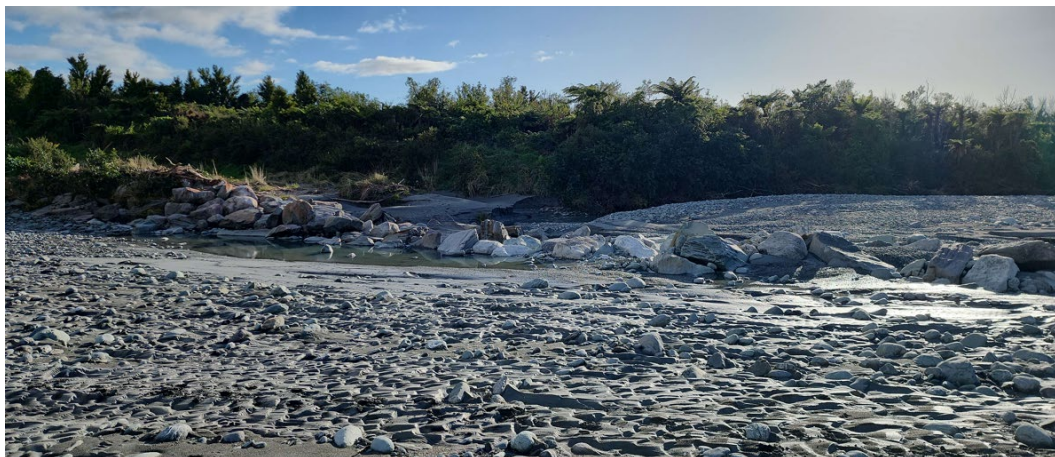
Location: Left bank, Deflector groyne, overtopping and settlement of tip of the groyne

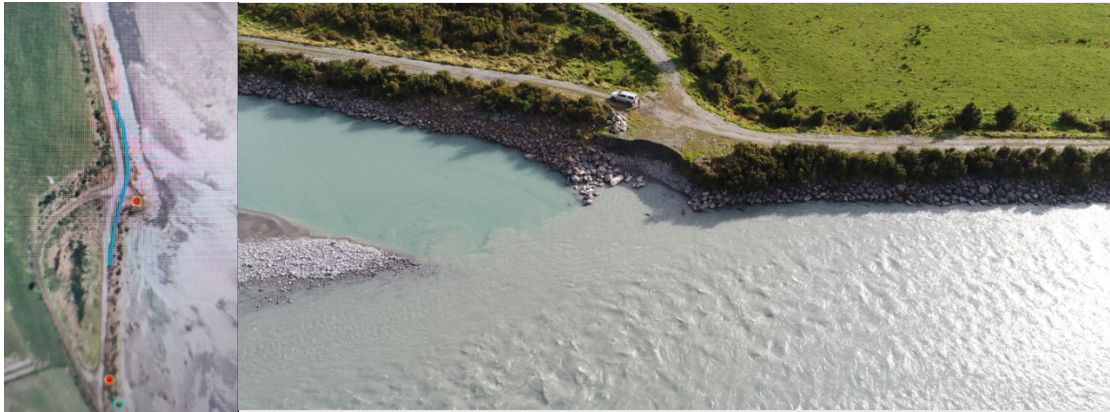
Location: Left bank, quotes are being sought and evaluated for remedial actions to repair this eroded spur groyne which was damaged during the event. The spokesperson and our team are assessing the urgency of initiating this remediation due to the heightened risk of erosion on the now exposed section of the stopbank. (See figure.)

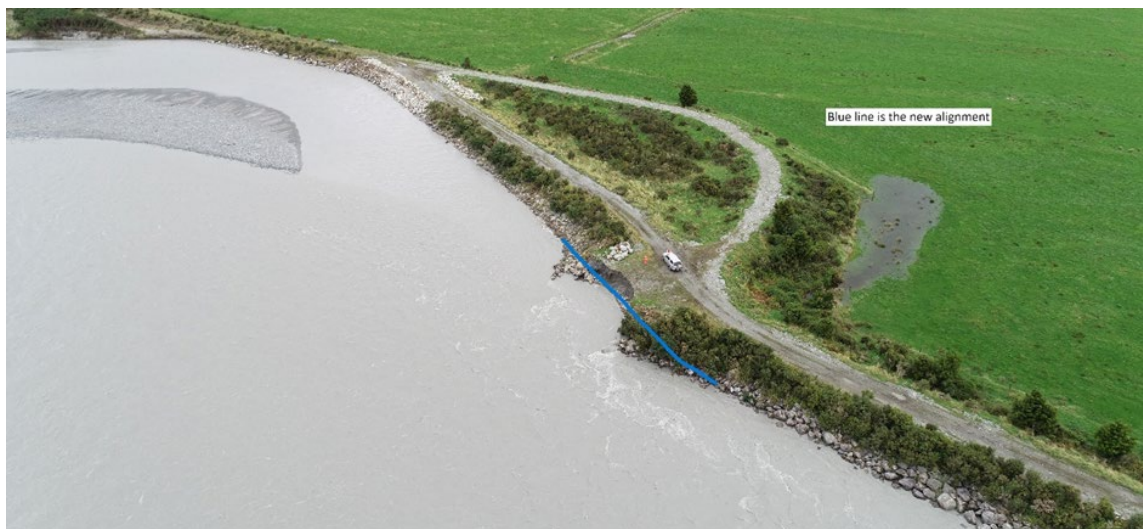
Rather than opting for the reconstruction of the spur groyne, WCRC Engineers are planning a realignment of the rock lining along this section of the stopbank, as illustrated by the blue line in the figure.

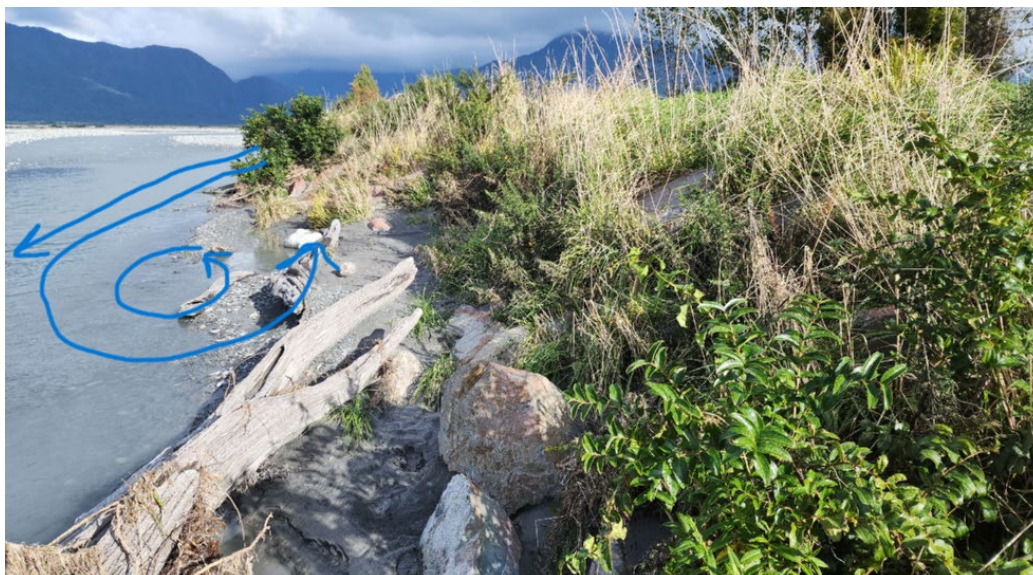
Location: Left bank, an eddy has caused minor erosion behind a spur that will need ongoing monitoring.

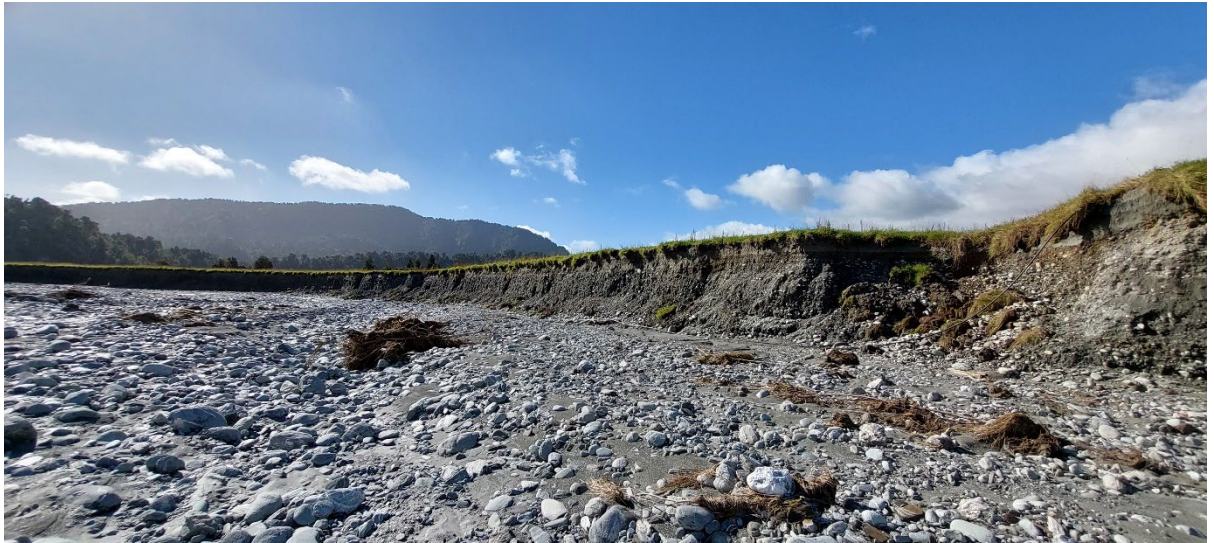
Downstream, erosion has caused further loss of farmland, this image shows a large bite that was scoured out.

Figure 5: significant erosion down stream of Havills wall

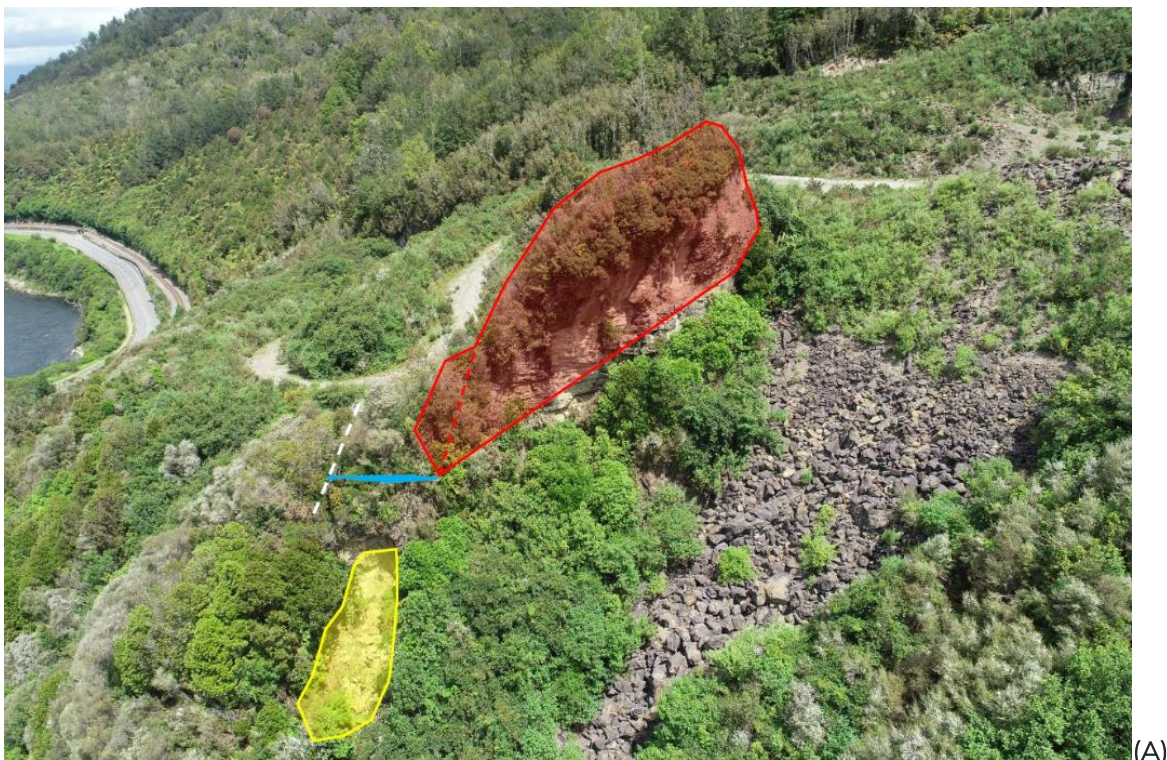
Figure 4 Pinnacle feature (A) Looking southeast, (B) Looking Northwest. Proposed remedial work by Terra Firma in dec 2022 report includes removal by blasting (highlighted red) and removal of hung up boulders (highlighted yellow) subsequently with excavator from hairpin widening (highlighted blue).

- 5) The material removed by blasting should be used to buttress the faces in the quarry.
- 6) The remainder of recommendations by Terra Firma to be implemented in order to allow complete closure of the quarry at the earliest opportunity.

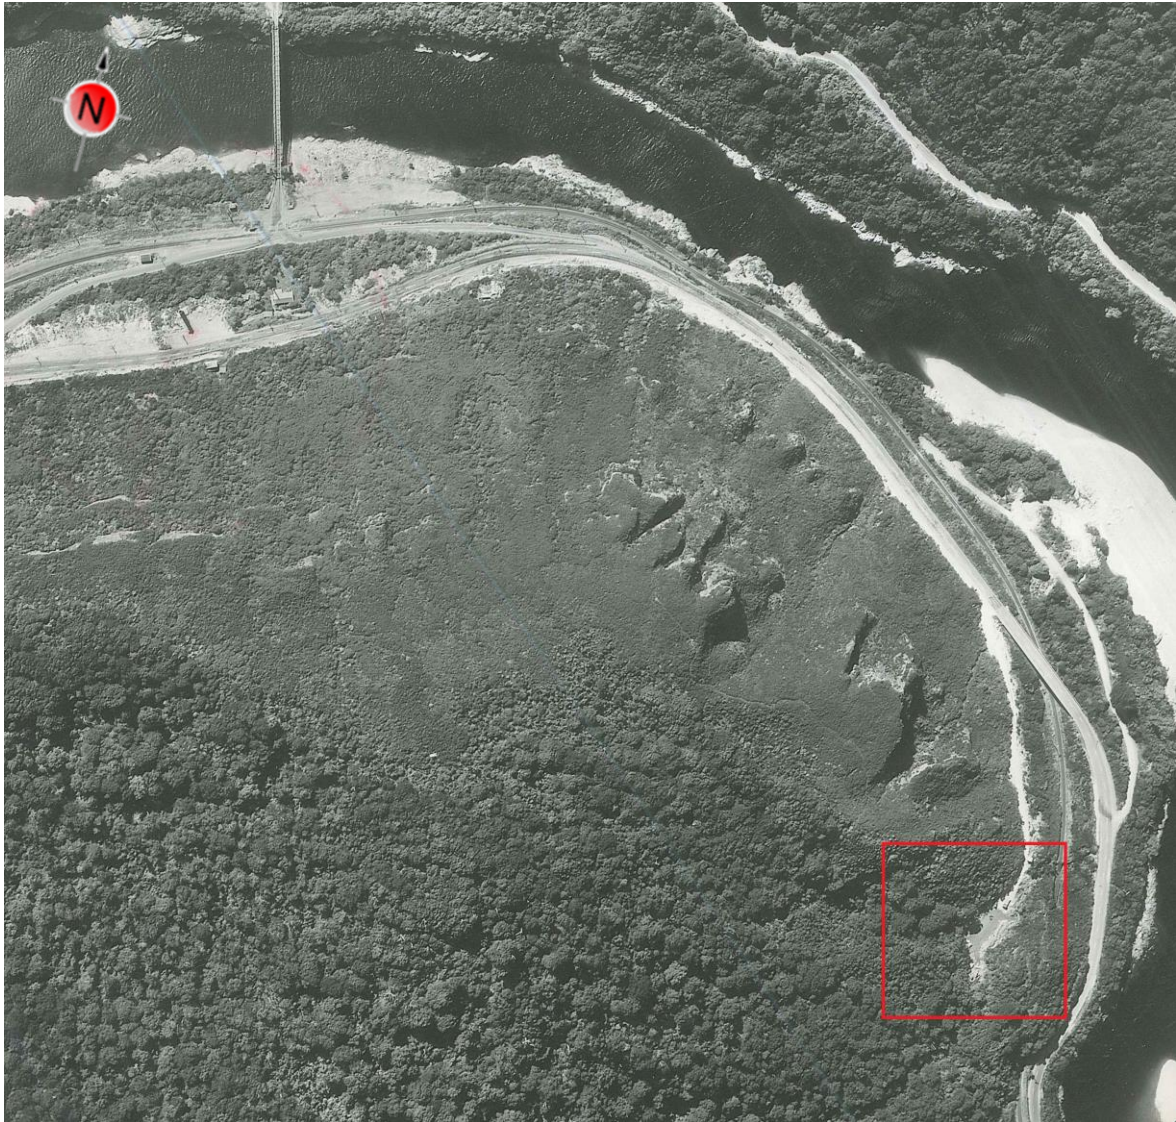
Aerial Photo 2 Site condition Anno 1973. An access road has been constructed upslope (west) and parallel to the rail corridor with some extraction likely at the end of the road (red outline).

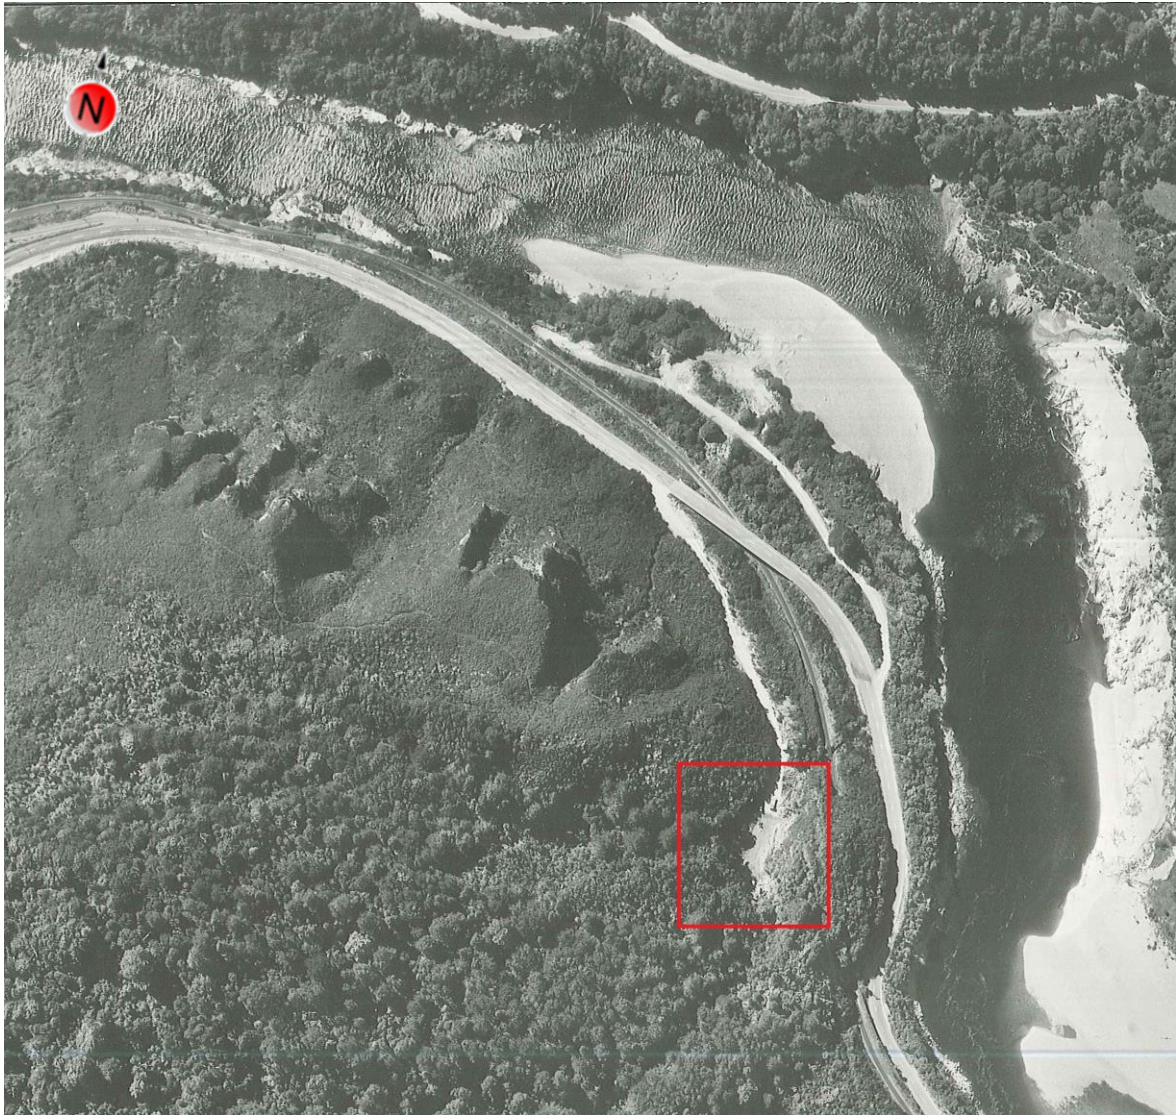
Aerial Photo 3 Site condition Anno 1975. Slightly widening of the extraction area at the southern end the access road relative to 1973 conditions.

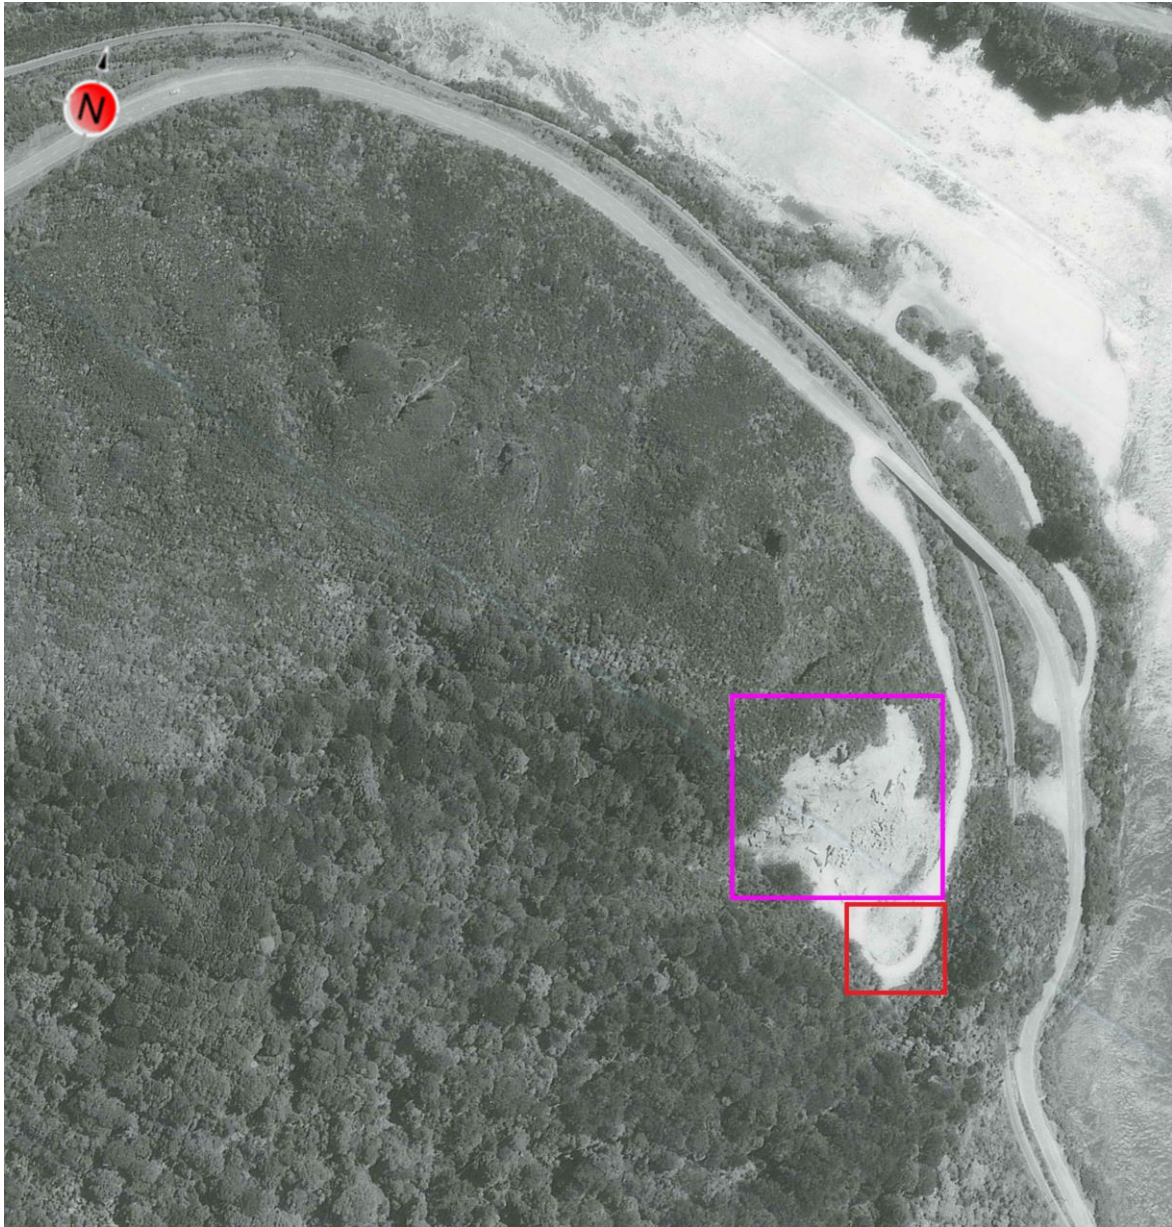
Aerial Photo 4 Site condition Anno 1994. The first (lower) switchback has been constructed on the access road (red outline). The area west of the lower leg of the access track is now an active quarry area (magenta outline).

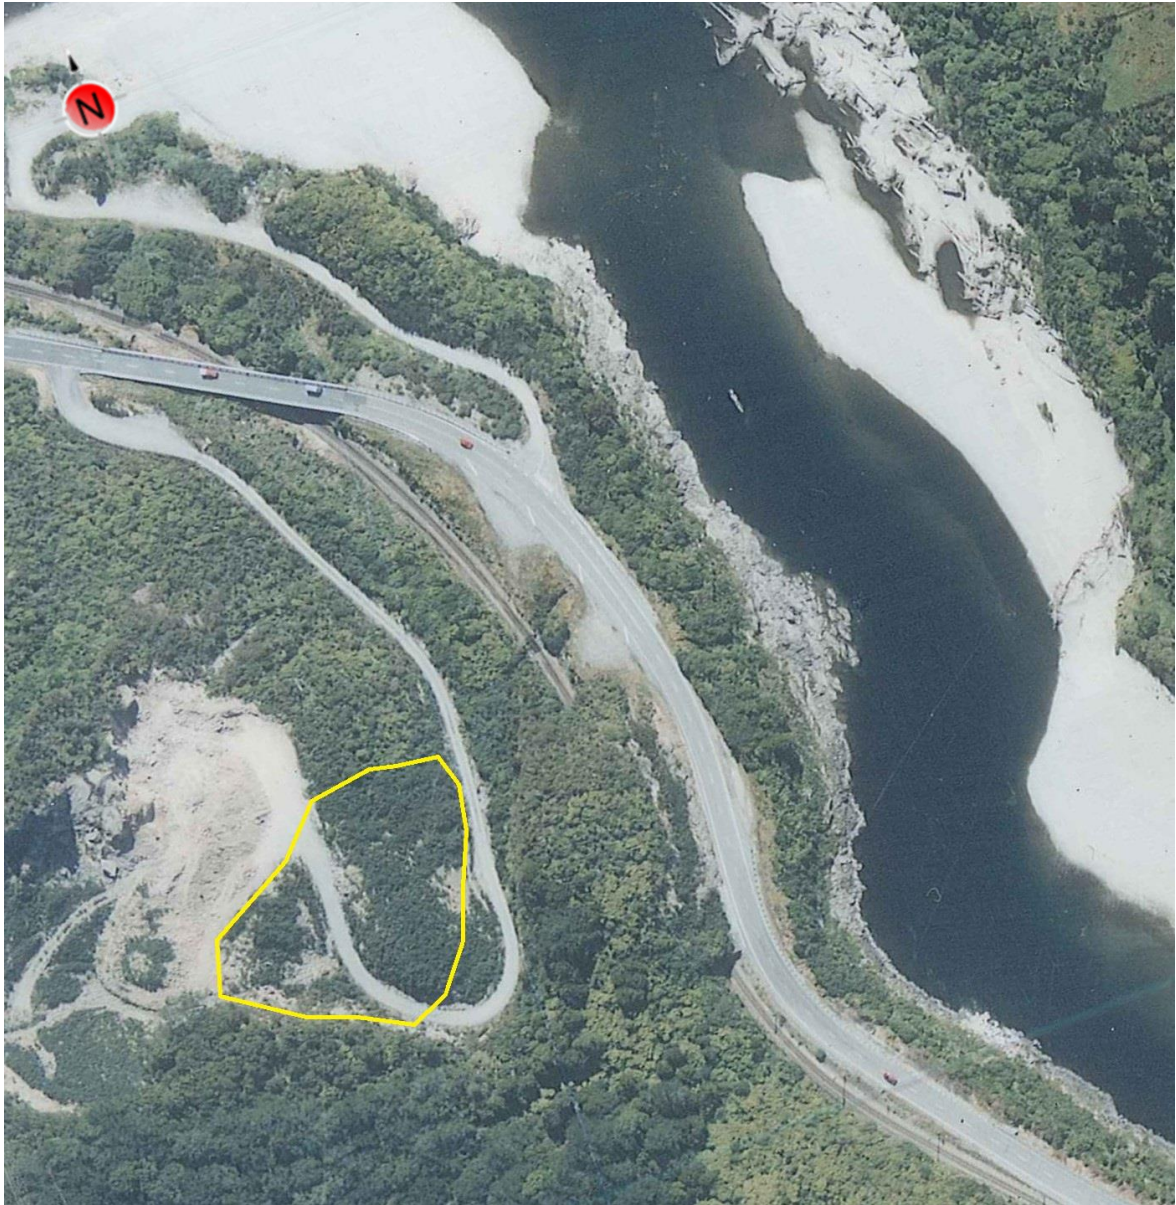
Aerial Photo 5 Site condition Anno 2001. The active quarry area has moved further west and northwest and previous active quarry area (yellow outline) has started to revegetate.

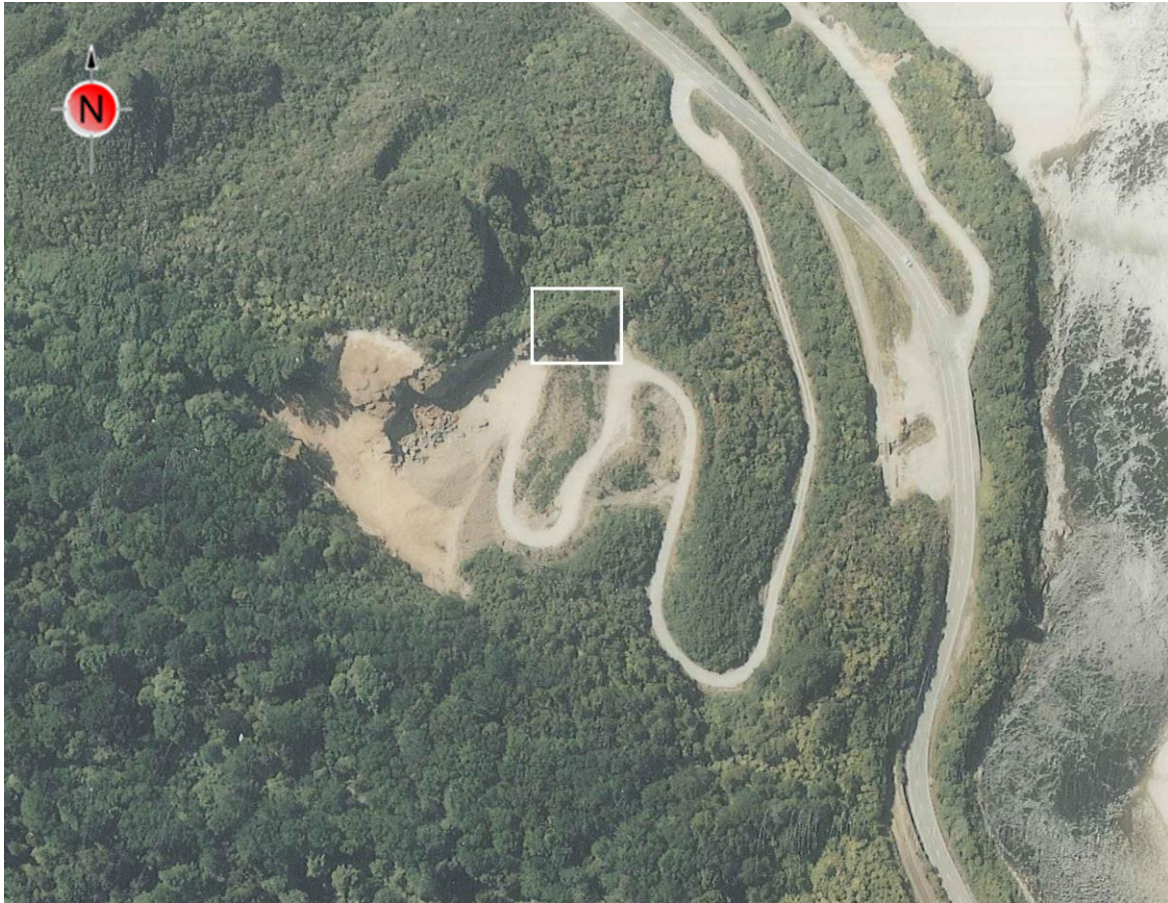
Aerial Photo 6 Site condition Anno 2008. The access road has been extended west including two additional switchbacks. A mining remanent feature, referred to as 'The Pinnacle', has been left behind by the second switchback.

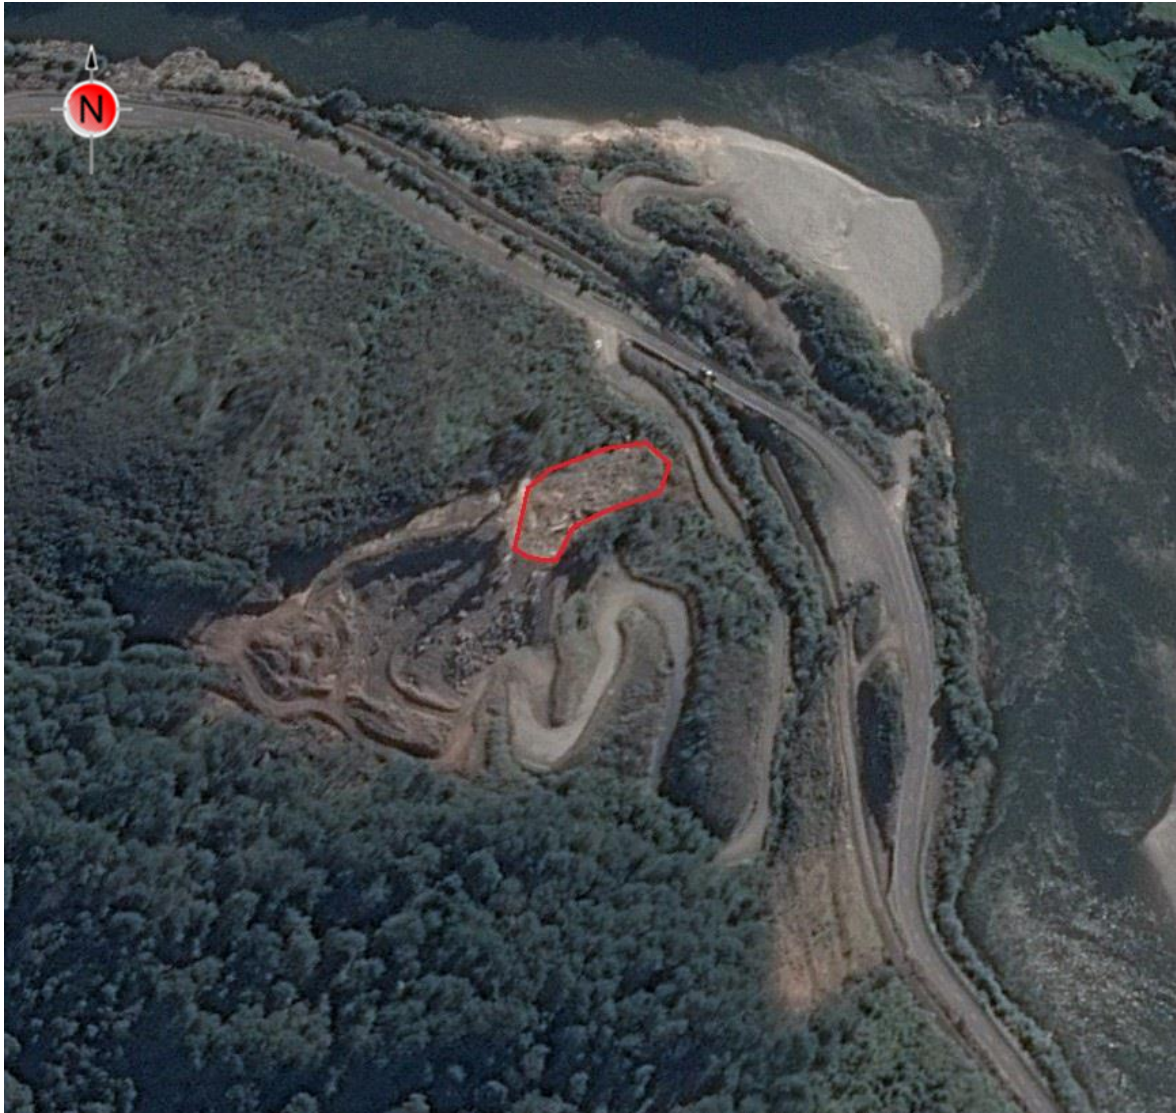
Aerial Photo 7 Site condition Anno 2013. The active quarry area has moved further west and north relative to 2008 conditions. Waste material appears to be dumped (in gully) on slope between high eastern rock face and lower section of the access road (red outline).

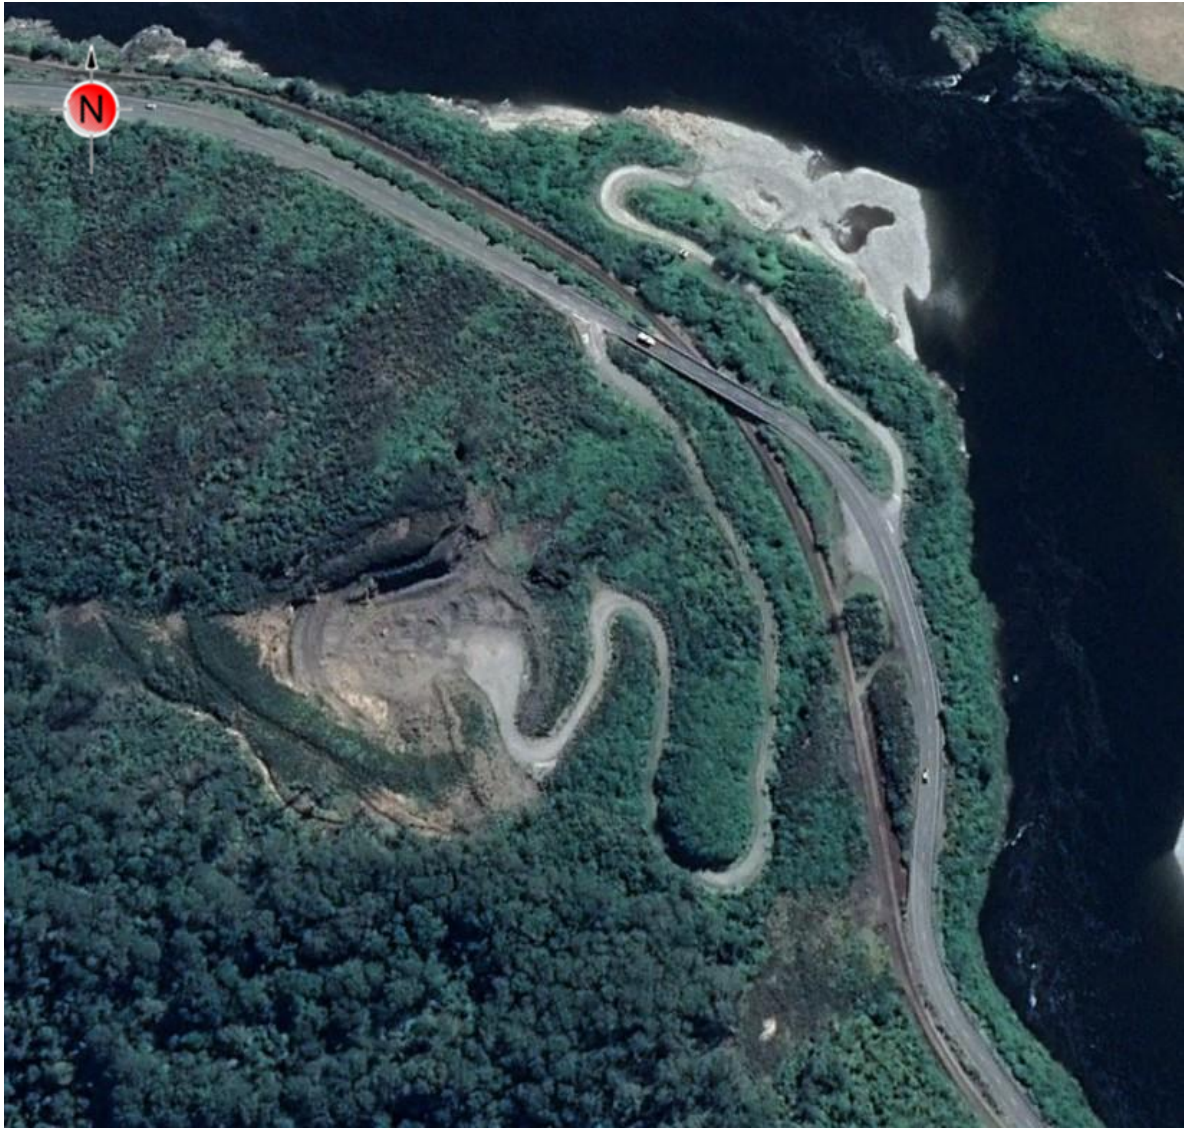
Aerial Photo 8 Site condition Anno 2020. Most quarry activities appear to have ceased. The waste dump (in gully east of the quarry, visible on the 2013 photo) is almost fully covered in low vegetation. The western and northern areas of the quarry have started to revegetate.

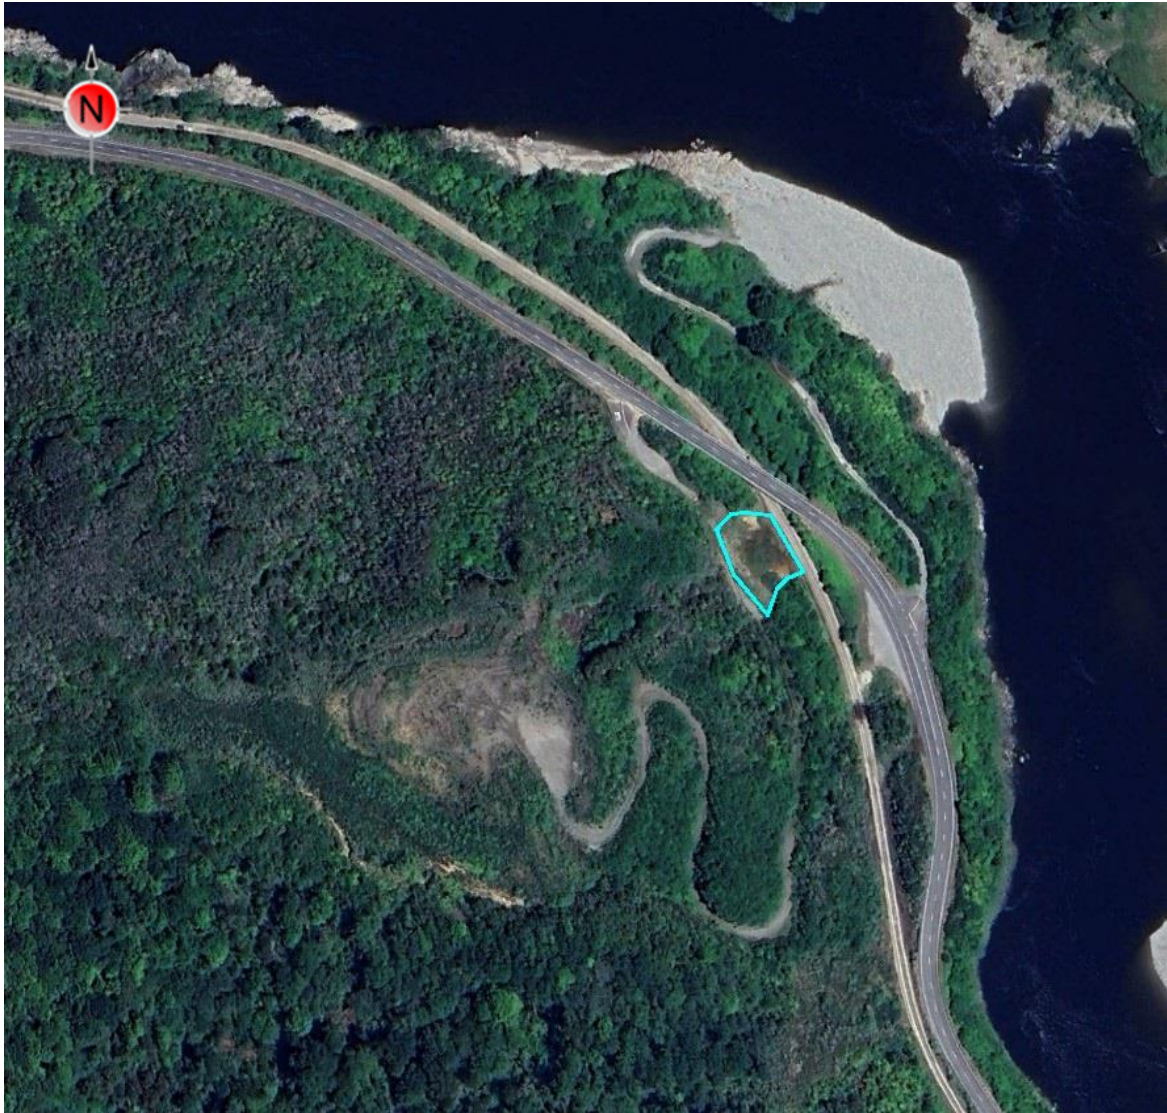
Aerial Photo 9 Site condition Anno 2024. The wider quarry area is now well vegetated. The slip on the lower part of the access road which occurred on 13 June 2022 has started to revegetate (blue outline).

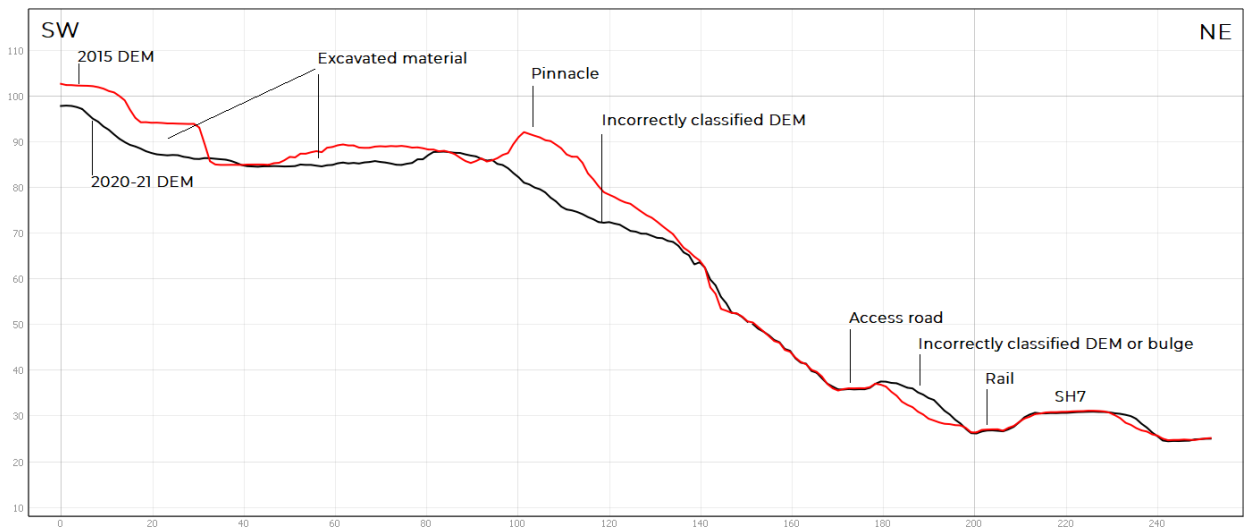
Section A – Southwest to northeast topographical section through western pit wall, pit floor, the Pinnacle, lower part of access road, rail corridor and SH7.

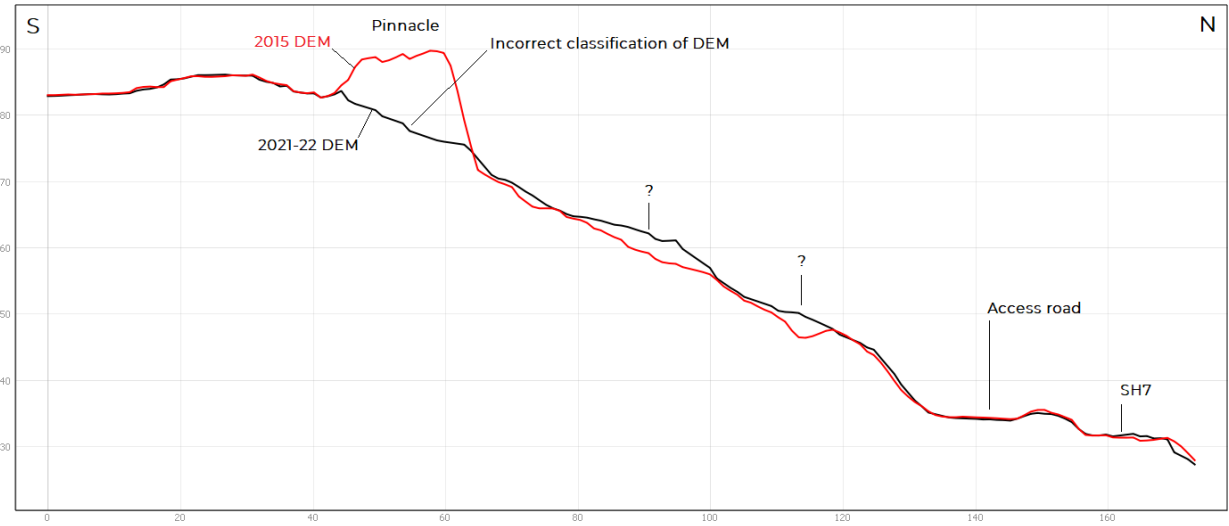
Section B – South to north topographical section through the Pinnacle, start of access road and SH7.

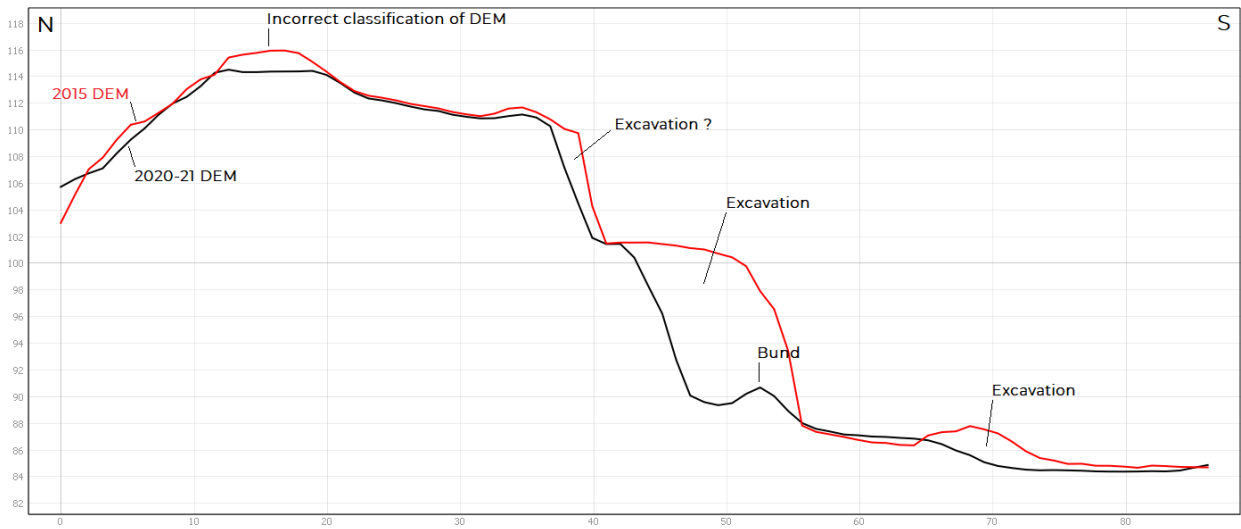
Section D – North to south topographical section through the northern high wall, bund below highwall and pit floor.

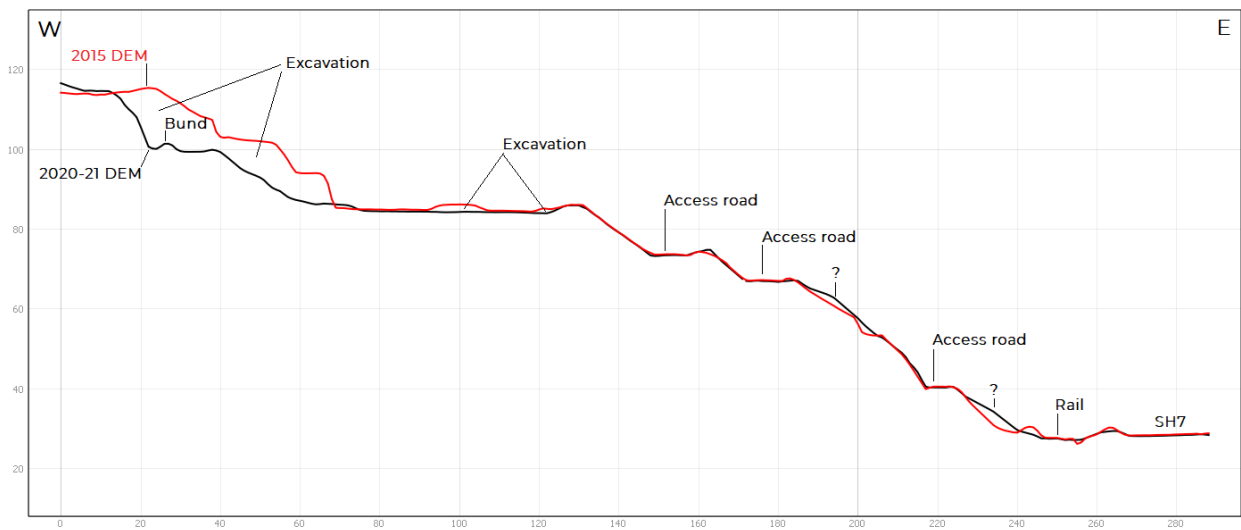
Section E - West to east topographical section through western pit wall, pit floor, access road (3 intercepts), rail corridor and SH7.

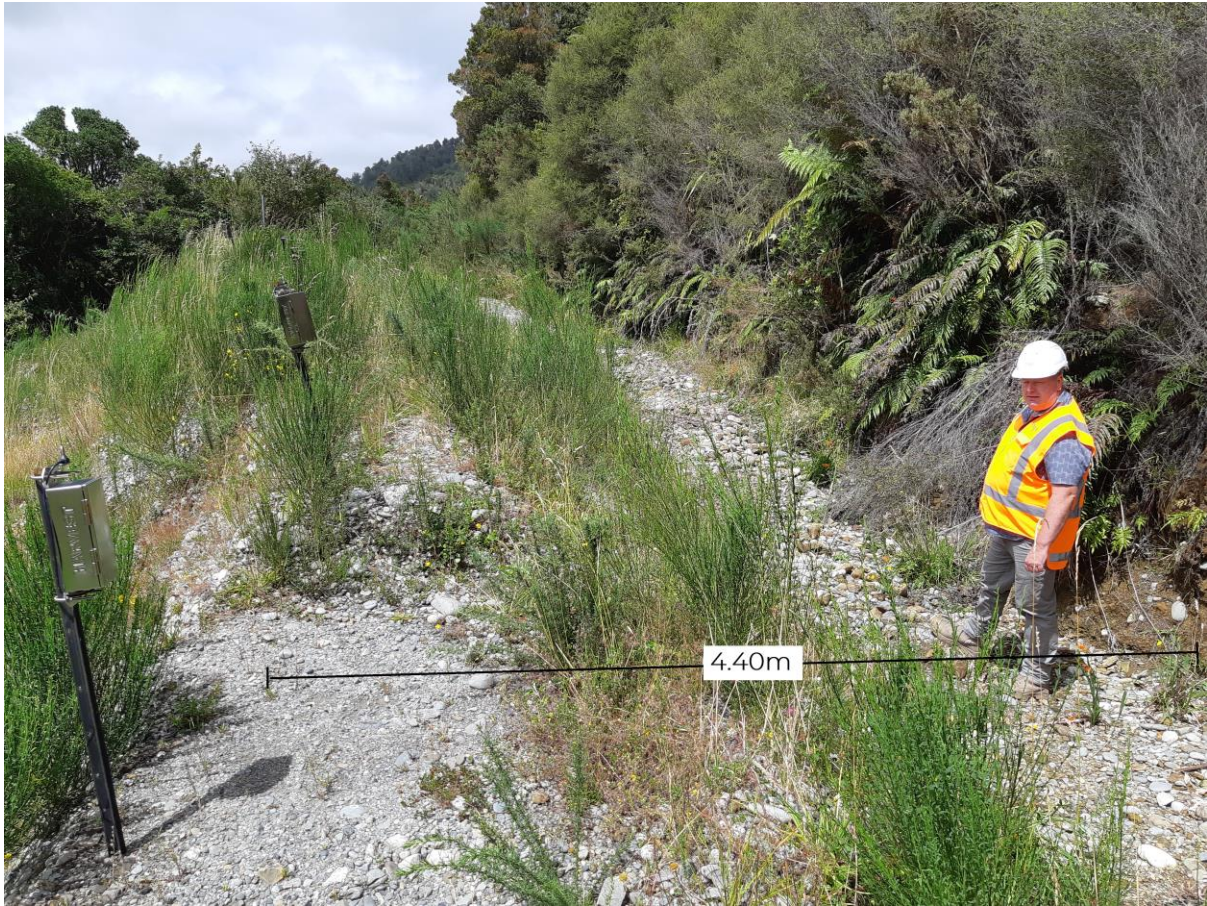
Site Photo 1 Failed section (KiwiRail Slip 198.7km) of the lower part of access road to Kiwi Quarry. KiwiRail has installed a series of tiltmeters along a bund straddling the crest of the slip to monitor the slope. The road width is currently 4.40m at the narrowest point.

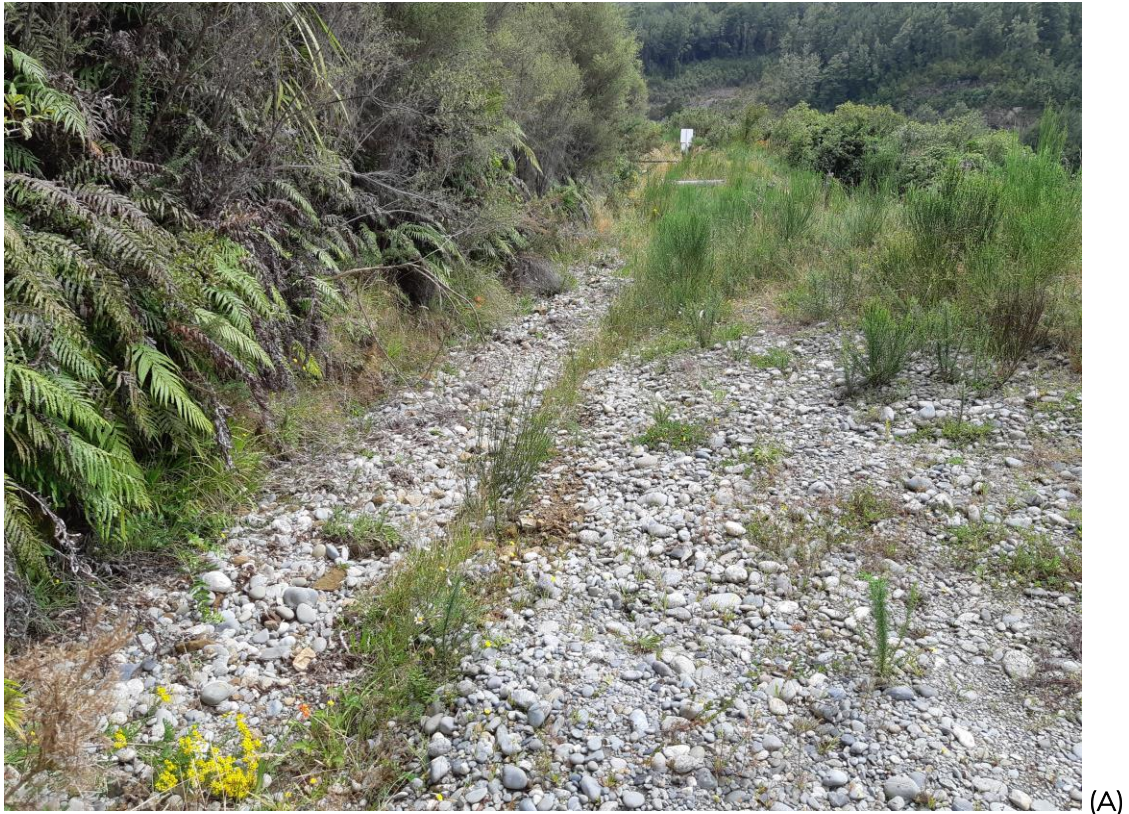
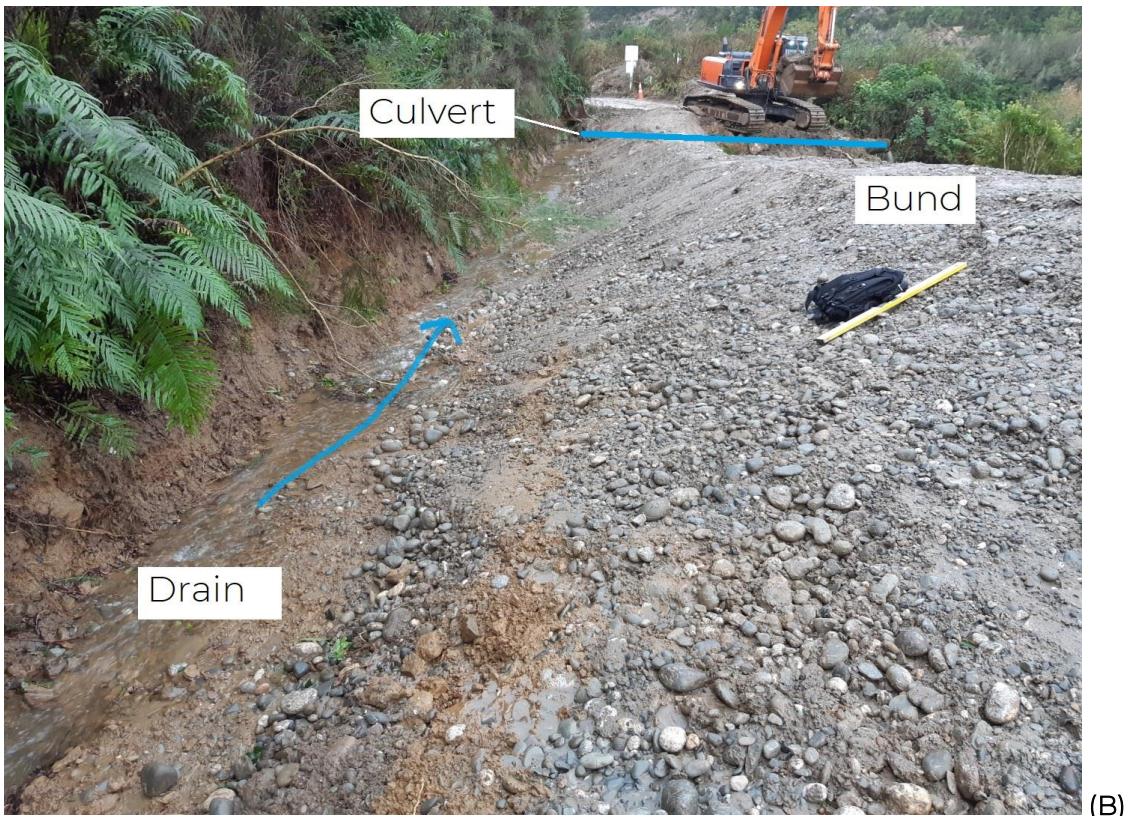
Site Photo 2 Swale drain above KiwiRail Slip 198.7km: (A) Current site conditions on 8/2/2024, (B) Site conditions on 14/6/2022, following emergency works. Significant debris accumulation was noted relative to 2022 site conditions, refer to Site Photos 3 and 4.

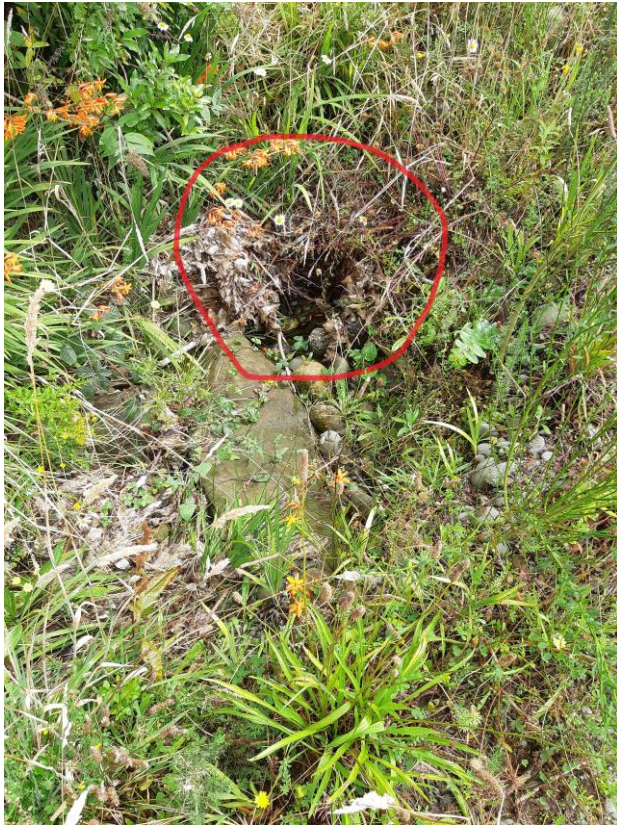
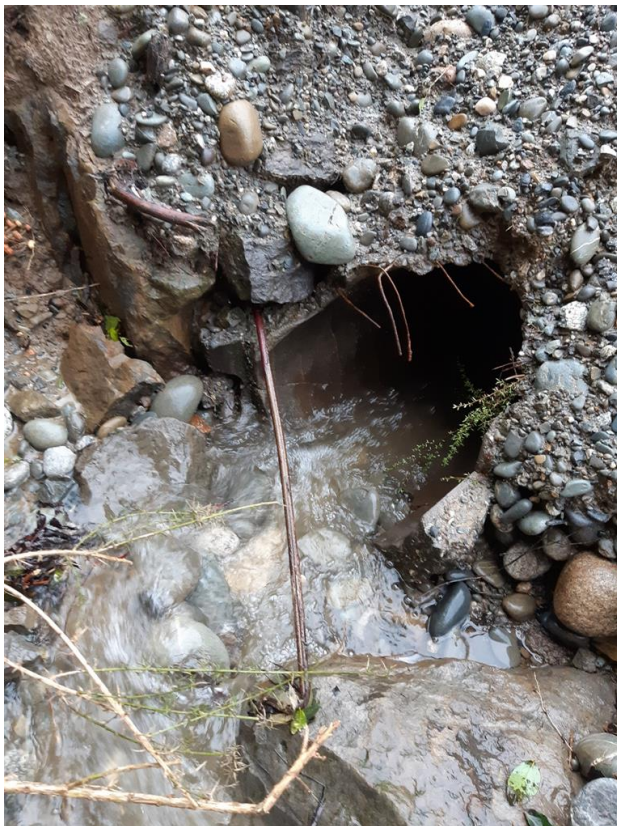
Site Photo 3 Culvert intake north side of KiwiRail Slip 198.7km: (A) Current site conditions on 8/2/2024, (B) Site conditions on 14/6/2022. The intake needs a cleanout to prevent blockage.
