WEST COAST
REGIONAL COUNCIL

Meeting of Infrastructure Governance Committee
(Te Huinga Tu)

Tuesday, 7 May 2024

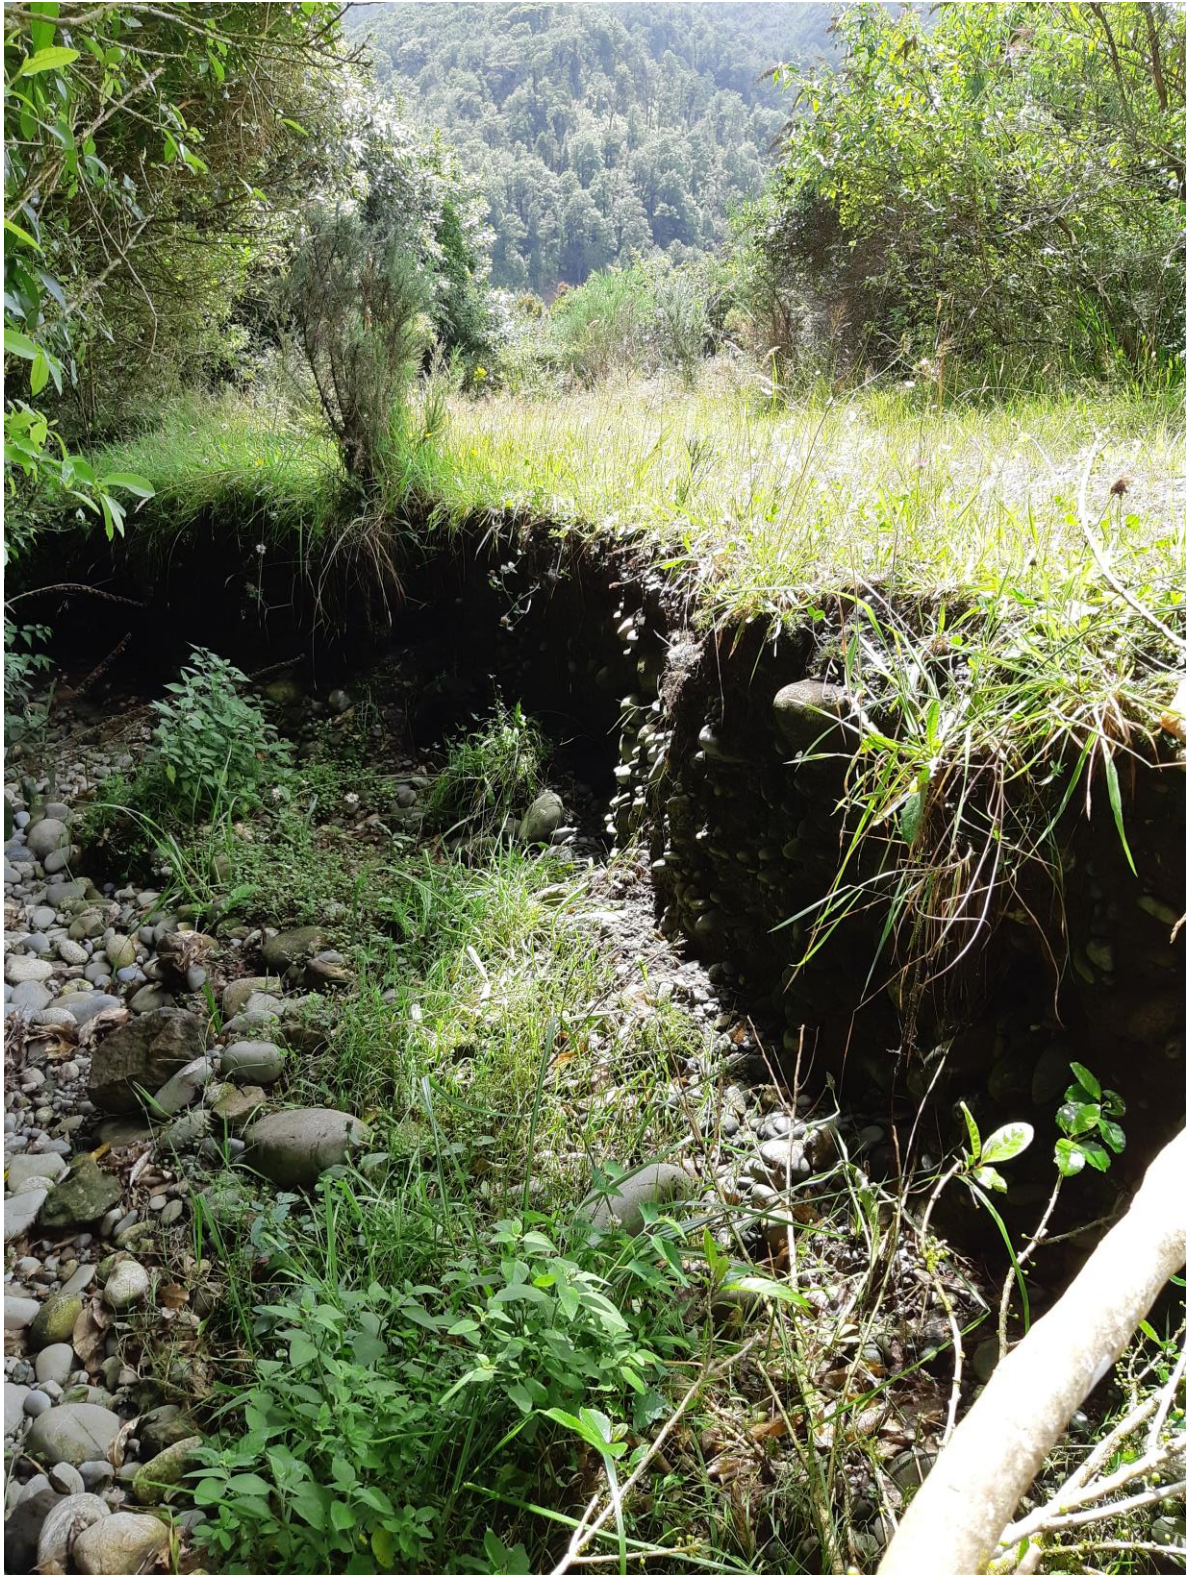
Site Photo 4 Swale drain - upslope side of access road approximately 20m below lower switchback. Recent scour of road subgrade, which is the most likely source area for recent gravel built up in stormwater channel above the KiwiRail Slip 198.7km, refer to Site Photo 2A.

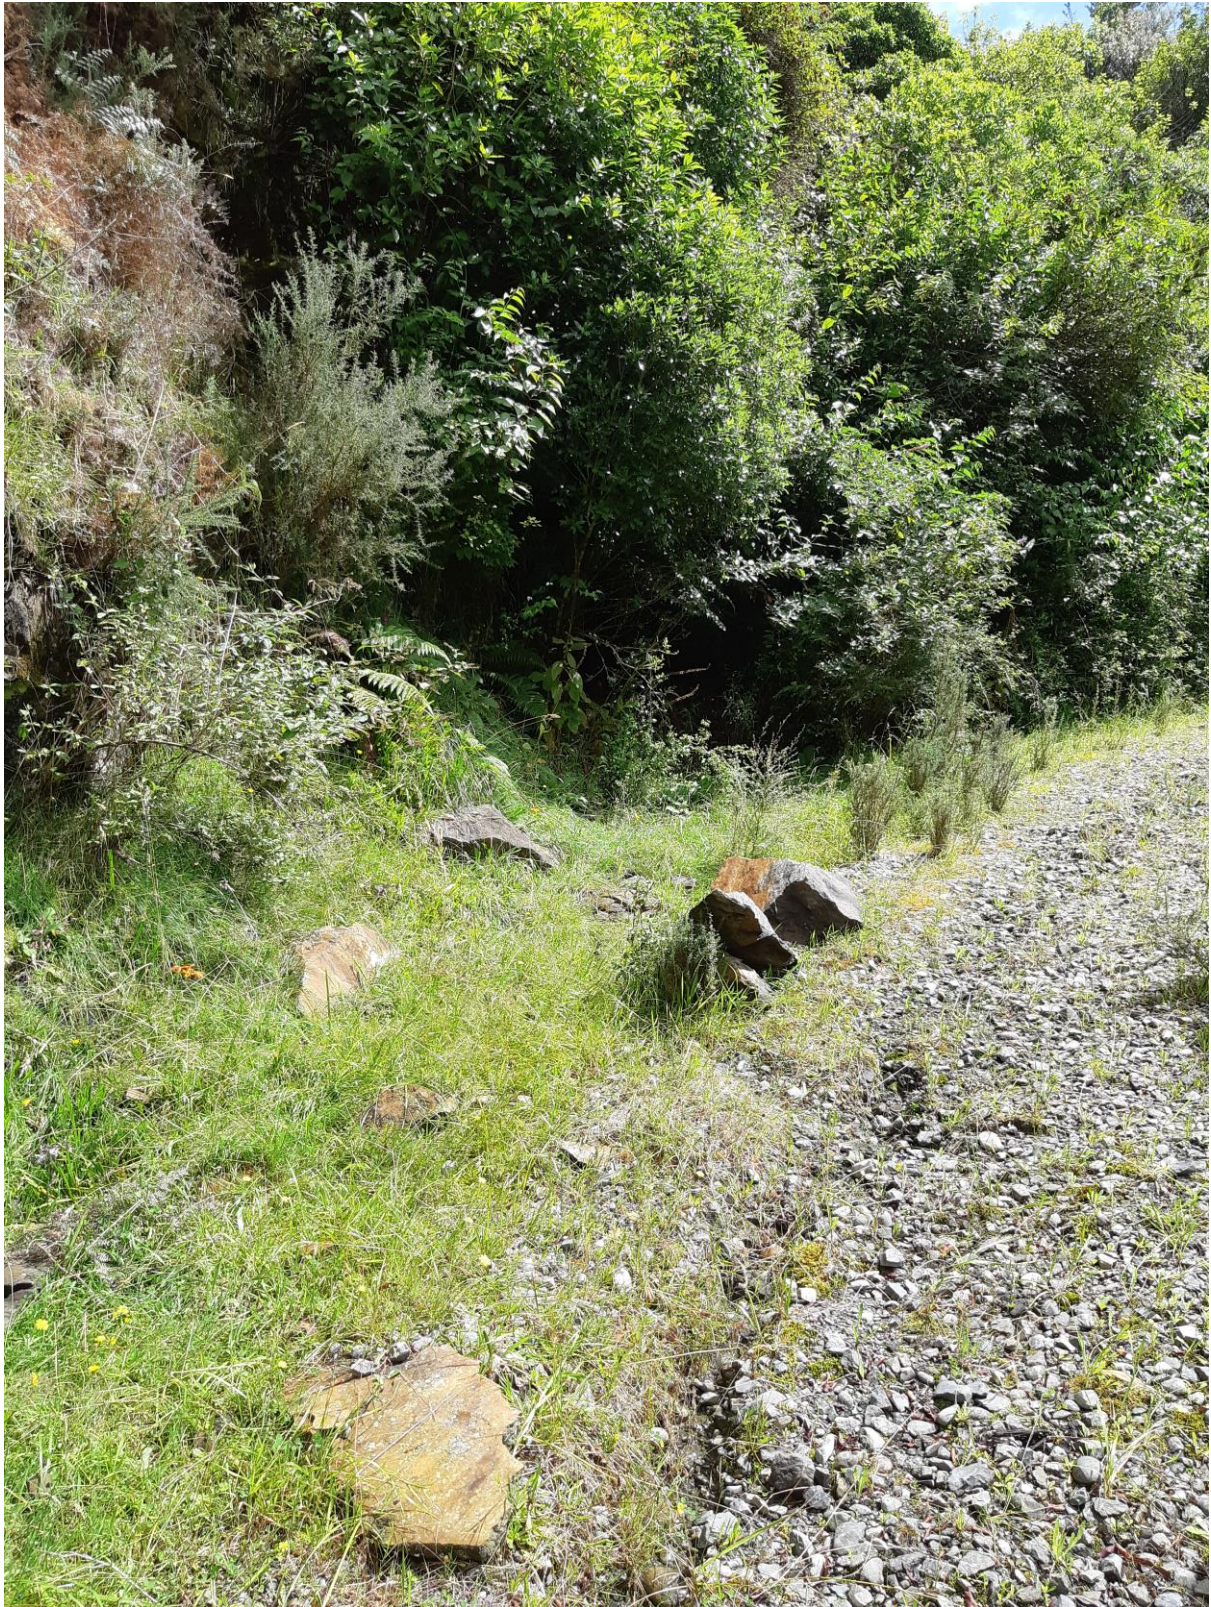
Site Photo 5 Rockfall in shoulder of access road by lower switchback. Block size up to 0.80x0.55x0.45m maximum size.

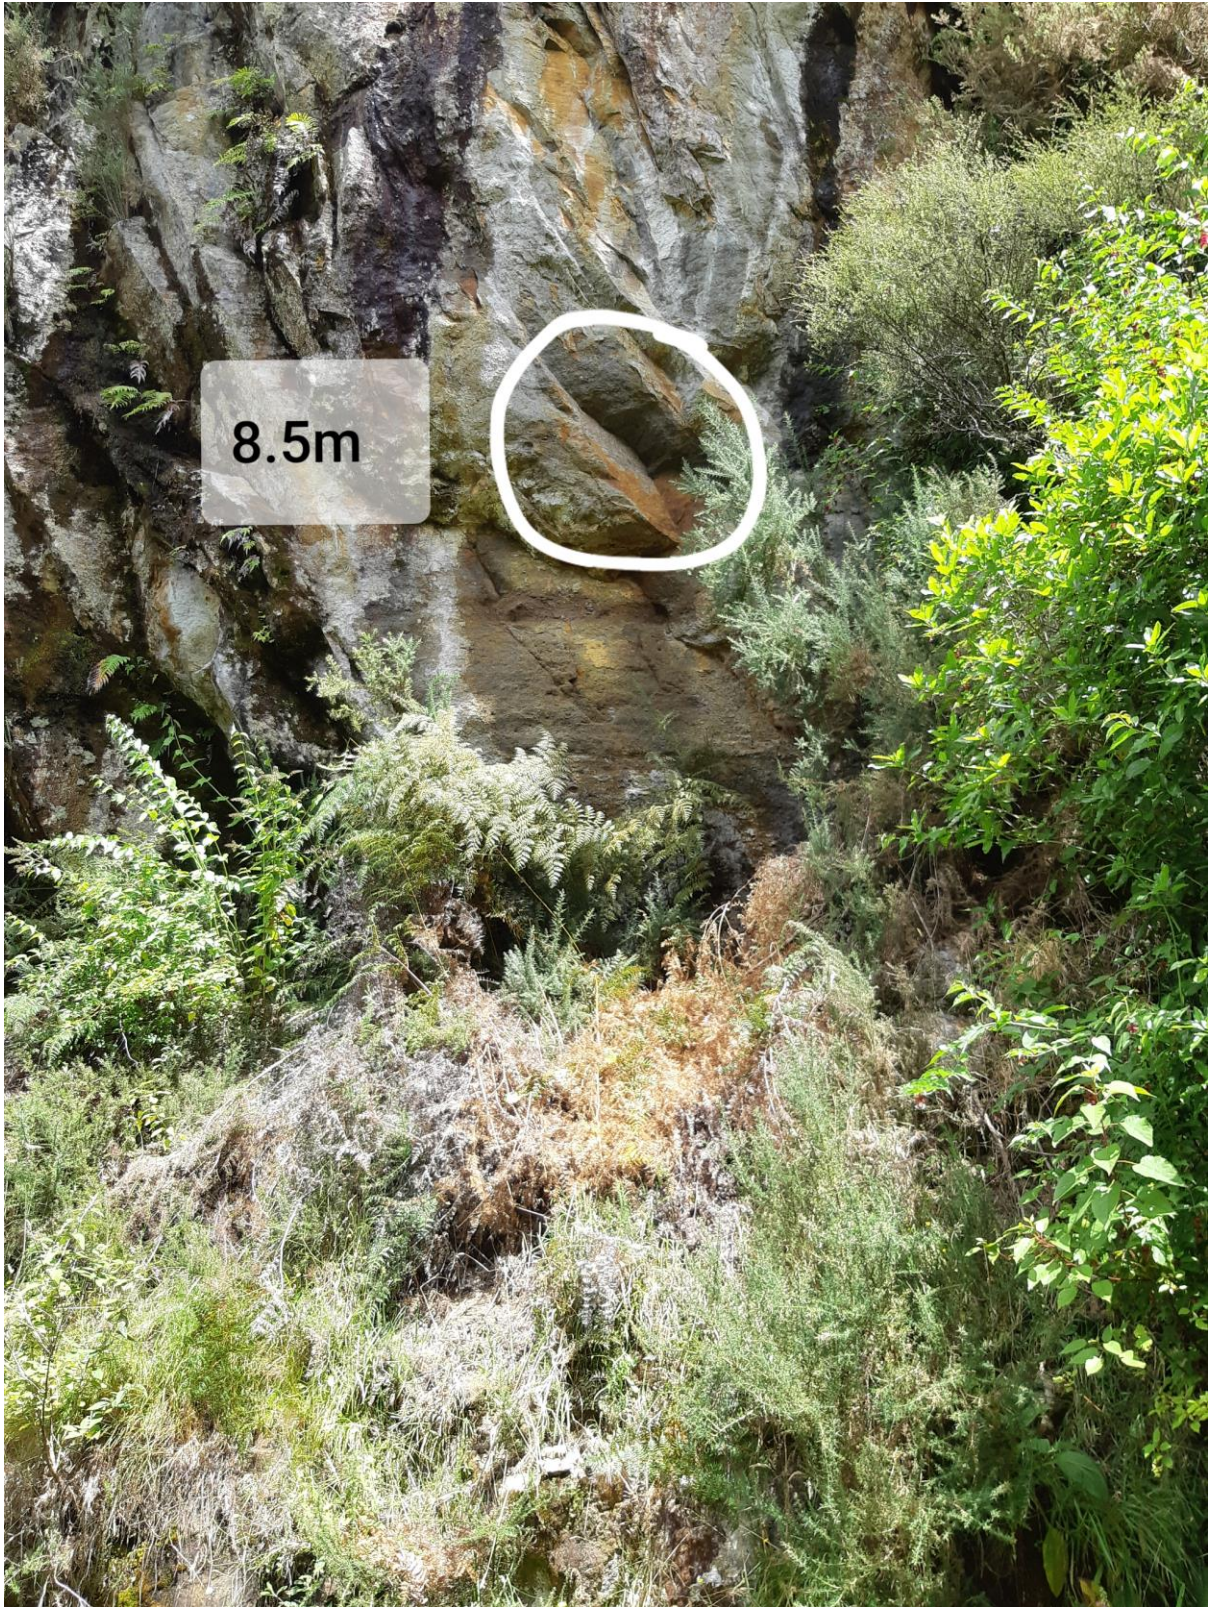
Site Photo 6 Overhanging face above rockfall by lower switchback. Source area of rockfall likely from small wedge failure 8.5m vertical distance above the road.

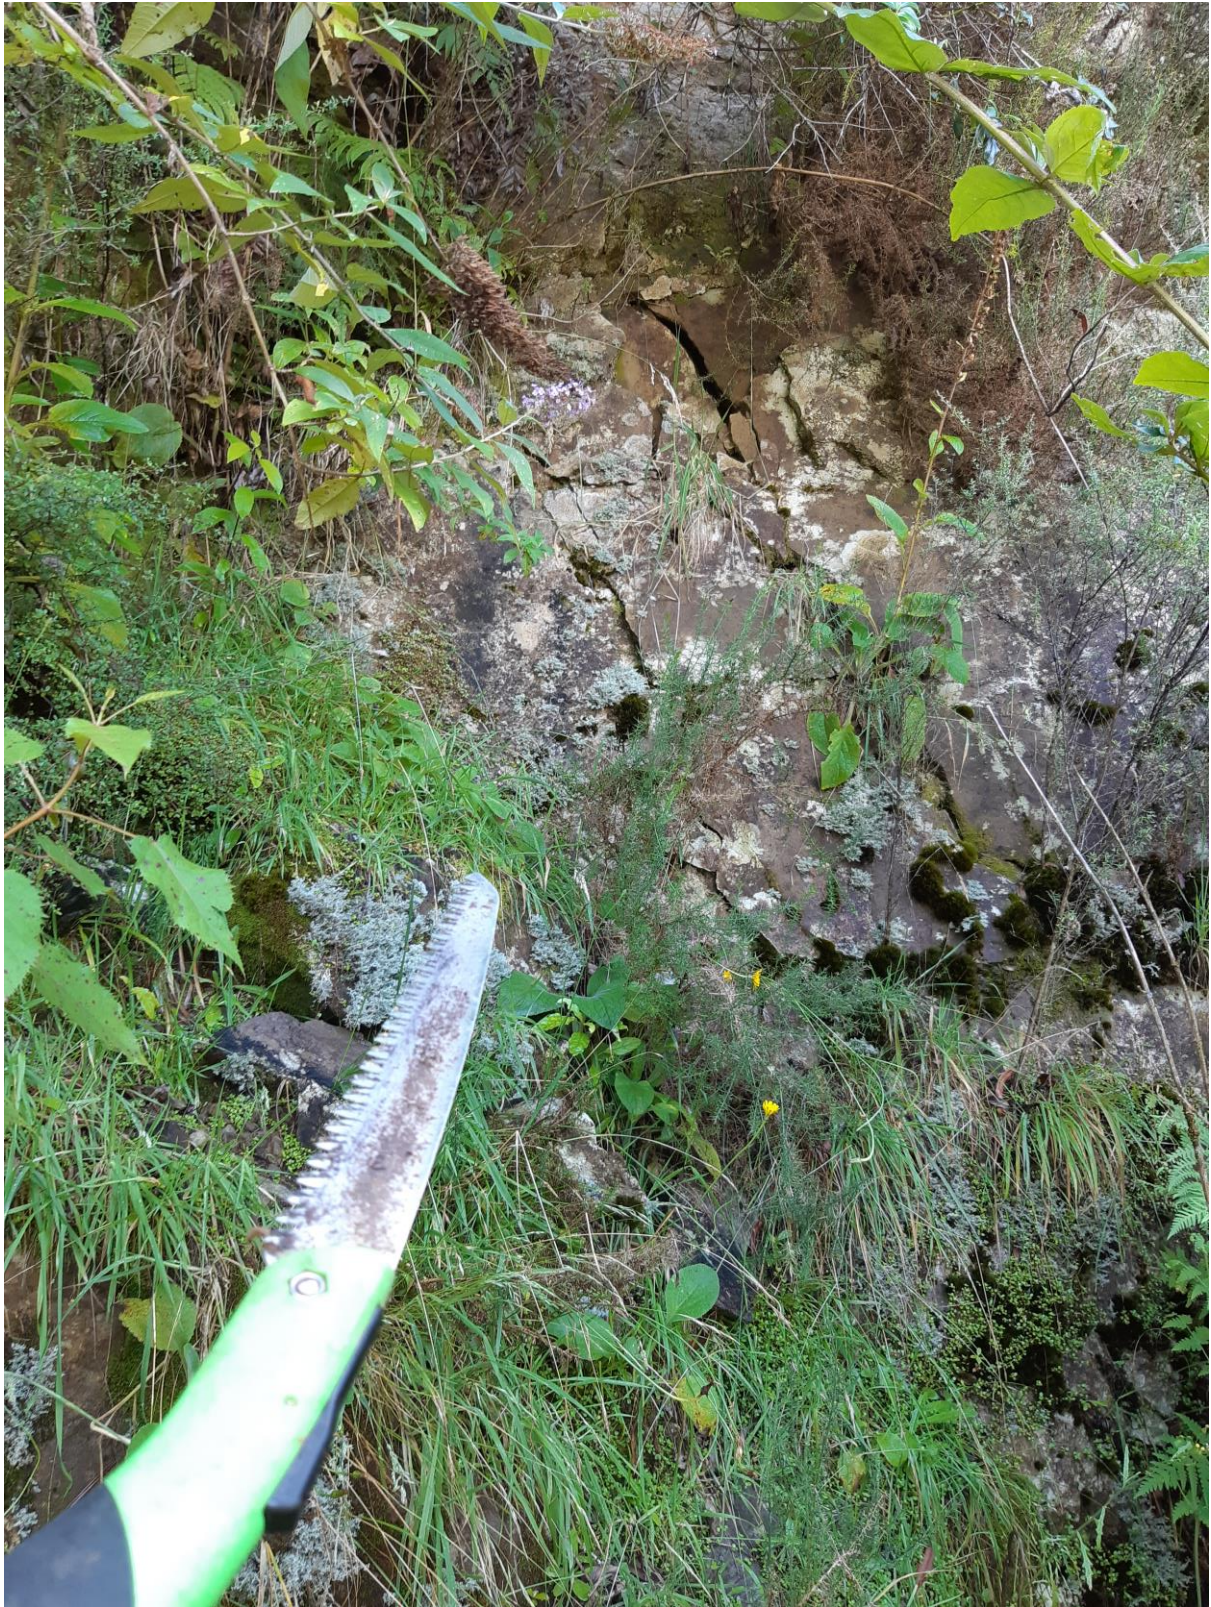
Site Photo 8 Developing surface cracks observed in rockface on southeastern side of the Pinnacle.

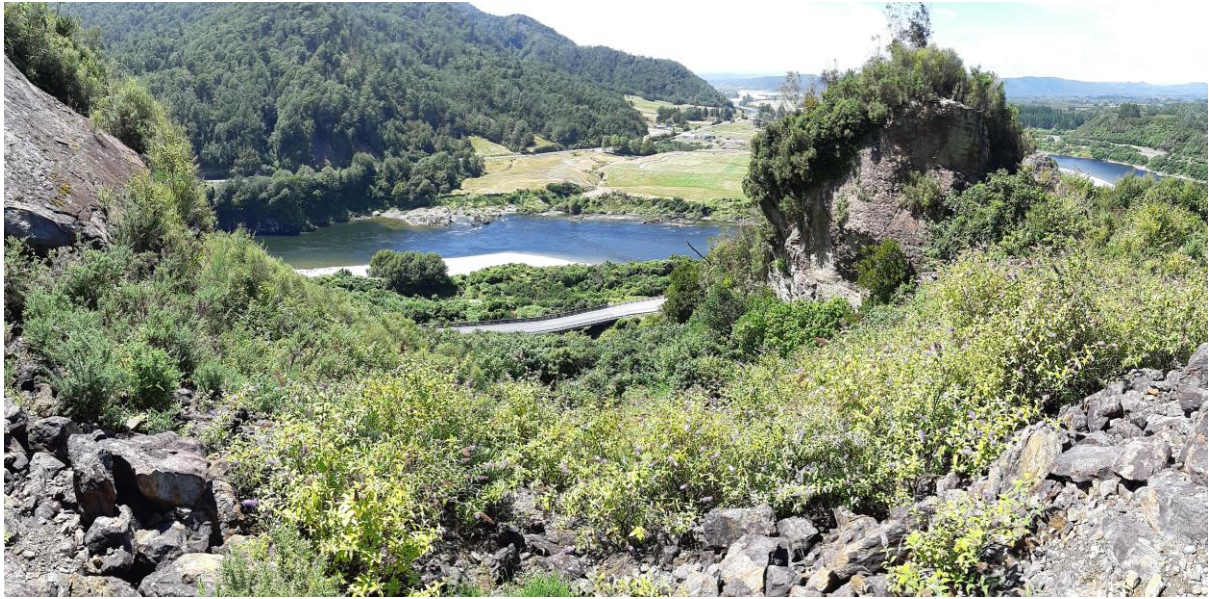
Site Photo 9 Eastern extent of Kiwi Quarry. Photo taken from a bund constructed along the slope crest, looking down the debris filled gully (east) towards SH7. The Pinnacle can be seen in the RHS of the photo.

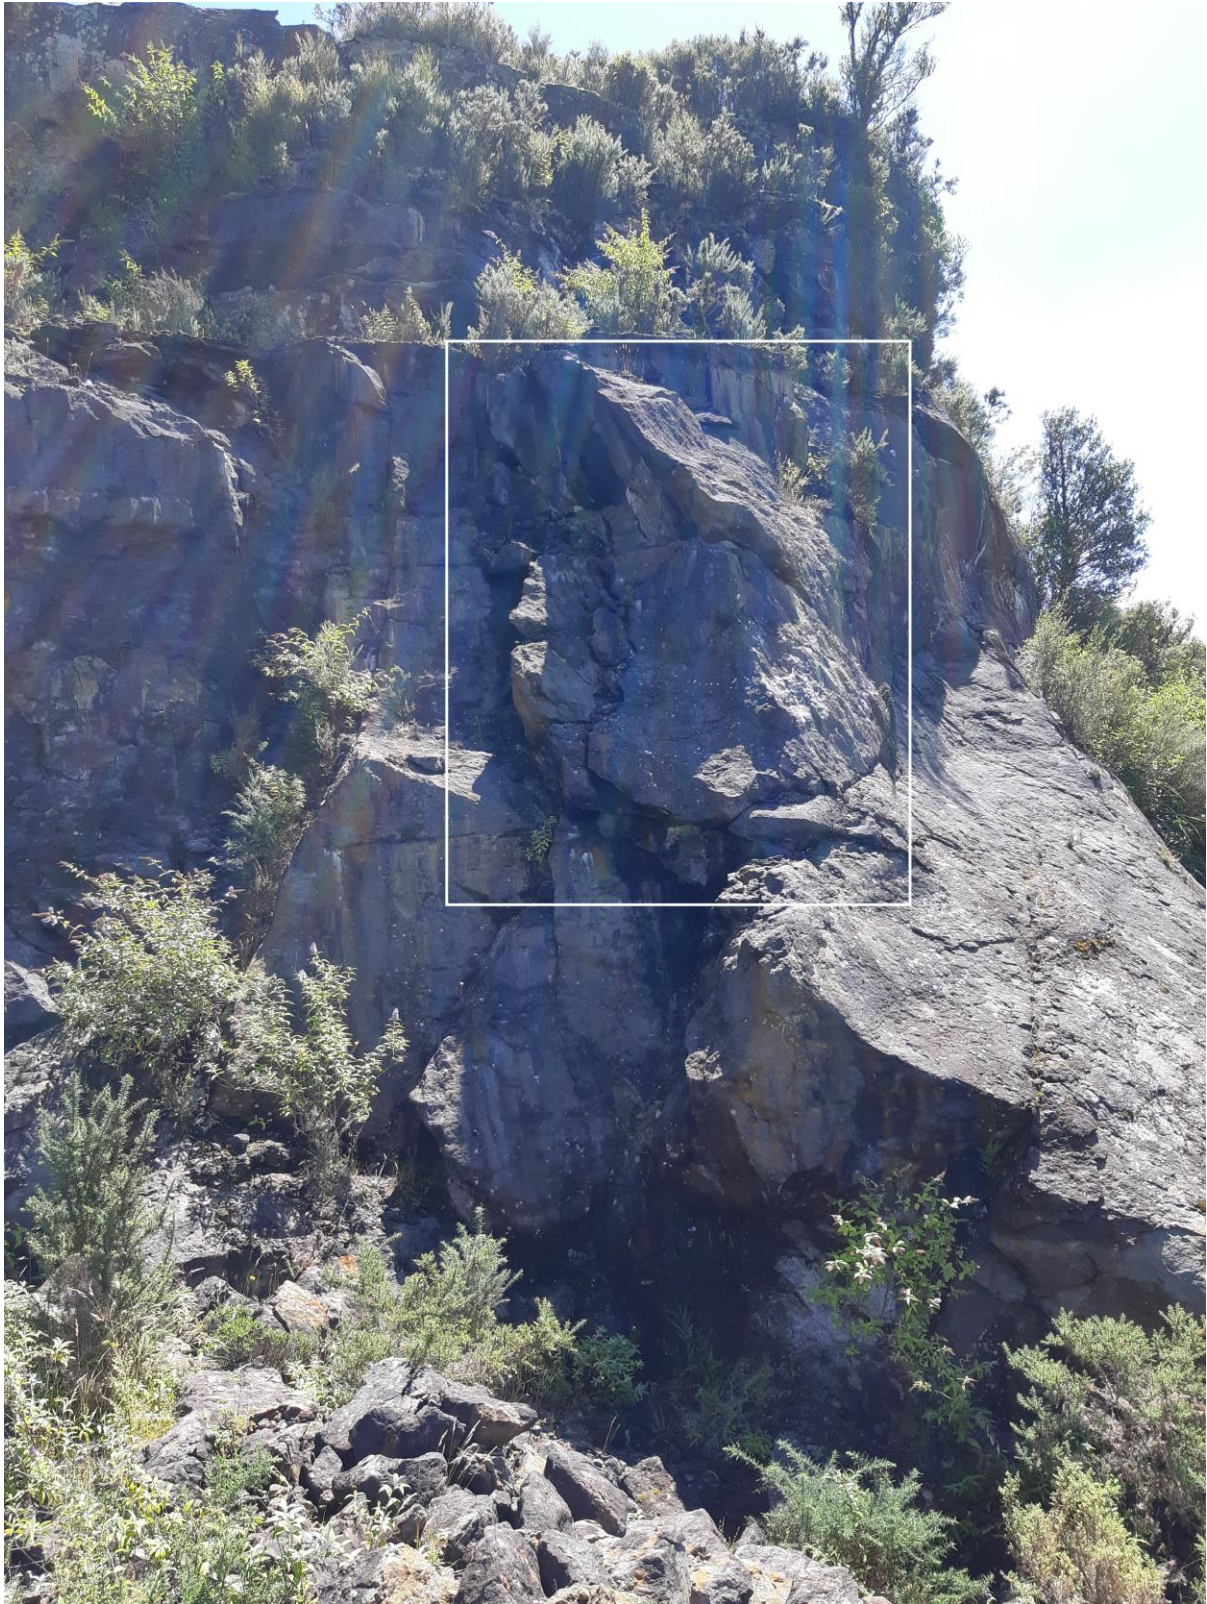
Site Photo 12 Lower batter of the Nose. A large slab (estimated at 3x2x1m) of rock appears to be partly detached.

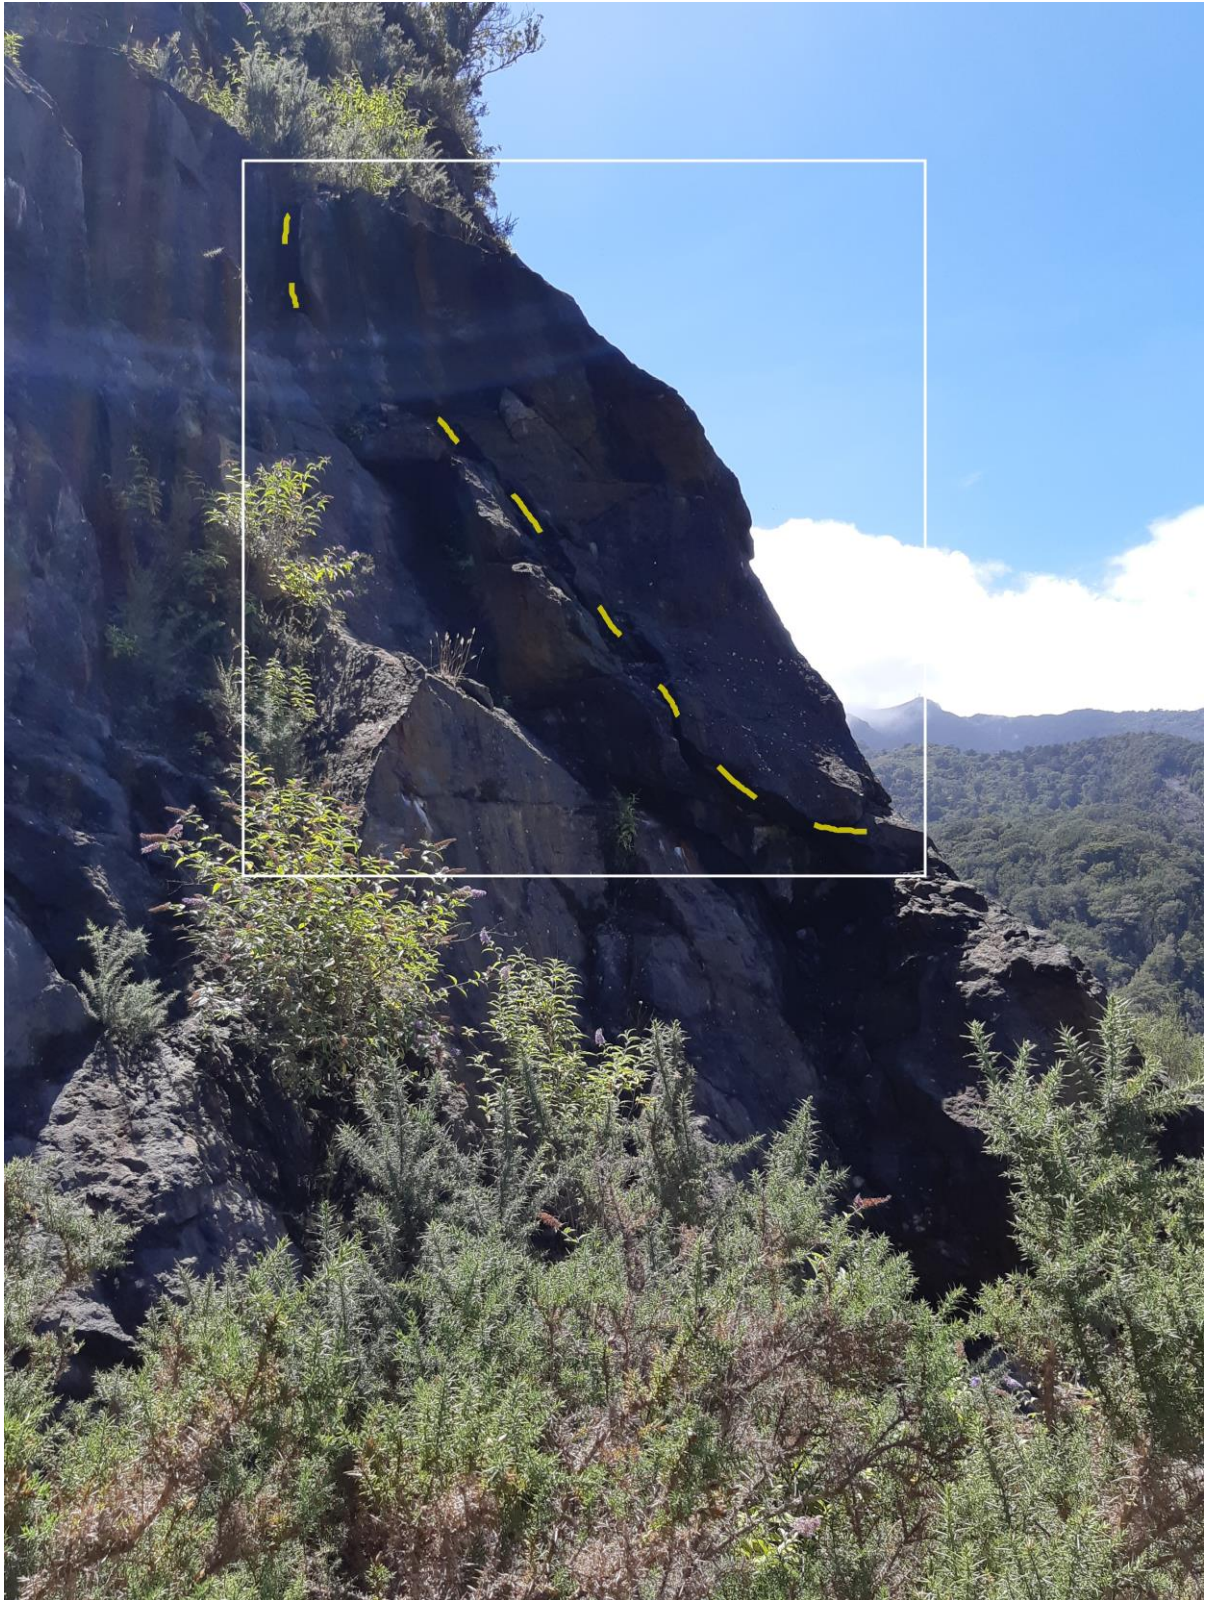
Site Photo 13 Lower batter of the Nose. Large slab (estimated at 3x2x1m) of rock appears to be partly detached.

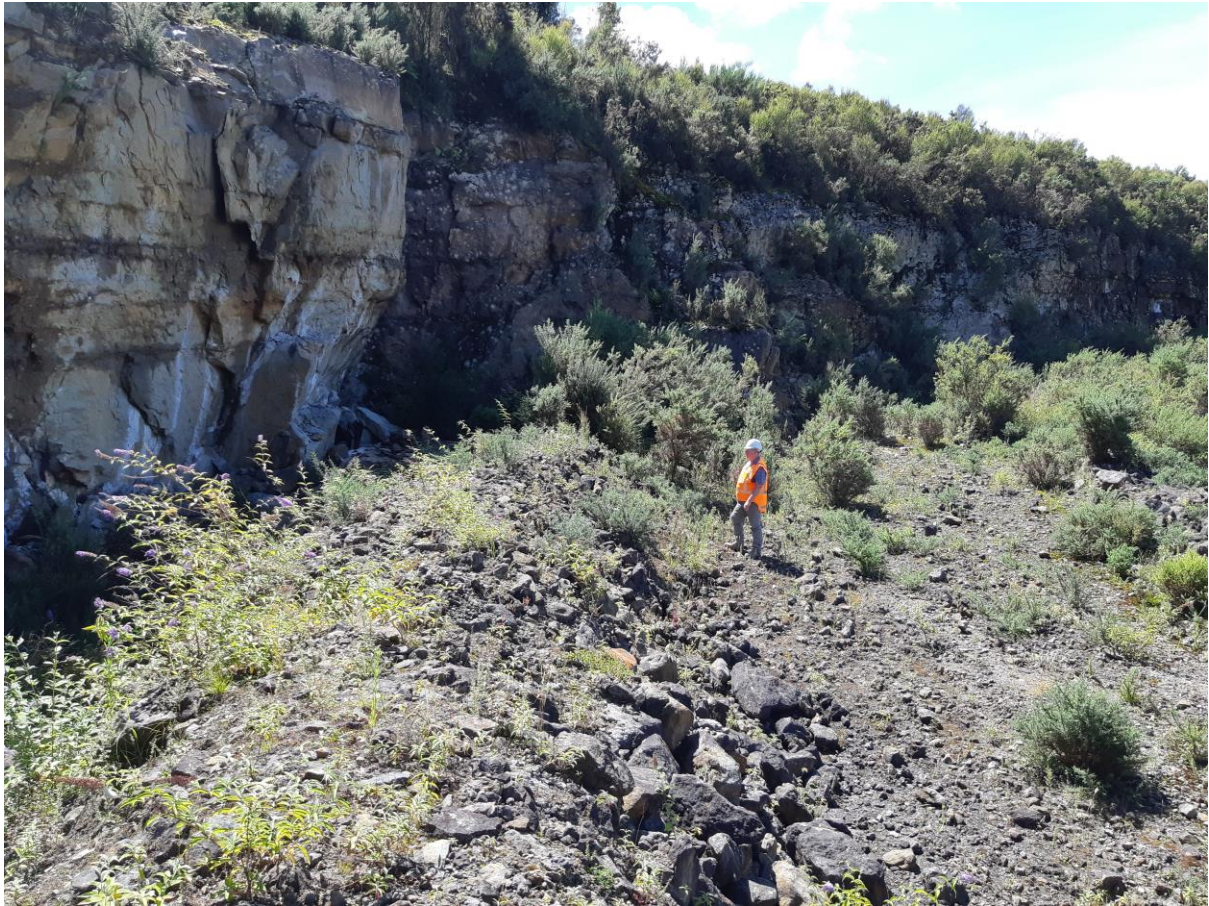
Site Photo 15 Western pit wall. A bund has been constructed at the toe, refer to *Site Photo 14*.

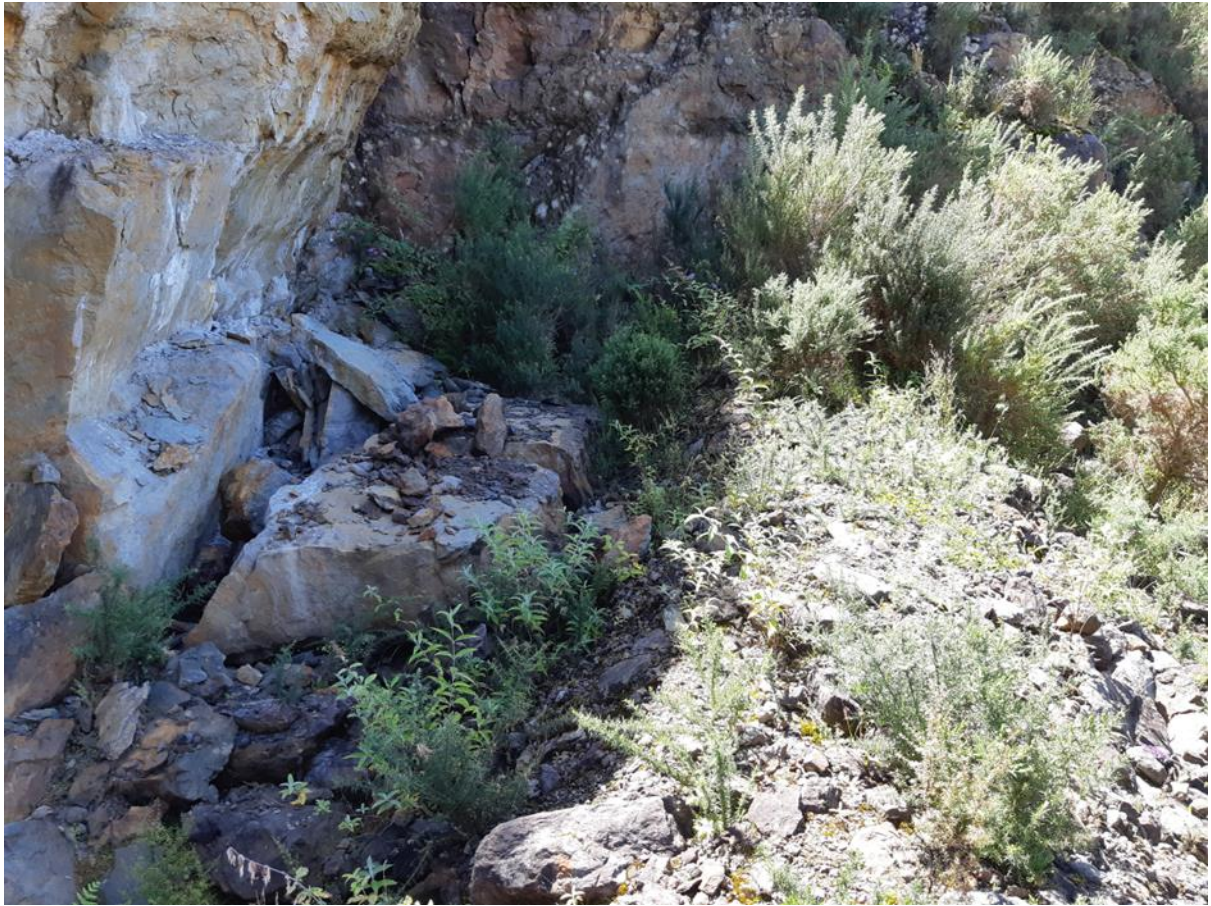
Site Photo 16 Western pit wall. Large block of sandstone caught behind earth bund (post 2015 rockfall).

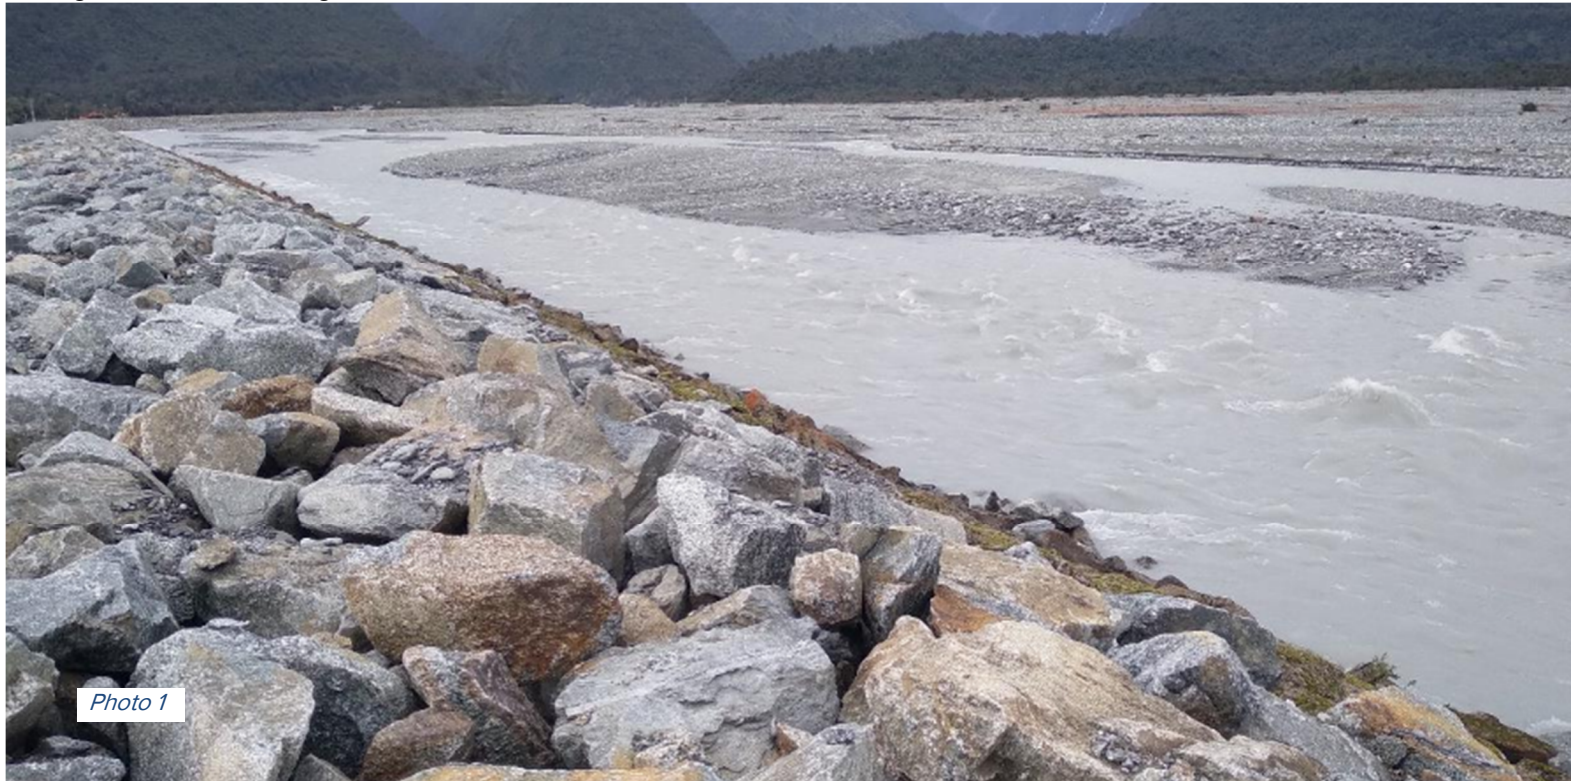
Photo 1 below was taken on 16 April 2024 and was taken at approximately chainage 100 (Havil Wall) looking toward the Link Bank showing completed stopbank raising and rock armouring.
