West Coast Lakes Aquatic Weed Surveillance 2022

West Coast Regional Council

June 2022

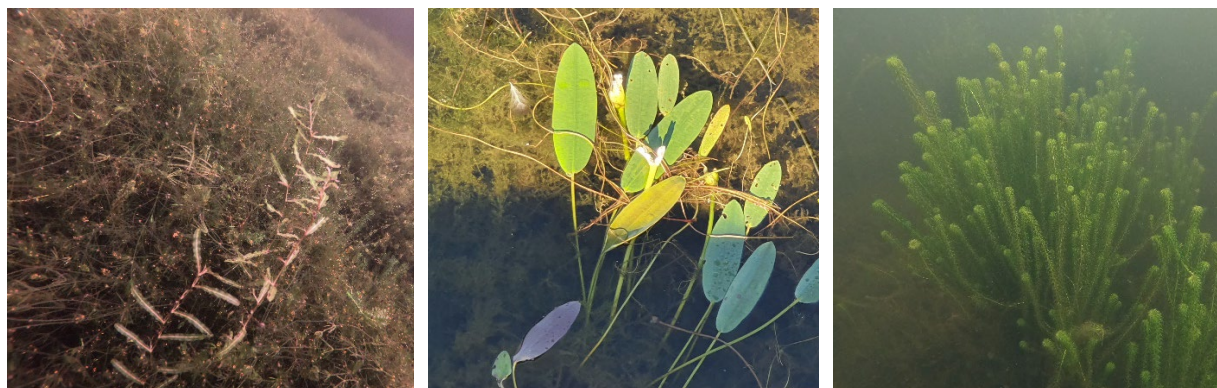
Lagarosiphon major – lanthe and Paringa (Figure 1). Already known in these lakes.

Potamogeton crispus – Brunner (main ramp – Figure 1, Orangipuku River Mouth) and Mahinapua (main ramp). Minor component of overall vegetation and present among indigenous vegetation rather than displacing. Previously recorded in Lake Brunner (BOPRC, 2021).

Aponogeton distachyos - Mahinapua (main ramp and Picnic Bay) (Figure 1), known in Mahinapua since 1950 (Champion & Clayton, 2004). It does not appear to be displacing native species at these sites.

Figure 1 Examples of several introduced species, *P. crispus* (left), *A. distachyos* (middle) and *L. major* (right).

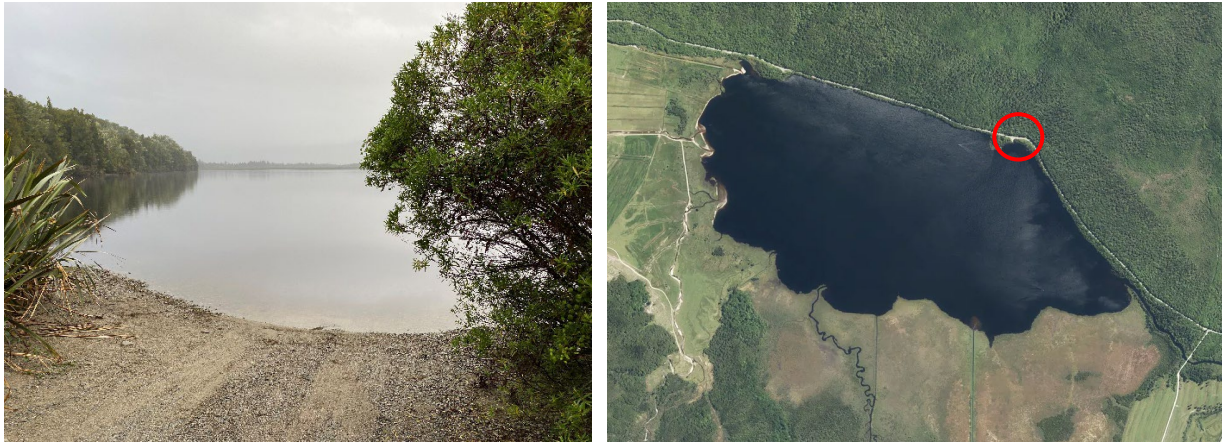
The area surveyed at Lake Haupiri was directly adjacent to the boat ramp and was very shallow across the whole survey area, with dark, tannin-stained water (Figure 2). Elodea was the only recorded invasive species at less than 5% invasive ratio. The site was dominated by native vegetation including charophytes, isoetes, milfoils and pondweeds. The shallow water introduced species, *L. palustris* remained present at low densities in <1m depth.

A smothering algal mat was also noted across large areas of the site (see additional video footage).

Figure 2 Site photo and location (red circle), Lake Haupiri.

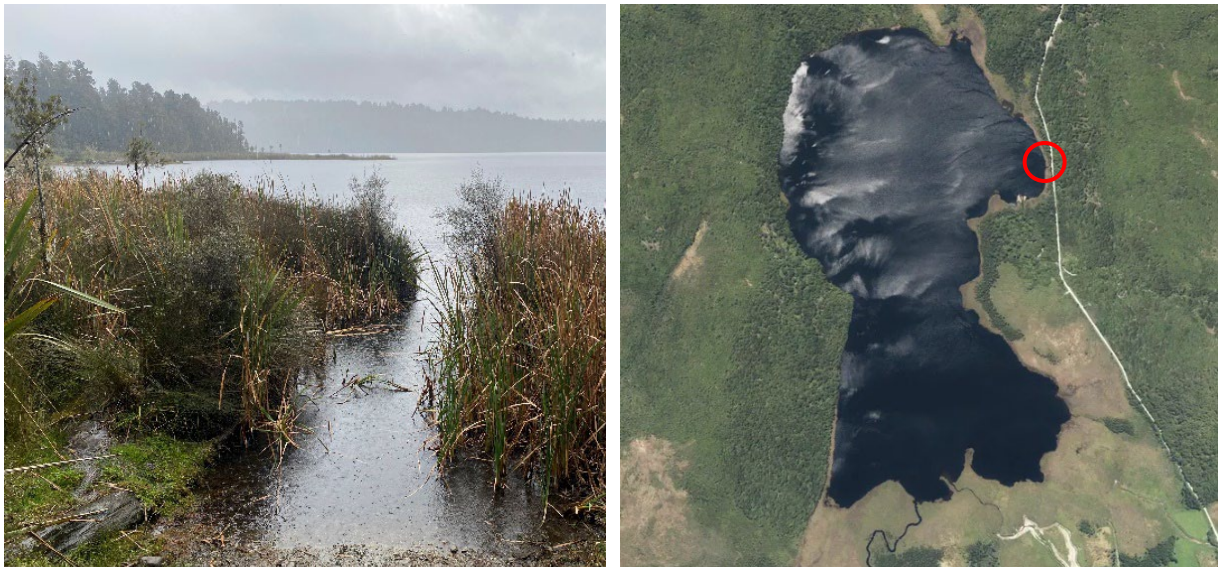
The Lady Lake survey area was accessed via the road through a narrow gap in the Raupō (Figure 3). The very dark water made observations difficult. Elodea was recorded at 6-25% compared to natives. *L. palustris* was very common along the shallow margin. Native vegetation included emergents, turf, charophytes, isoetes, milfoils and pondweeds.

Figure 3 Site photo and location (red circle), Lady Lake.

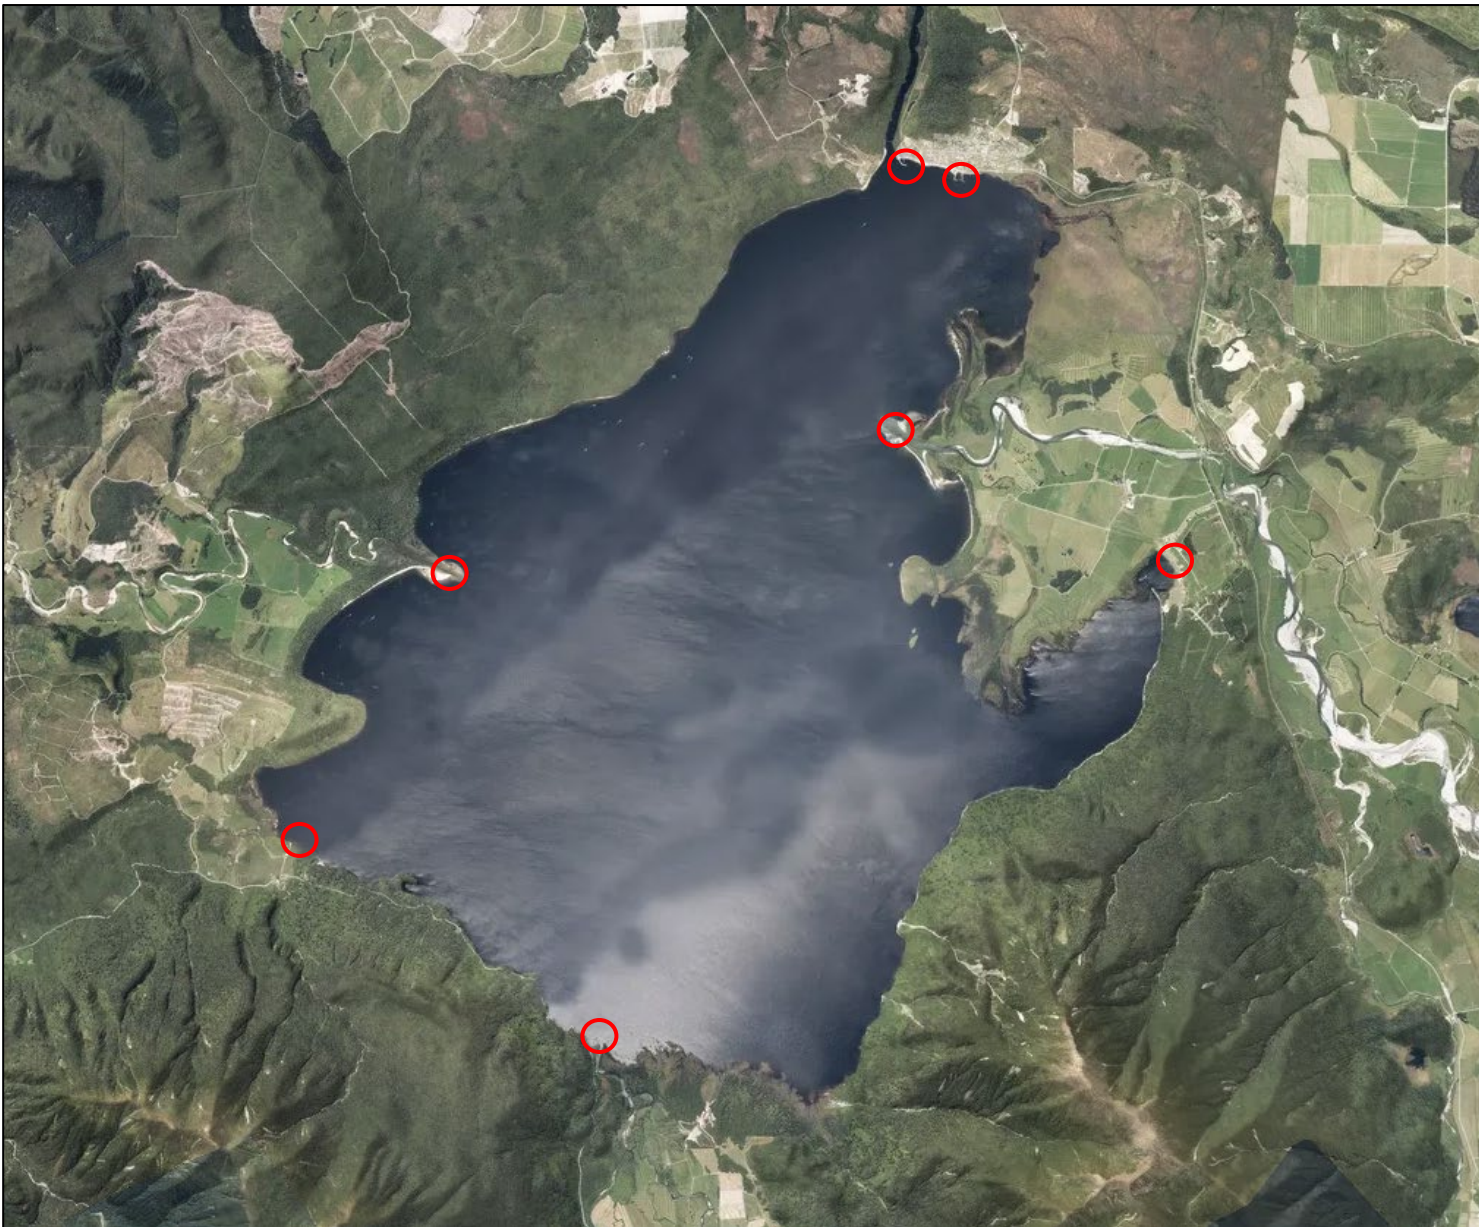
Seven sites were surveyed at Lake Brunner (Figures 4 & 5).

Figure 4 Lake Brunner and location of sites (red circles). Top left moving anticlockwise: Main Ramp, Hohonu River Mouth, Mitchell's Ramp, Orangipuku River Mouth, Cashmere Bay, Crooked River Mouth, Yacht Club.

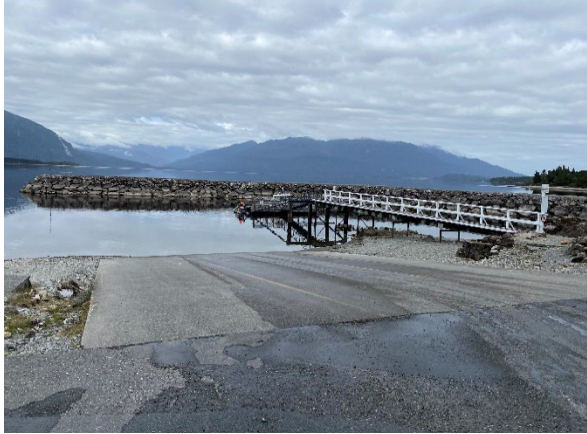
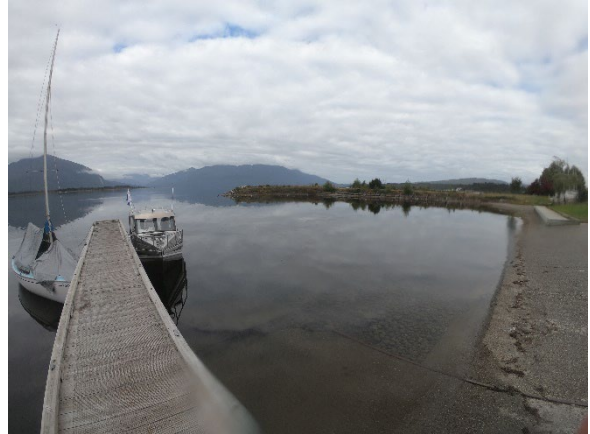
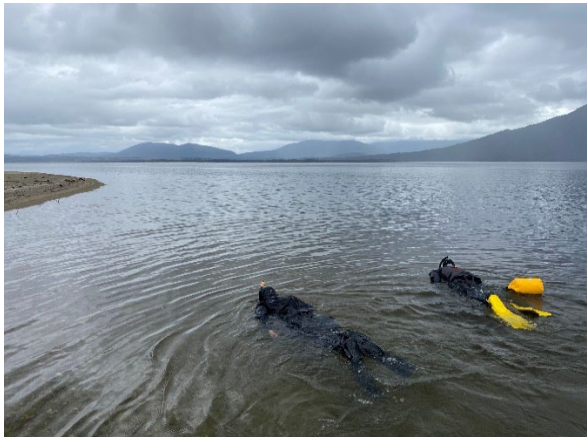
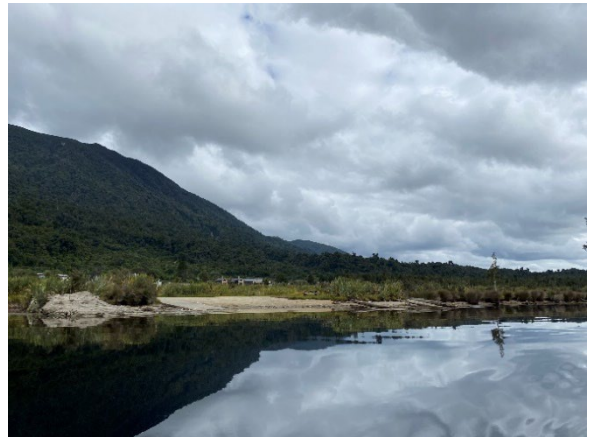
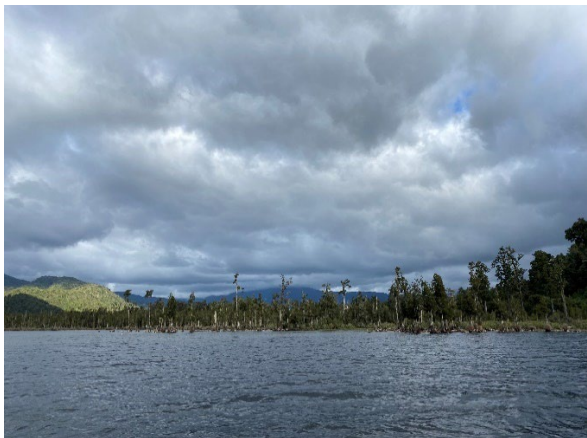
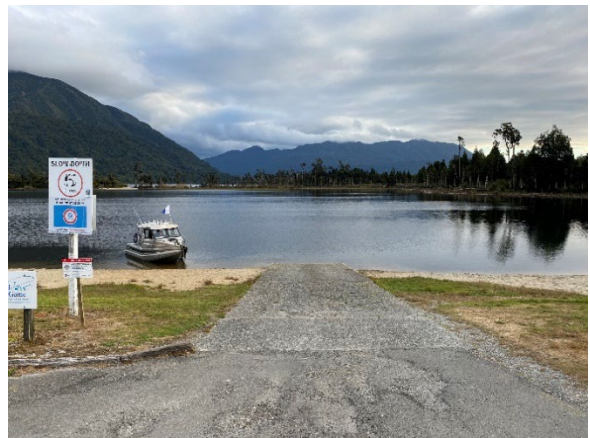
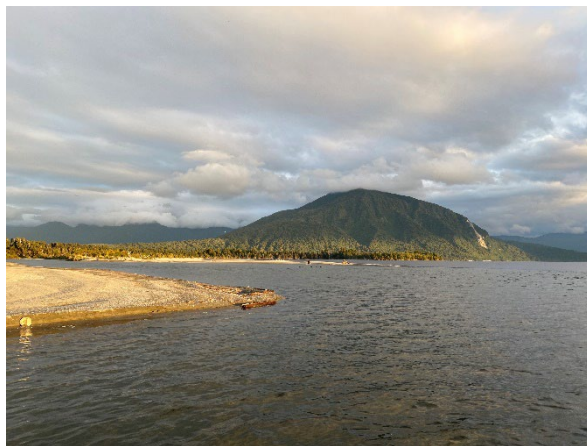
The surveyed area was shallow (<3m) with *E. canadensis* (95%) and *P. crispus* (5%) the invasives recorded. Native presence included emergents, turf, charophytes, isoetes, milfoils and pondweeds at a ratio of 51-75% compared to 26-50% invasives, with dense areas of *E. canadensis*. Introduced, *L. palustris* was also observed.

The surveyed area was also consistently shallow (<2m) with dense areas of invasive *E. canadensis*. Native turf, charophytes, isoetes, milfoils and pondweeds were observed at 76%-95% compared to 6-25% invasives.

The area surrounding Hohonu River Mouth was very patchy and bare in most places. *Elodea canadensis* was occasional, but present at 6-25% ratio compared to natives at 76% -95%. Charophytes, milfoils and pondweeds were recorded. The bank dropped off relatively steeply, with vegetation recorded down to 3.6m.

The bank adjacent to Mitchell's Ramp sloped off with vegetation recorded down to 5m (natives) and 3.8m (invasives). *Elodea canadensis* accounted for the invasive species, with introduced *L. palustris* also present. Native vegetation included emergents, turf, charophytes, isoetes, milfoils and pondweeds, at a ratio of 51-75% compared to 26-50% invasives. Kākahi (freshwater mussels) were abundant near the deepest margin of macrophytes.

The area surrounding the river mouth was shallow with dense *E. canadensis* dominating the site. A small amount of *P. crispus* and *R. trichophyllus* were noted. Native vegetation present included emergents, turf, charophytes, isoetes, milfoils and pondweeds, at a ratio of <5% compared to invasives at >95%. An unusual sample suspected to be *E. densa* was collected however was later confirmed as *E. canadensis*.

The site at Cashmere boat ramp was dark and silty with vegetation dominated by *E. canadensis*. Native vegetation included charophytes, milfoils and pondweeds at 6-25% ratio compared to invasives at 76-95%. Charophytes were recorded down to 4.4m and *E. canadensis*, 3.5m.

The area surrounding the Crooked River Mouth was bare, with patchy vegetation. Native vegetation consisted of charophytes extending to 2.6m and *E. canadensis* the invasive to 2m. The ratio of vegetation was 26-50% native to 51-75% invasive.

Figure 5 Site Photos left to right. Main Ramp, Yacht Club, Hohonu River Mouth, Mitchell's Ramp, Orangipuku River Mouth, Cashmere Bay and Crooked River Mouth, Lake Brunner.

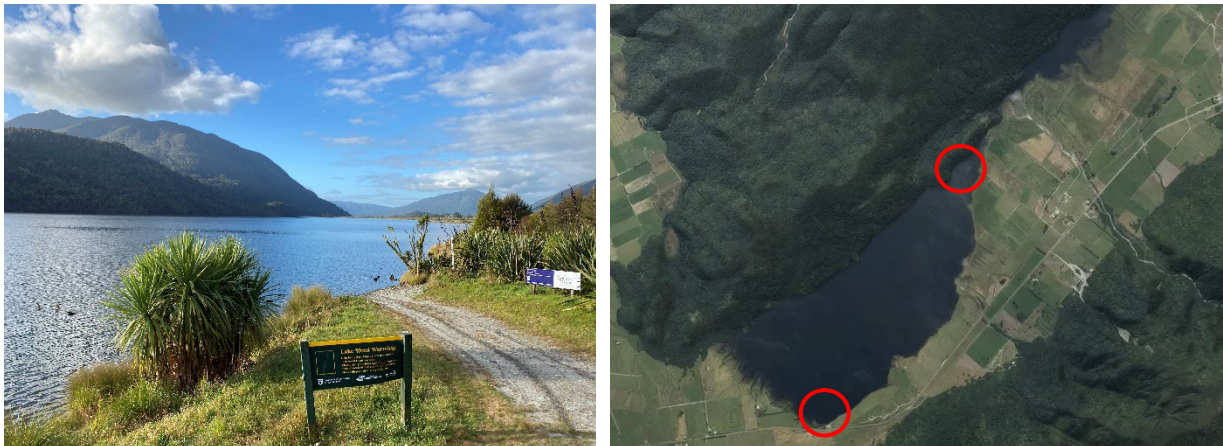
The area adjacent to the boat ramp was characterised by a shallow plateau with vegetation extending out a significant distance (Figure 6). Divers were unable to reach the edge of the vegetation due to the large extent, however the vessel echo sounder indicated a maximum invasive depth of 4m and native of 4.8m. Native vegetation included emergents, turf, charophytes, isoetes, milfoils and pondweeds, at a ratio of 6-25% compared to 76-95% invasive. Invasive species present were dense areas of *E. canadensis* (95%) and to a much lesser amount, *R. trichophyllus* (5%).

The northeast arm itself was not accessed due to the draft of the vessel, however divers swam across the expansive shallow area at the intersection of the main lake and northeast arm (Figure 6). The echo sounder showed taller vegetation (likely *E. canadensis*) to 4m depth and shorter vegetation (likely charophytes) to 5.4m. Divers observed native emergents, turf, charophytes, milfoils and pondweeds. Invasives were dense areas of *E. canadensis* at 26-50% ratio compared to 51-75% native. Introduced *L. palustris* was also present in the shallow margins.

Figure 6 Site photo (main ramp) and birds eye view of sites (main and northeast arm) Lake Poerua.

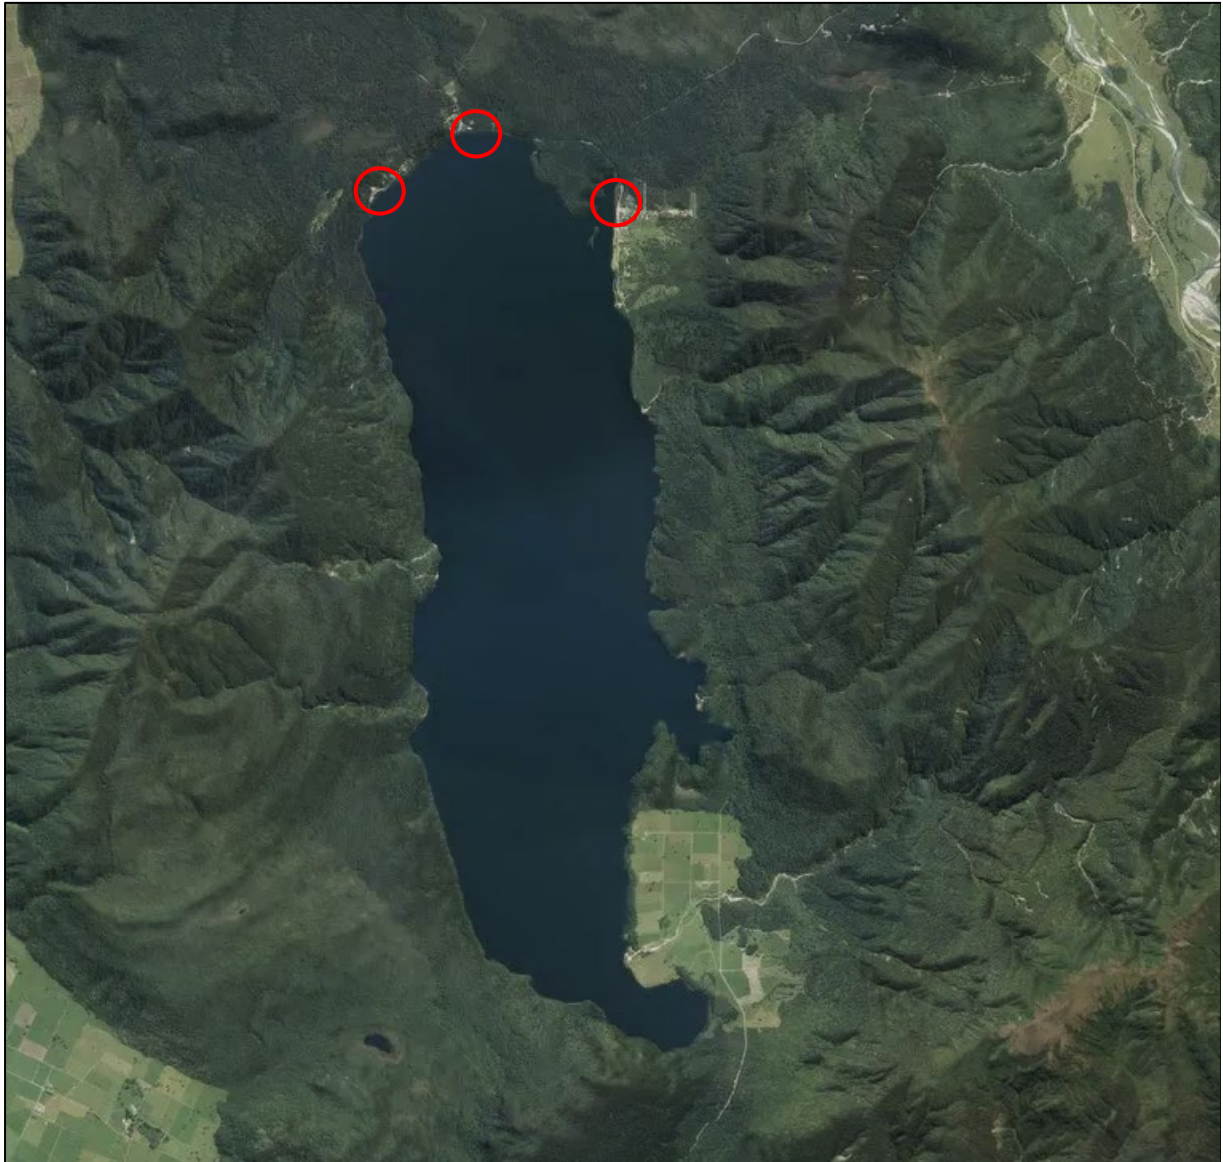
Sunny Bight surveillance included a shallow shelf area which sloped off to 6.5m (Figures 7 & 8). Native vegetation was diverse and included emergents, turf, charophytes, isoetes, milfoils and pondweeds at 26-50% ratio compared to 26-50% invasives. Invasive species included dense areas of *E. canadensis* down to 5.2m.

Hans Bay surveillance included a band of vegetation adjacent to the boat ramp (Figures 7 & 8). Native charophytes extended to 7.5m beyond which an algal mat could be seen. Other natives present included turf plants, isoetes, milfoils and pondweeds at 51-75% ratio compared to invasive, 26-50%. Dense areas of *E. canadensis* were present down to 5.4m, with a small amount of *J. bulbosus* at the margin.

Canoe Cove surveillance included the area around the outlet and walkway where charophytes grew down to 7.3m and invasive *E. canadensis* reached 4m (Figures 7 & 8). The site was characterised by large charophyte meadows and other natives including turf, isoetes, milfoils and pondweeds. *Elodea* was occasional and *J. bulbosus* was also present. Invasive ratio was 5% compared to 95% natives.

Figure 7 Site locations Lake Kaniere. Sunny Bight (left), Canoe Cove (centre) and Hans Bay (left).

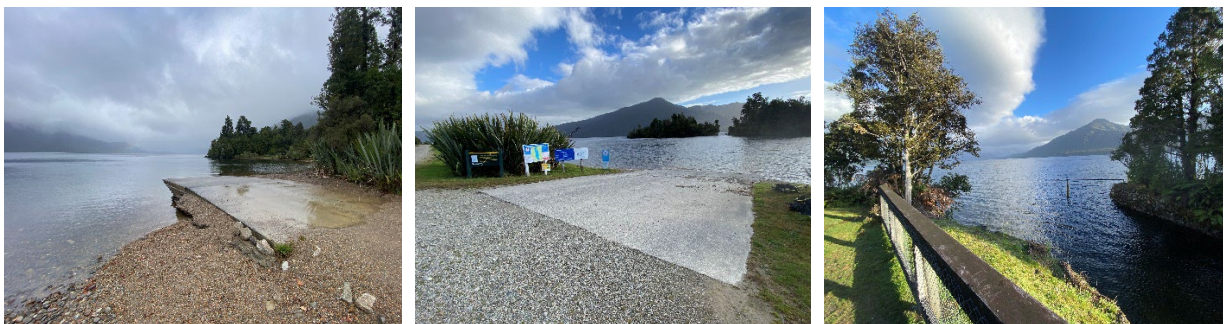
Figure 8 Sunny Bight, Hans Bay and Canoe Cove sites, Lake Kaniere.

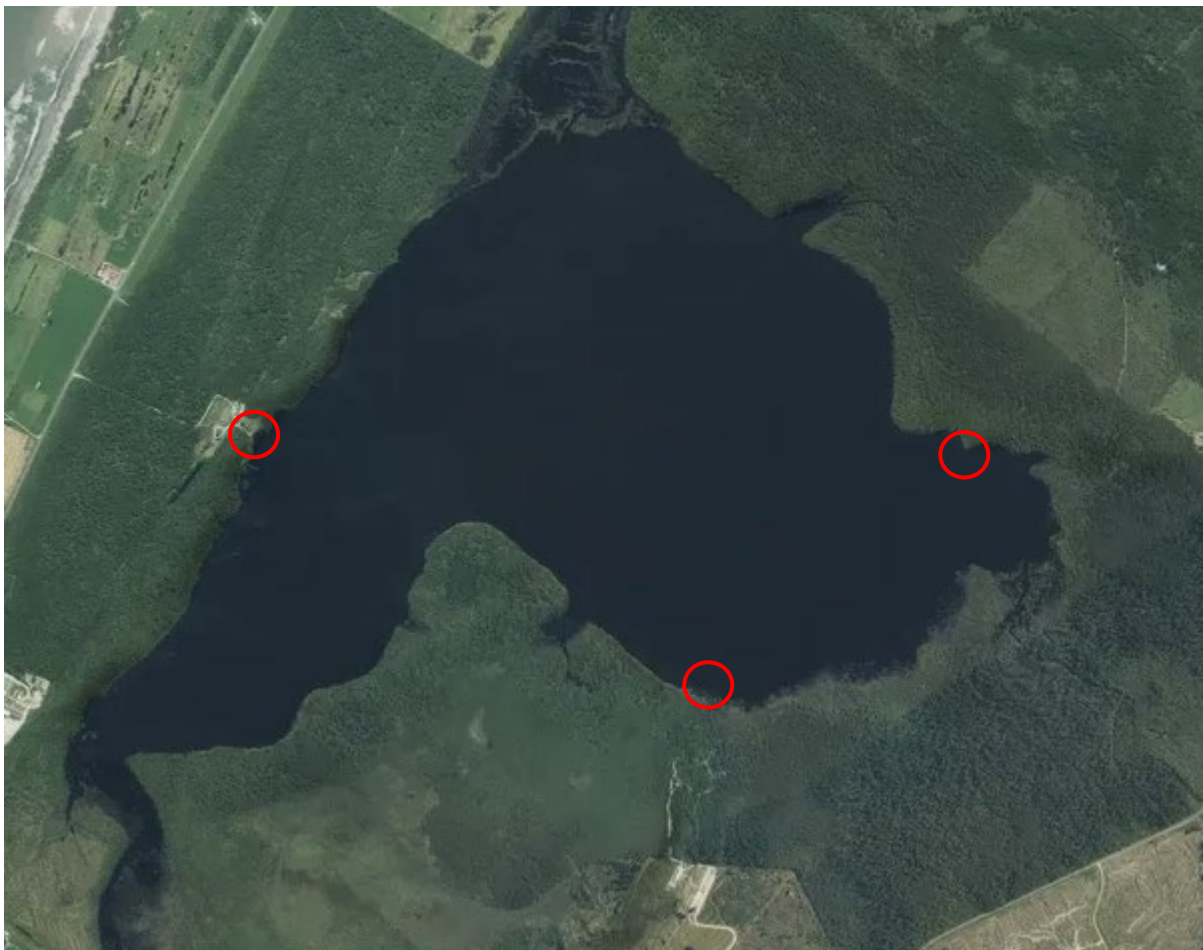
Mahinapua main ramp surveillance included the very shallow (<2m) area to the left and lakeward from the jetty (Figures 9 & 10). Two introduced species already known in this lake were observed, the dominant *E. canadensis* and *A. distachyus*. In addition, *P. crispus* and *U. geminiscapa* were also recorded. Native vegetation included emergents, charophytes, milfoils and pondweeds at 95% compared to 5% invasives. The nature of *E. canadensis* was noted as occasional.

Daylight Bight was also very shallow (<1m) across the entire survey site, directly out from Johnnies Creek and the treetop walkway (Figures 9 & 10). Native vegetation included emergents, turfing, charophytes, isoetes, milfoils and pondweeds at 95% ratio. Invasive species were occasional <5% and included *E. canadensis* and *J. bulbosus*. Other introduced species present were *U. geminiscapa* and *L. palustris*.

Picnic Bay surveillance was conducted at the end of Picnic Point Track (Figures 9 & 10). The majority of the area was shallow (<1m), with a drop-off to 3m offshore. Native emergents, turf, charophytes, milfoils and pondweeds were all present at 95% ratio compared to 5% invasives. *Elodea canadensis* was the main invasive present, with *J. bulbosus* and *A. distachyus* recorded along the lake margins.

Figure 9 Lake Mahinapua sites - Main ramp (left), Daylight Bight (centre) and Picnic Bay (right).

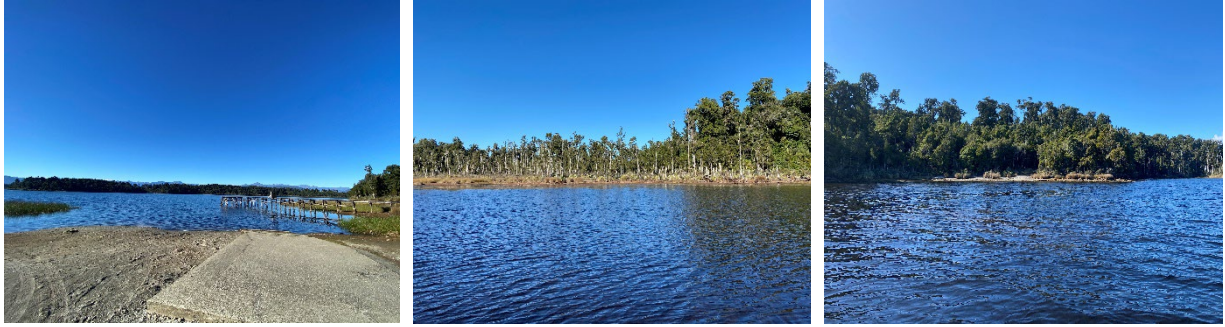
Figure 10 From left to right, Lake Mahinapua main ramp, Daylight Bight and Picnic Bay.

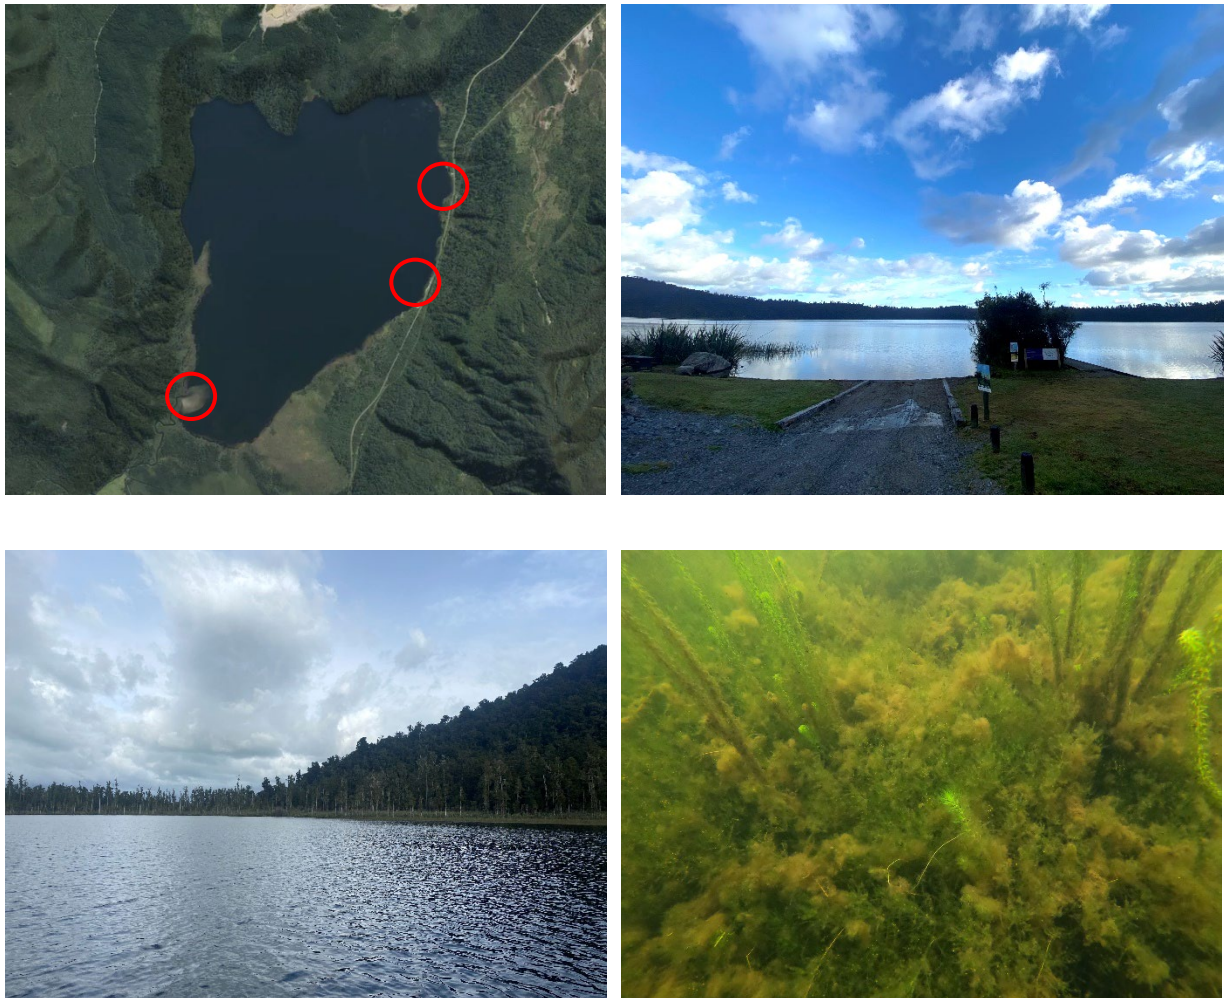
Lagarosiphon major is known in both Lakes lanthe and Paringa. During the survey, *L. major* was present at all sites surveyed (Figure 11).

Lagarosiphon major was the dominant submerged vegetation species at the main ramp at a ratio of 51-75% compared to 26-50% natives. *L. major* was dense and extended to depths of 3.5m with natives to 5.5m. Native vegetation included emergents, turf, charophytes, isoetes, milfoils and pondweeds. A small amount of *E. canadensis* was also present.

Native vegetation surrounding the landing extended to 5.1m, with emergents, charophytes, isoetes, milfoils and pondweeds all present. The ratio of natives to invasives was 51-75% to 26-50%. Both *E. canadensis* and *L. major* were present, however *L. major* was dominant with partly closed areas from the shallows down to 2.6m.

The shallow area surrounding lanthe Creek Outlet had a ratio of 26-50% natives to 51-75% invasives. The invasive present was *L. major* in dense patches among charophytes and other natives. Native emergents, turfing species, charophytes, isoetes, milfoils and pondweeds were present. An algal mat was noted covering all vegetation in the shallow area surrounding the creek mouth (Figure 11).

Figure 11 Top images - Lake Lanthe showing sites (red circles) and main ramp (right). Bottom images - , lanthe creek outlet topside (left) and lanthe Creek Outlet (right) showing algae atop of submerged vegetation. (bottom right).

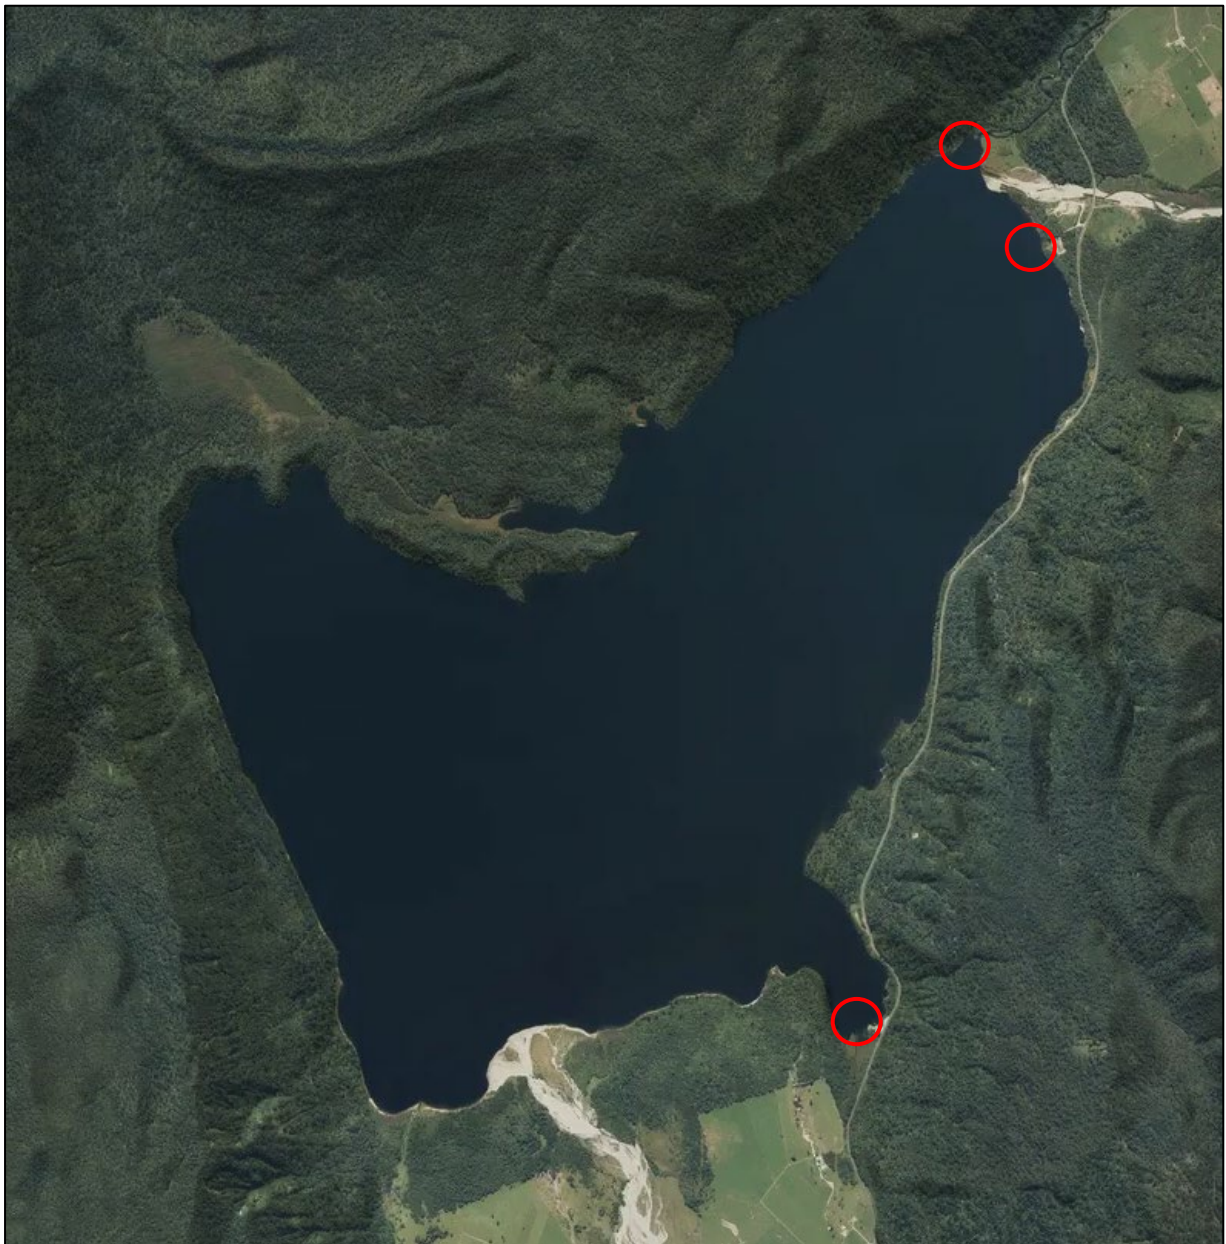
The main ramp was surveyed out to 4m depth where natives and invasives were present (Figures 12 & 13). Natives included emergents, turf, charophytes, isoetes, milfoils and pondweeds at a ratio of 51-75% natives to 26-50% invasives. *Elodea canadensis* was the invasive species present with areas of dense cover.

Native vegetation ratio was 51-75% compared to 26-50% invasives in the area surrounding the DOC camp and boat ramp (Figures 12 & 13). Native emergents, turf, charophytes, isoetes, milfoils and pondweeds were present and charophytes extended to 5.5m. Invasive *E. canadensis* was dense where present and observed to 4m depth. Introduced species, *L. palustris* and *U. geminiscapa* were also recorded at this site. A dense kākahi bed was noted below the vegetation margin at this site.

The vegetation observed surrounding Okarito River Mouth was dominated by native species including emergents, turf, charophytes, isoetes and milfoils at 76-95%, with charophytes to 4.7m. The areas of *E. canadensis* were dense and observed to 3m depth, accounting for 6-25% of the

Figure 2 Lake Mapourika sites (red circles), main ramp (bottom), DOC area (middle) and Okarito River Outlet (top).

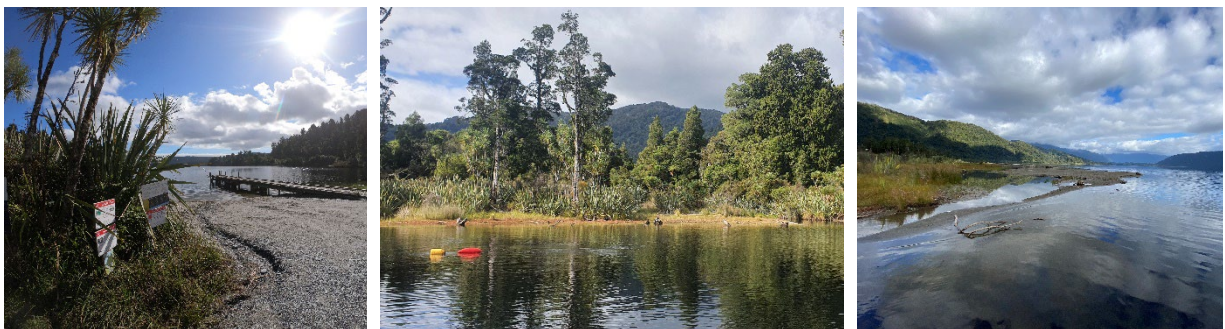
Figure 13 Lake Mapourika sites, main ramp, DOC area and Okarito River mouth.

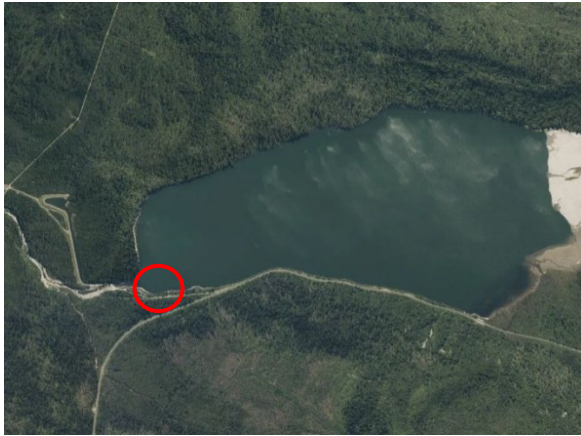
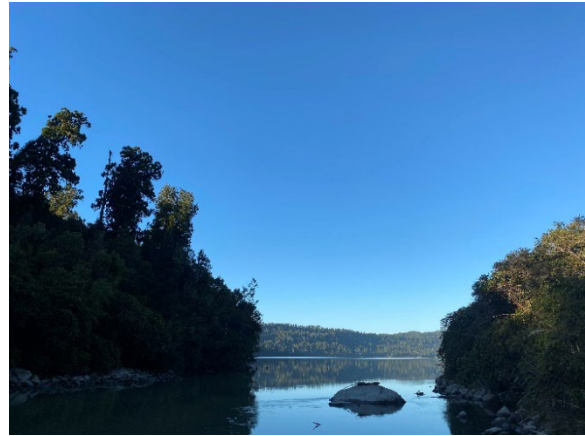
Surveillance at Wahapo proved difficult due to the limited visibility (<0.5m), however divers were able to note the main species in the western outlet area (Figure 14). No footage was taken due to the limited visibility. Native species observed by divers included charophytes and milfoils extending past 4m depth. *E. canadensis* was observed at 4m and accounted for 26-50% invasives compared to 51-75% natives. Kākahi were abundant in the channel.

Figure 14 Lake Wahapo showing the western outlet site.

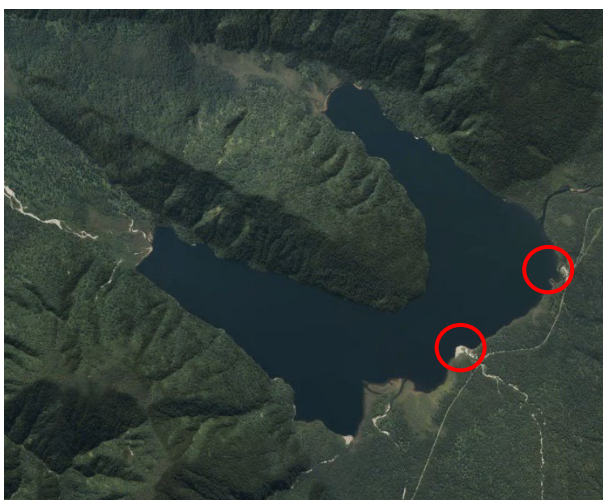
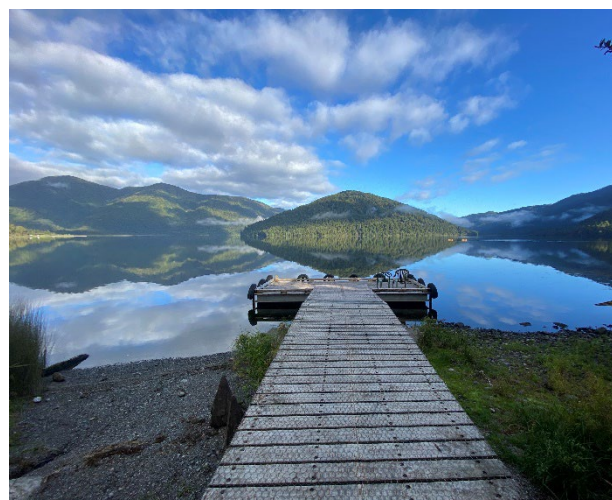
Native vegetation included turf, charophytes, isoetes, milfoils and pondweeds, at a ratio of 51-75% compared to 26-50% invasive. Invasives included *L. major* (90%) and *E. canadensis* (10%). A tuft-like algae covered much of the vegetation (see attached footage). *Lagarosiphon major* extended down to 4m and charophytes to 5.4m. Kākahi were common in shallow at 0.5m.

Lagarosiphon major was dense at the lodge site across the shallow area (<1.5m) lakeward of the jetty (Figure 15). It accounted for 76-95% of the observed vegetation and *E. canadensis* was also present to a lesser extent. Emergents, turf, charophytes, isoetes and milfoils were among the native vegetation observed. The site was also largely covered by a fluffy algal mat.

Figure 35 Lake Paringa showing main ramp and lodge sites. Lodge jetty (right image).

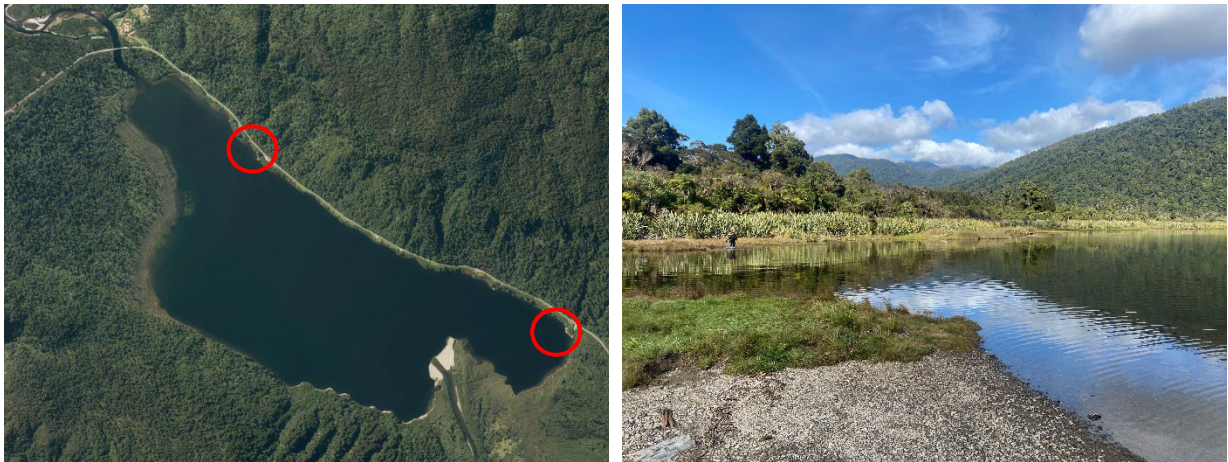
The northern ramp site was dominated by dense *E. canadensis* down to 5m at 76-95% compared to 6-25% native vegetation (Figure 16). Emergents, turf, charophytes, isoetes, milfoils and pondweeds were present to 5.5m.

Dense *E. canadensis* was the only invasive recorded at the southern ramp site in Moeraki down to 5.6m depth (Figure 16). Emergents, turf, charophytes, isoetes, milfoils and pondweeds were native vegetation present at 26-50% compared to 51-75% invasives. Kākahi were abundant near the deeper vegetative margin.

Figure 46 Lake Moeraki sites (red circles), north (top) and south (bottom) ramps. Right image is the southern ramp.
