West Coast Lakes Aquatic Weed Surveillance 2022

West Coast Regional Council

June 2022

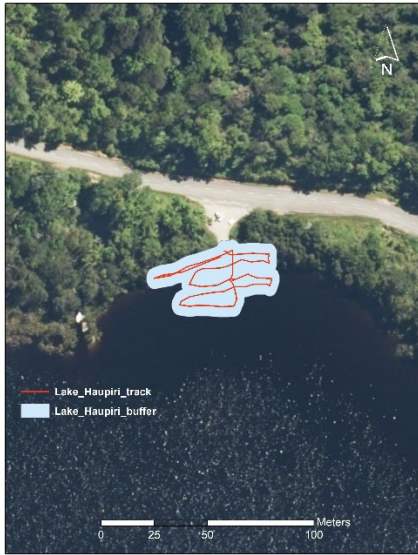
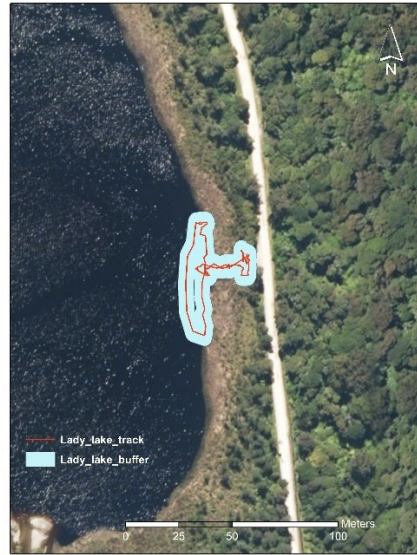
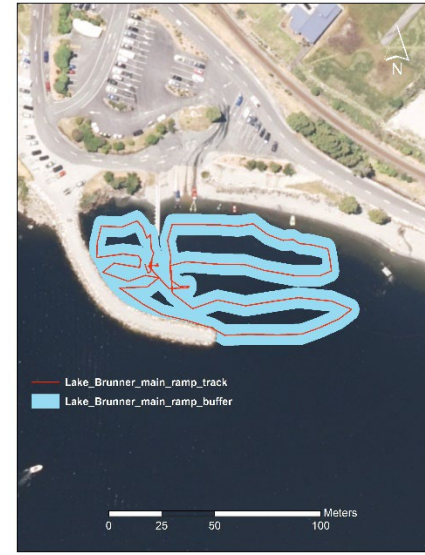
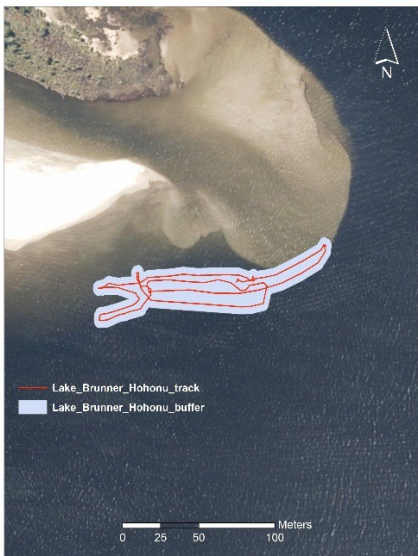
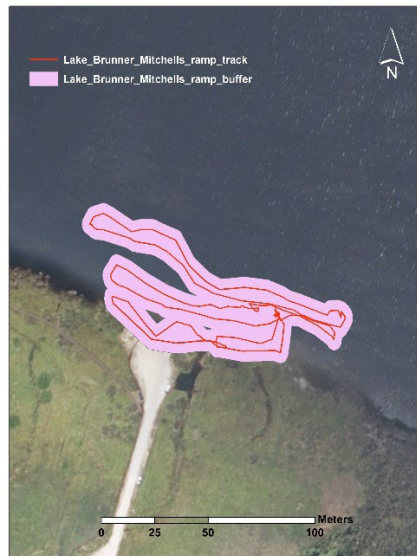
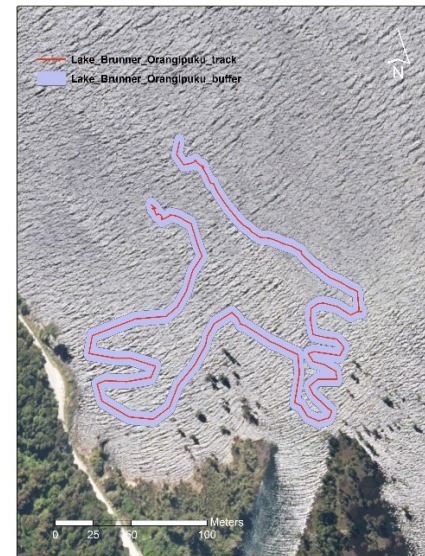
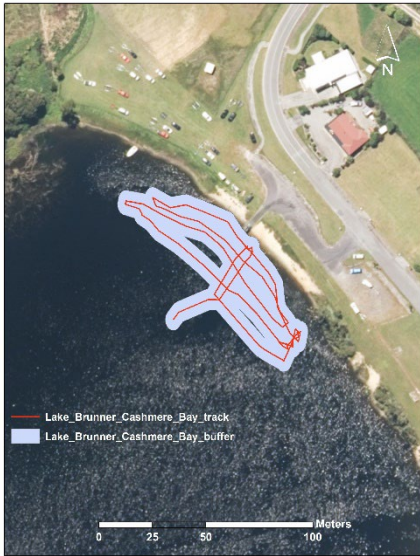
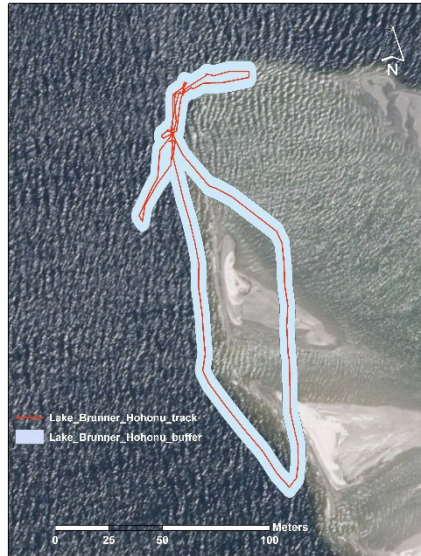
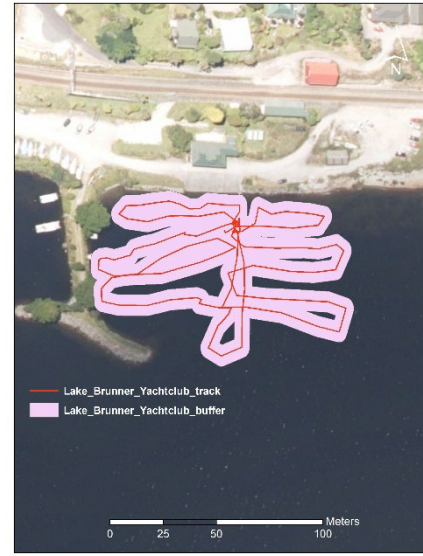
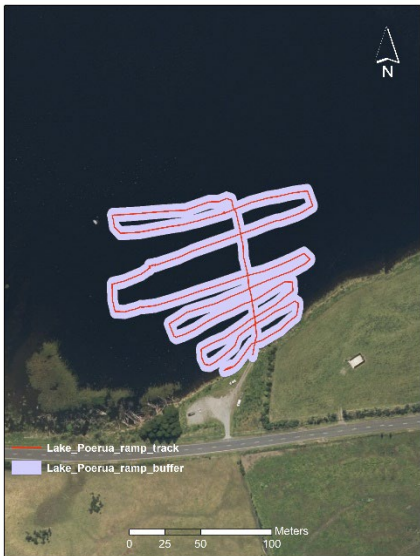
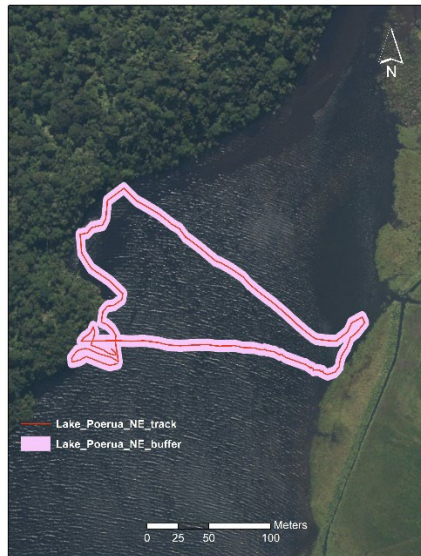
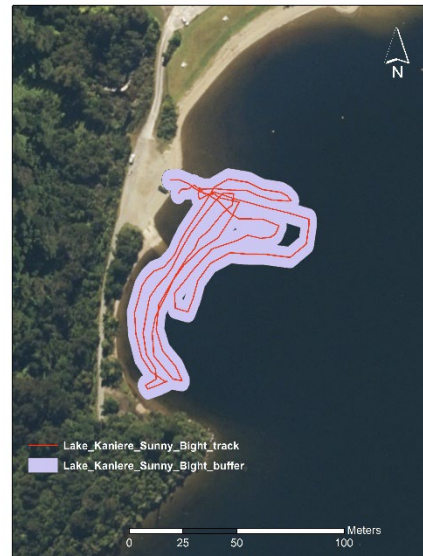
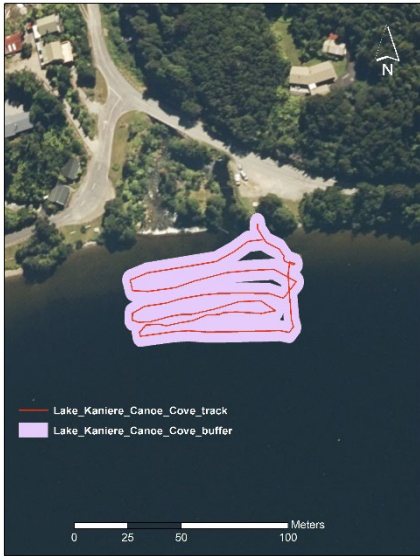
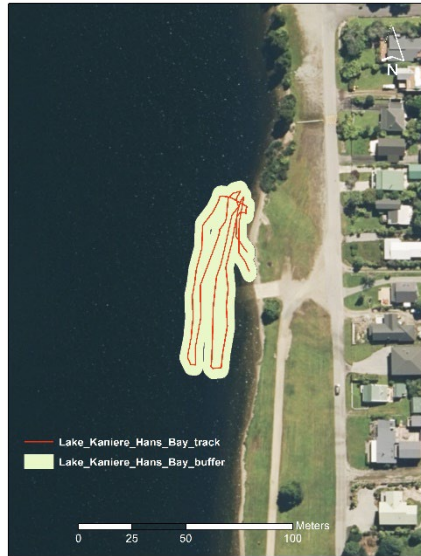
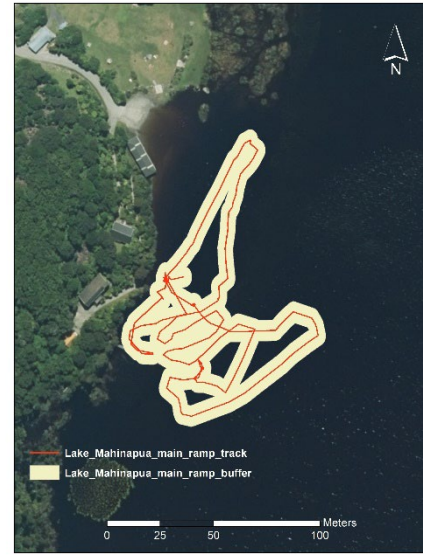
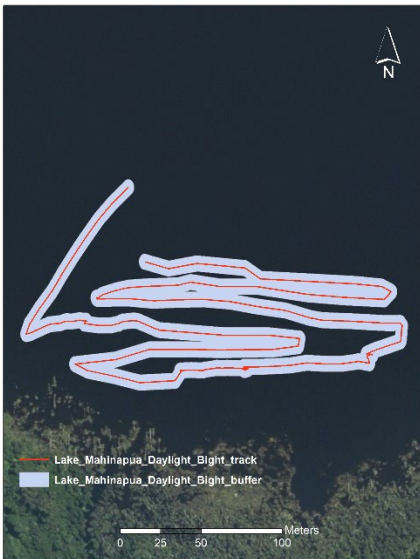
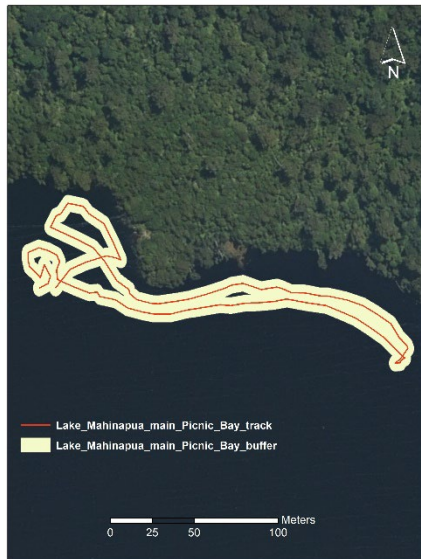
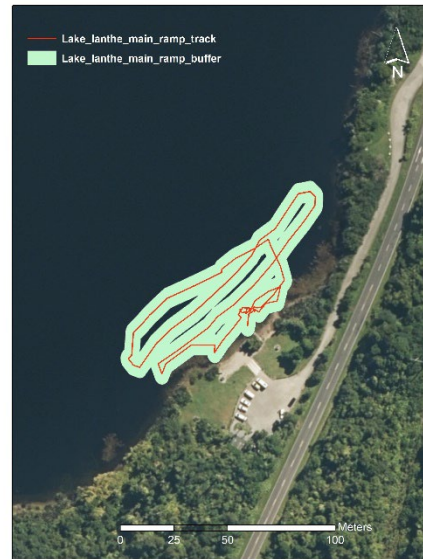
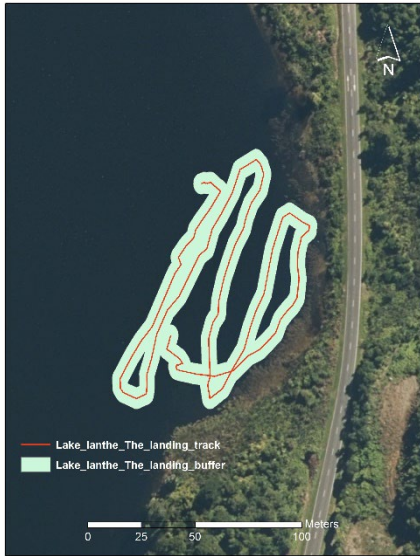
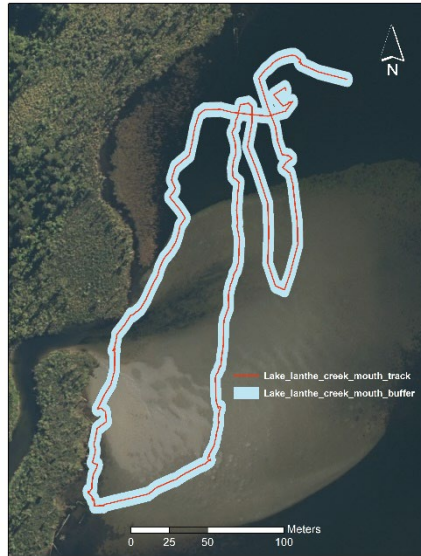
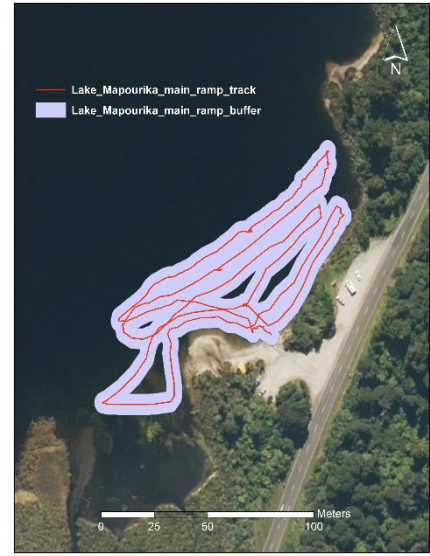
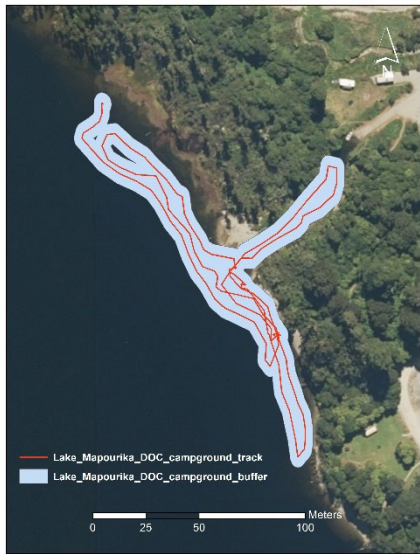
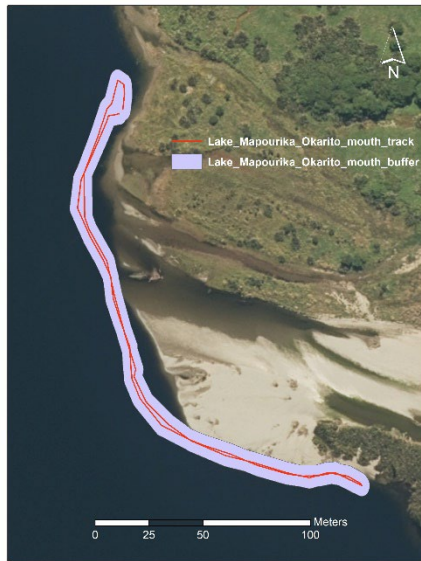
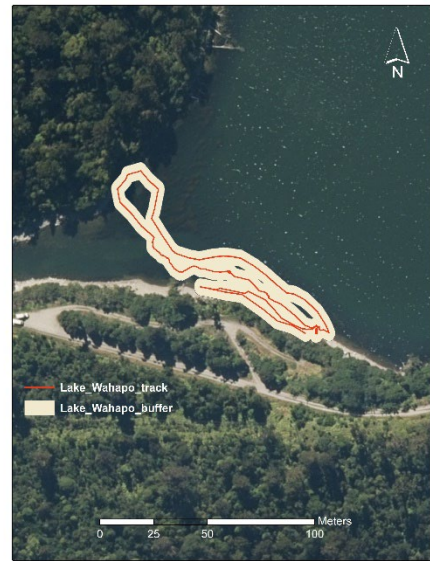
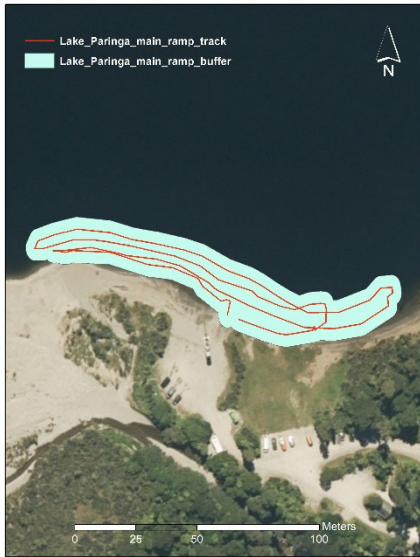
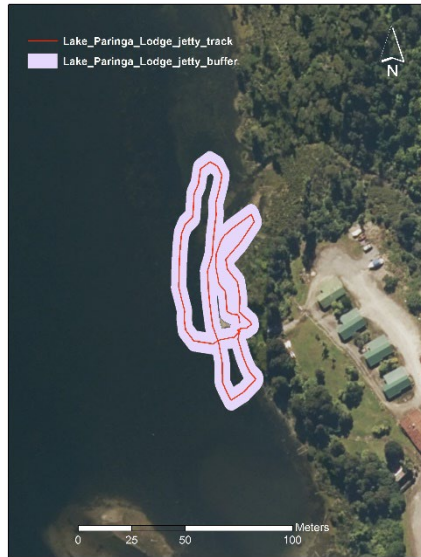
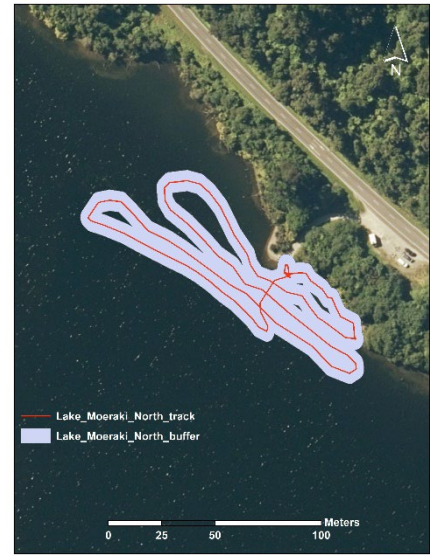
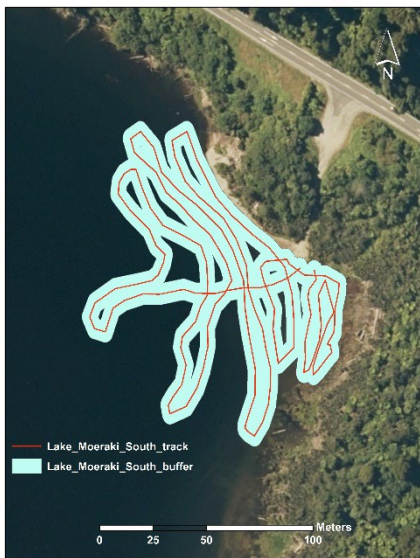
Table of lakes and sites surveyed by divers with total dive times followed by images showing GPS tracks and search area.
