West Coast Lakes Aquatic Weed Surveillance 2023

West Coast Regional Council

May 2023

TC Environmental Ltd
51 Beach Road, Nelson

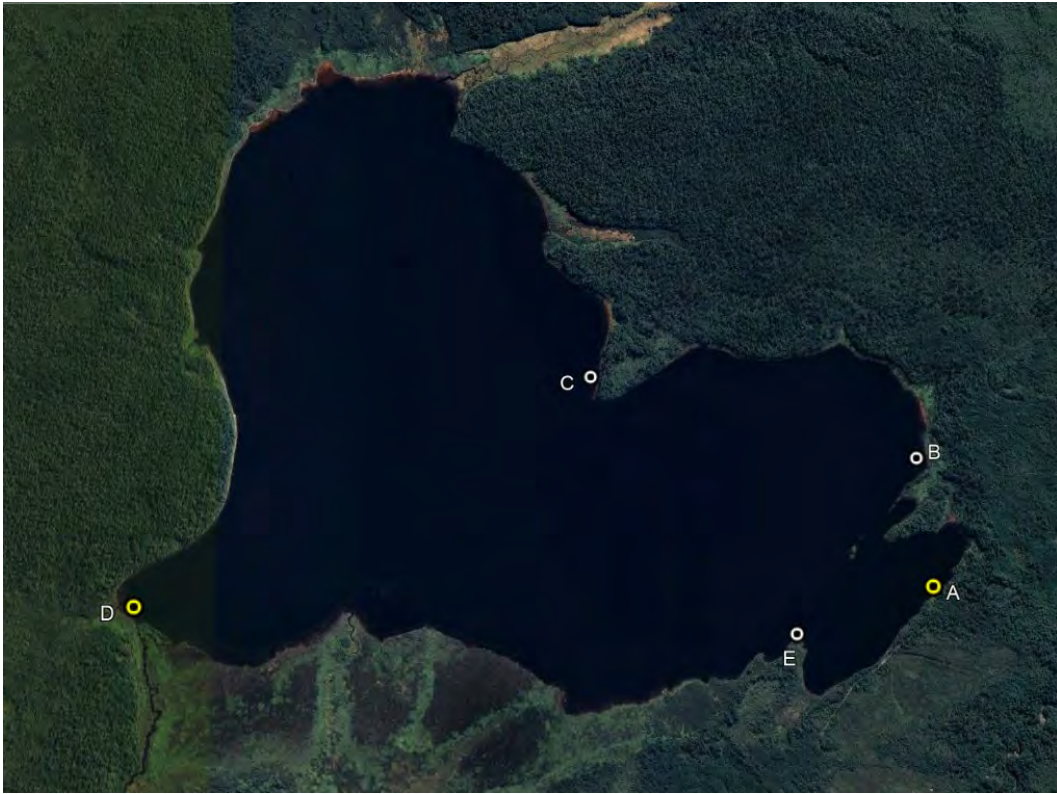
Figure 3 Lake Hochstetter showing locations of 5 LakeSPI transects and two surveillance sites (yellow).

Two sites were surveyed for submerged aquatic weeds in Lake Hochstetter (Figure 3), with *J. bulbosus* the only invasive recorded. An additional 3 LakeSPI transects were conducted (Table 3). Overall, Lake Hochstetter has very little submerged vegetation.

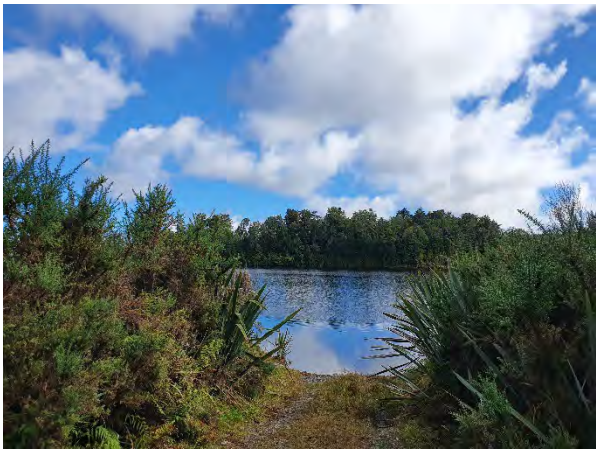
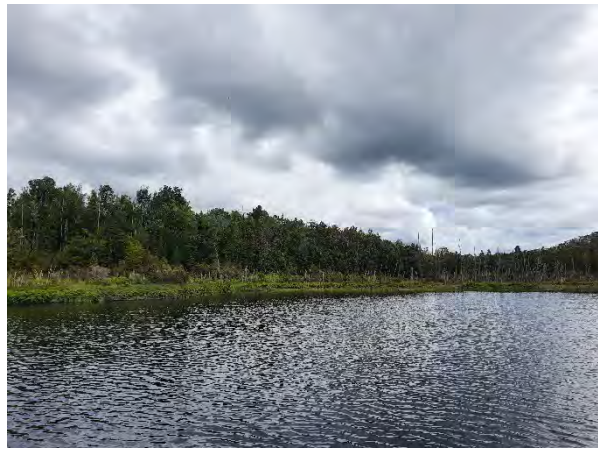
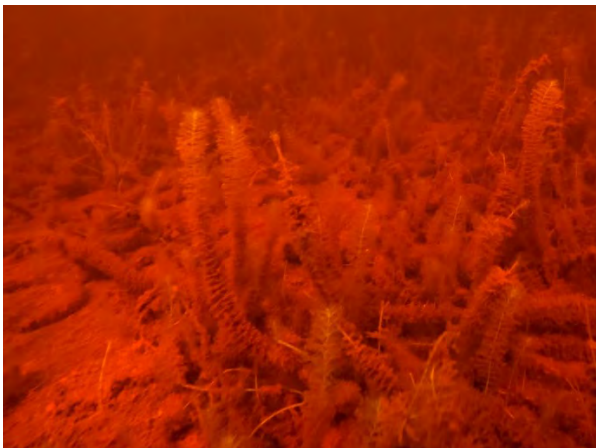
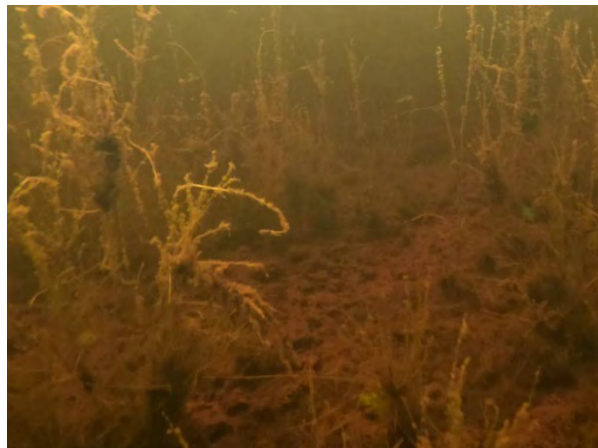
Figure 4 Lake Hochstetter surveillance sites, Site A (Top left) and Site D (Top right). Native milfoils (bottom left) and invasive *J. bulbosus* (bottom right).

The survey area was located adjacent to the boat ramp on the south-eastern lake border (Figures 3 & 4, Site A). The site was dominated by invasive *J. bulbosus* (Figure 4). Native presence included emergents, turf, charophytes, isoetes and milfoils at a ratio of 6-25% compared to 76-95% invasives. The survey area was very shallow, with dark, tannin-stained water likely limiting the growth of submerged plants. Natives were recorded at a maximum depth of 2m, while *J. bulbosus* was shallower at 0.6m.

Submerged vegetation in the area surrounding Nelson Creek Outlet was largely absent, aside from a few patches (Figures 3 & 4, site D). The site was dominated by *J. bulbosus* at >95% ratio compared to natives. A very low cover of charophytes were present down to 2m, with native emergents at the lake edge.

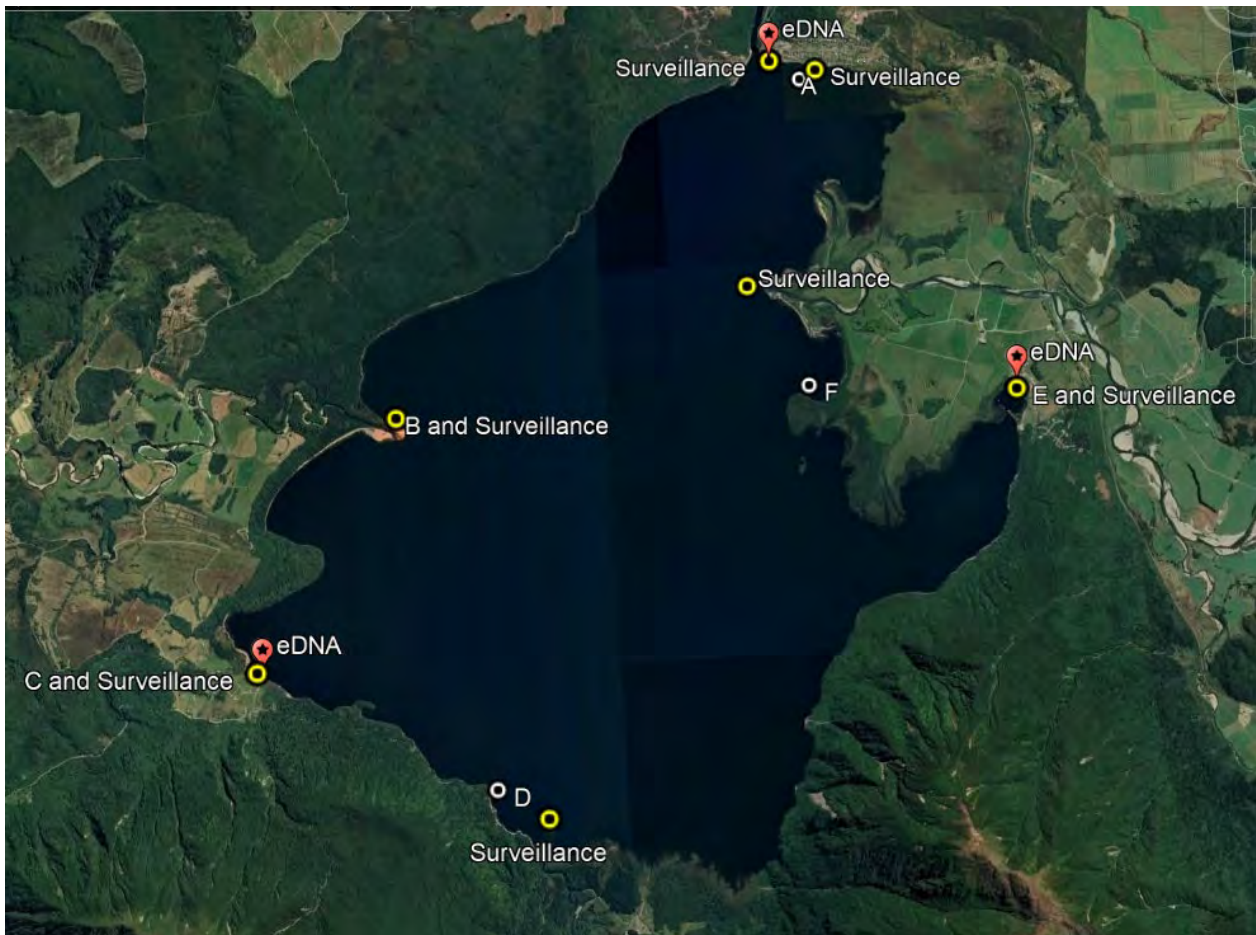
Figure 5 Location of surveillance sites (yellow) and additional LakeSPI transects, Lake Brunner.

Seven sites were surveyed at Lake Brunner (Figures 5 & 6). The dominant invasive species recorded was *E. canadensis*. Minor components of *P. crispus*, *R. trichophyllus* and *L. palustris* were also present. Six LakeSPI transects were used for analysis and where possible were shifted slightly away from surveillance sites (Table 4). Due to the complexity and size of Lake Brunner, it is suggested additional LakeSPI transects are conducted to achieve greater representation of the lake and effort be made to avoid influences such as river mouths.

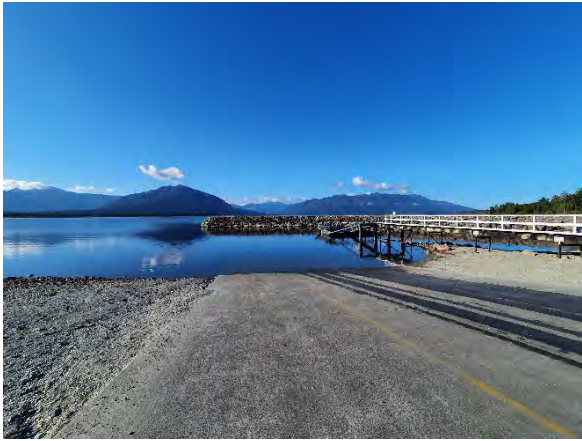
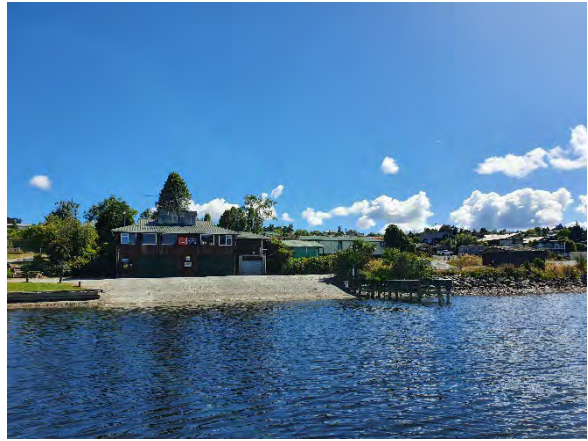
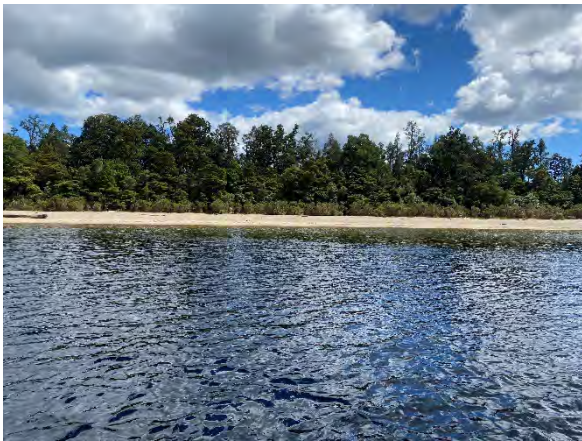
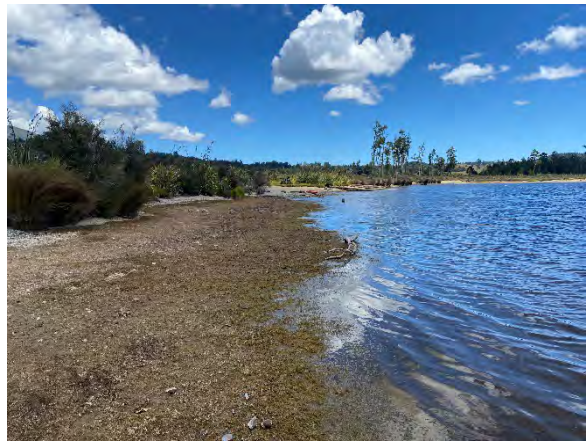
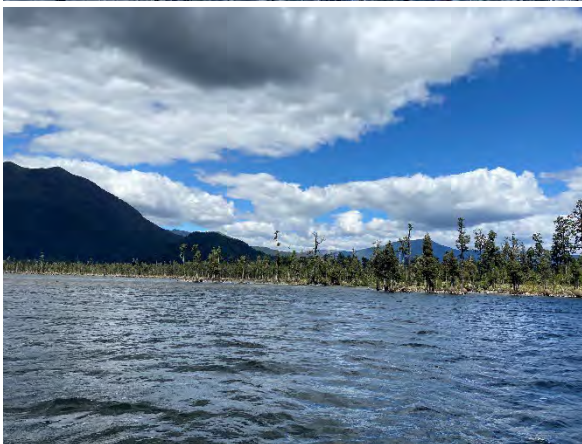
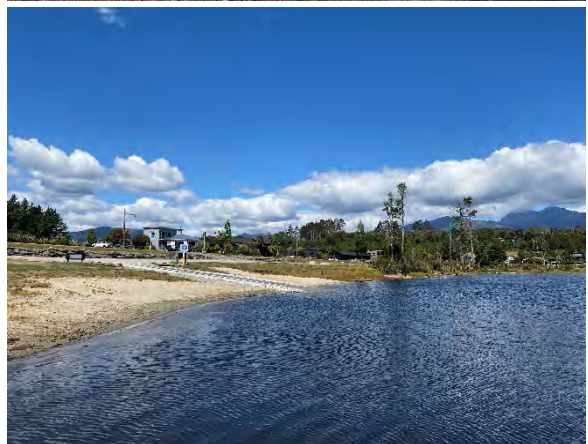
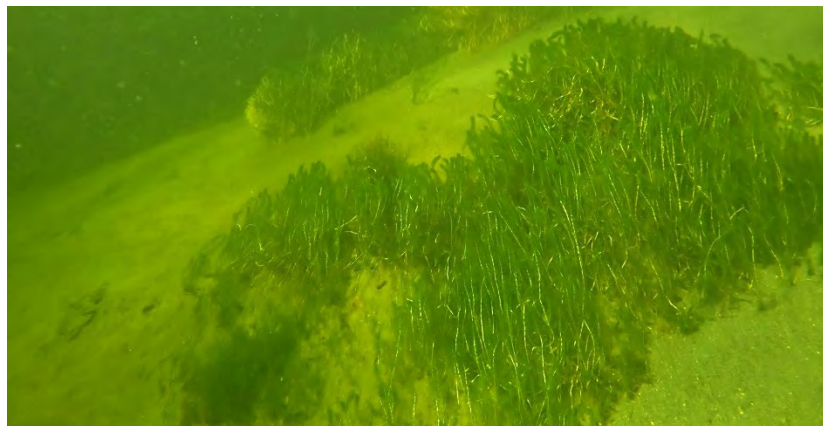
Figure 6 Site Photos left to right from top. Main Ramp, Yacht Club, Hohonu River Mouth, Mitchell's Ramp, Orangipuku River Mouth, Cashmere Bay and patchy vegetation at Crooked River Mouth, Lake Brunner.

The surveyed area by the main ramp was shallow (<3m) with invasive *E. canadensis* (95%) and *P. crispus* (5%) recorded. Native presence included emergents, turf, charophytes, isoetes, milfoils and pondweeds at a ratio of 51-75% compared to 26-50% invasives, with dense areas of *E. canadensis* reaching 1.2m height. Introduced, *L. palustris* was also present.

The surveyed area was consistently shallow (<3m) with invasive *E. canadensis* present at 0.8m height. Native vegetation included turf, charophytes, isoetes, milfoils and pondweeds at 51%-75% compared to 26-50% invasives. Introduced *L. palustris* was also present.

The vegetation surrounding Hohonu River Mouth remained patchy and was bare in most places. *Elodea canadensis* was occasional, but present at 26-50% ratio compared to natives at 51% -75%. Patches of *E. canadensis* were less than 1m in height. Native charophytes, milfoils and pondweeds were also present. The bank dropped off relatively steeply, with vegetation recorded to a depth of 3m.

Vegetation adjacent to Mitchell's Ramp extended to 5m depth for natives and 4.7m for invasives. *Elodea canadensis* was the dominant invasive species, with introduced *L. palustris* also present at the site, although not within the LakeSPI transect. Dense areas of *E. canadensis* reached 1.6m in height. Native species included emergents, turf, charophytes, isoetes, milfoils and pondweeds, at a ratio of 26-50% compared to 51-75% invasives.

The area surrounding the river mouth was shallow (<3m) with dense *E. canadensis* dominating the site, reaching a height of 1.8m. A small amount of *P. crispus* and *R. trichophyllus* were noted. Native vegetation present included emergents, turf, charophytes, isoetes, milfoils and pondweeds, at a ratio of 6-25% compared to invasives at 76-95%.

The site at Cashmere boat ramp was dark and silty with filamentous algae blanketing macrophytes. Vegetation was dominated by dense *E. canadensis*, near 2m tall, at a ratio of 76-95% compared with 6-25% natives. Native vegetation included charophytes and pondweeds. Charophytes were recorded down to 4.7m and *E. canadensis*, 3.5m.

The area surrounding the Crooked River Mouth was mainly bare, with patchy vegetation (Figure 6). Native vegetation consisted of pondweeds and charophytes extending to 3.5m. Invasive *E. canadensis* was occasional in cover extending to 3.5m depth and less than 1m height. The ratio of vegetation was 26-50% native to 51-75% invasive.

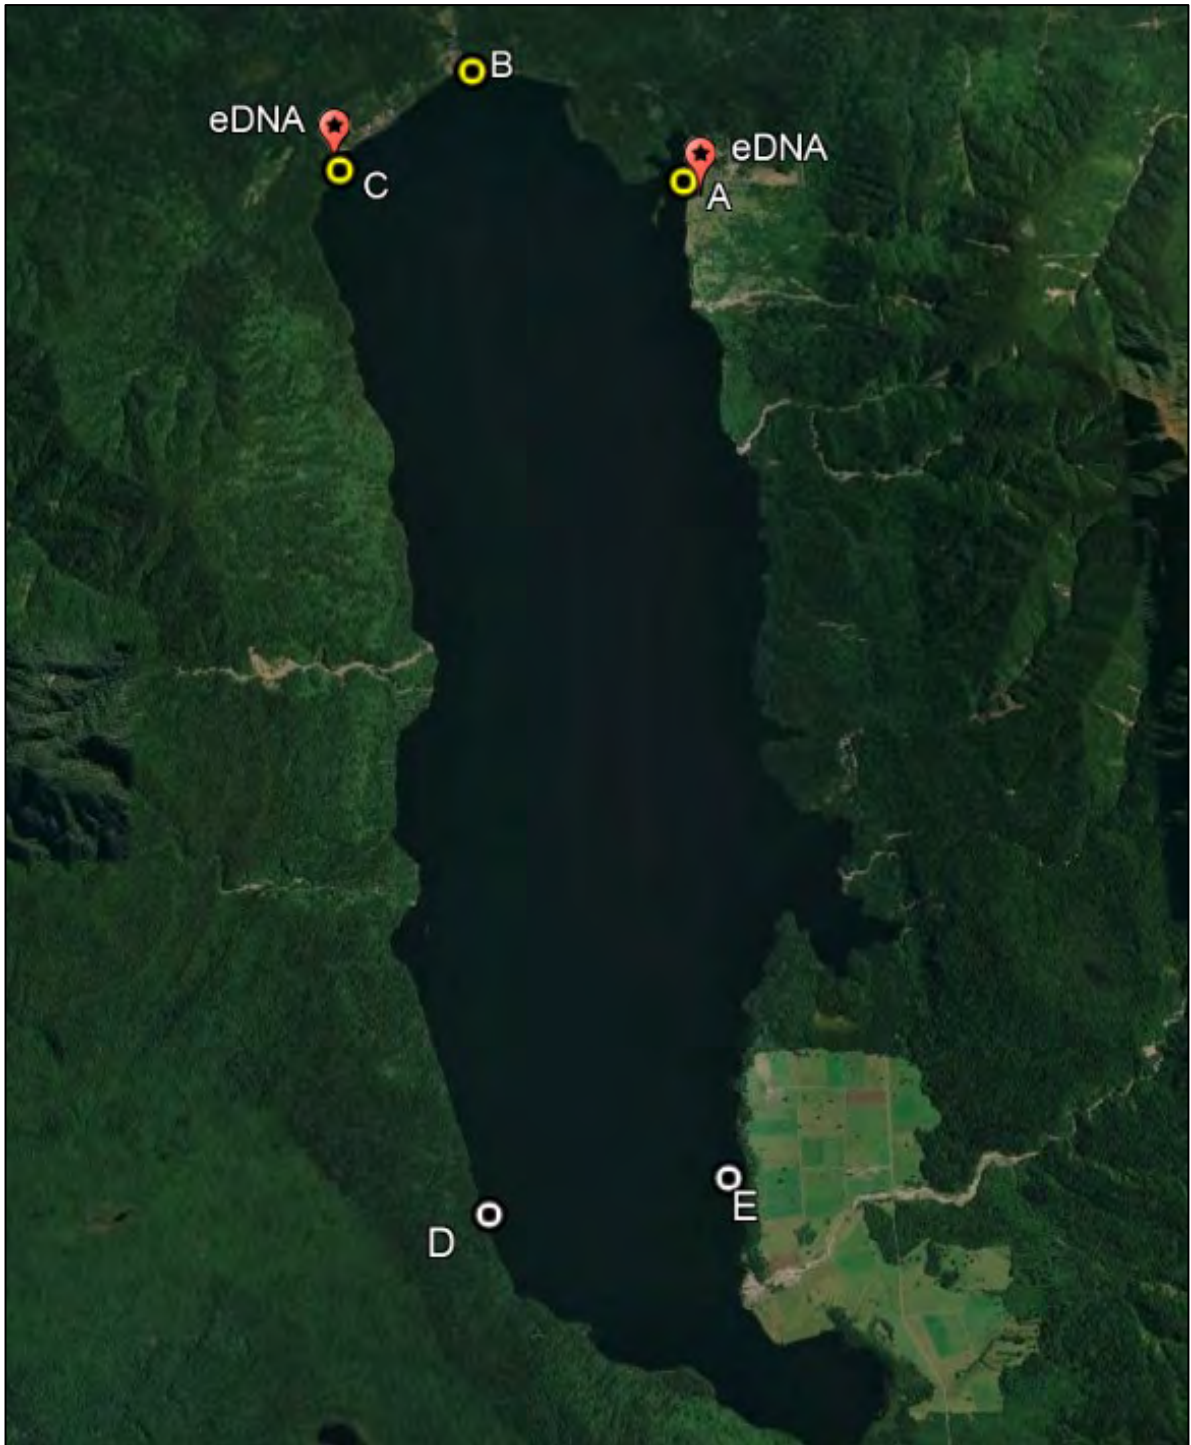
Figure 9 Sites at Lake Kanieri. Hans Bay (A), Canoe Cove (B), Sunny Bight (C) and additional LakeSPI transects (D & E).

Surveillance was undertaken at three sites in Lake Kaniere (Figures 9 & 10). *Elodea canadensis* remained the dominant invasive species. An additional 2 LakeSPI transects were conducted with summarised results provided in Table 5.

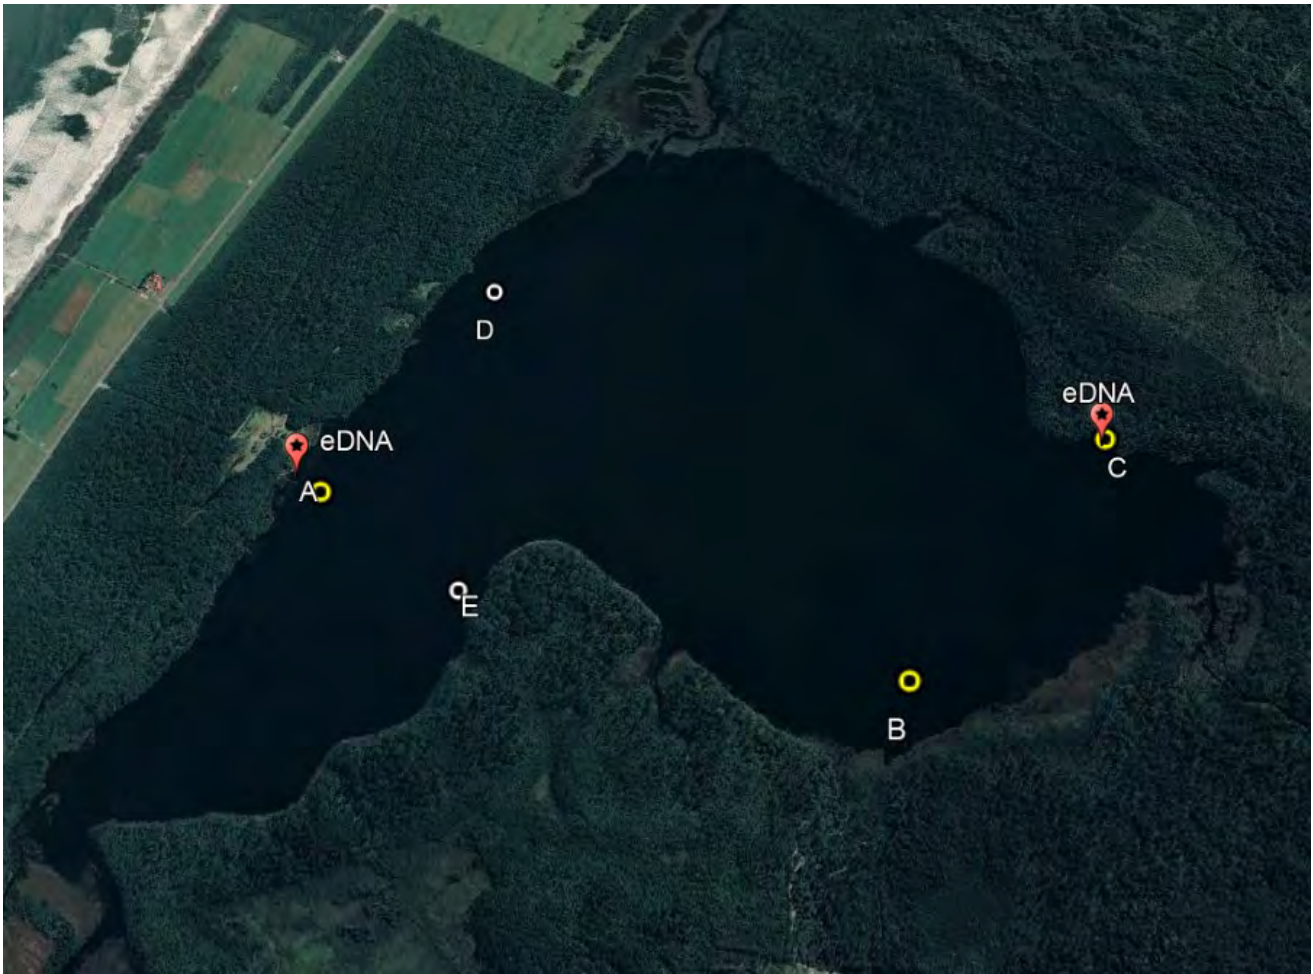
Figure 11 Lake Mahinapua surveillance sites - Main ramp (A), Daylight Bight (B) and Picnic Bay (C) and LakeSPI sites (D & E).

Lake Mahinapua is a shallow lake with dark tannin-stained water, thus submerged vegetation is relatively restricted. Surveillance was undertaken at three sites with natives more common than invasives at each of the sites (Figures 11 & 12). An additional 2 LakeSPI transects were conducted in Lake Mahinapua with summarised results provided in Table 6.

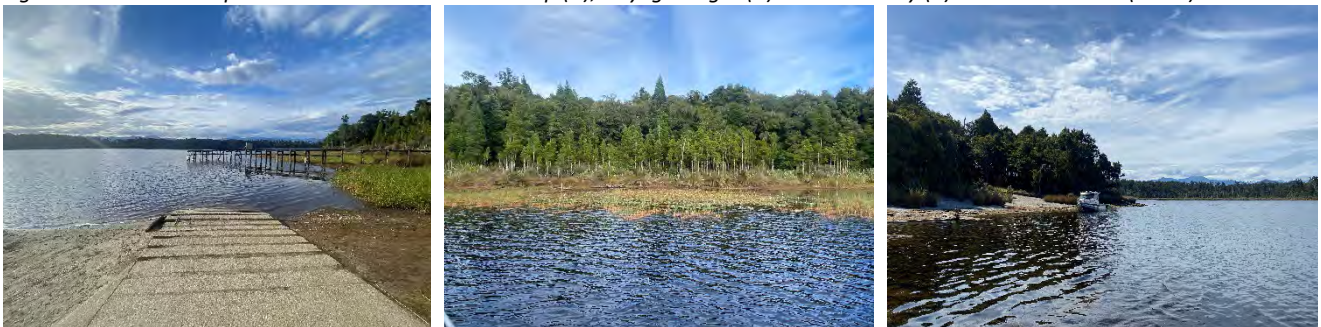
Figure 12 From left to right, Lake Mahinapua main ramp, Daylight Bight and Picnic Bay.

Mahinapua main ramp surveillance included the very shallow (<2m) area to the left and lakeward from the jetty. The water visibility during surveillance was very poor making it difficult to distinguish species. Invasive species, *E. canadensis*, *J. bulbosus* and *U. geminiscapa* were present at the site, in addition to floating *N. alba* and *A. distachyos*. Only *E. canadensis* was recorded on the LakeSPI transect with occasional cover. Native species on the transect included emergents, charophytes, milfoils and pondweeds at a ratio of 95% compared to 5% invasives. Vegetation reached a maximum depth of 1.2m.

Picnic Bay surveillance was conducted at the end of Picnic Point Track. The majority of the area was shallow (<1m), with a drop-off to 3m offshore. Native emergents, turf, charophytes, isoetes, milfoils and pondweeds were all present at 95% ratio compared to 5% invasives. The main invasive present was occasional specimens of *E. canadensis* and less often, *U. geminiscapa*. Introduced *L. palustris* and *J. bulbosus* were also present along the margins.

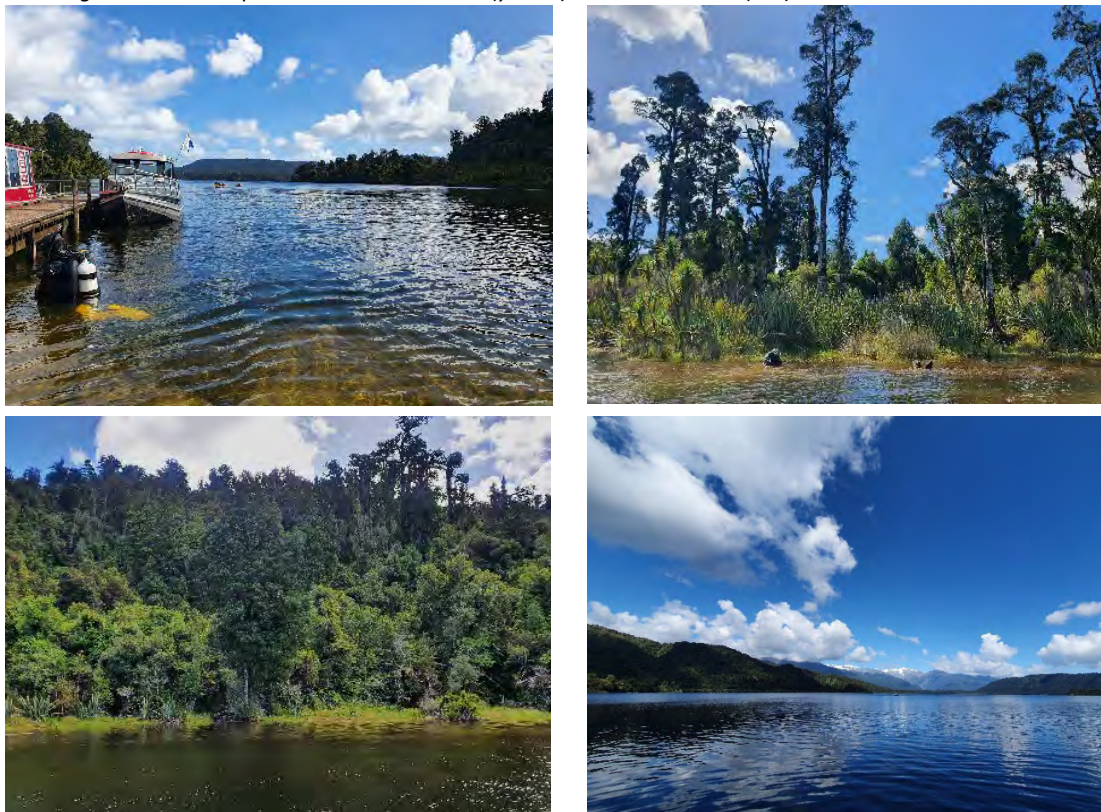
Figure 16 Mapourika surveillance sites (clockwise from top left) - Main ramp, DOC area, Okarito Outlet and southern aspect of lake.

The vegetation observed surrounding Okarito River mouth was dominated by native species including emergents, turf, charophytes, isoetes and milfoils at 76-95% compared to 6-25% invasives. Charophytes reached depths of 4.7m and *E. canadensis*, 3.4m. Where present, *E. canadensis* formed a dense, closed canopy at 1.1m height. *Ludwigia palustris* and *J. bulbosus* were also present on the margins.

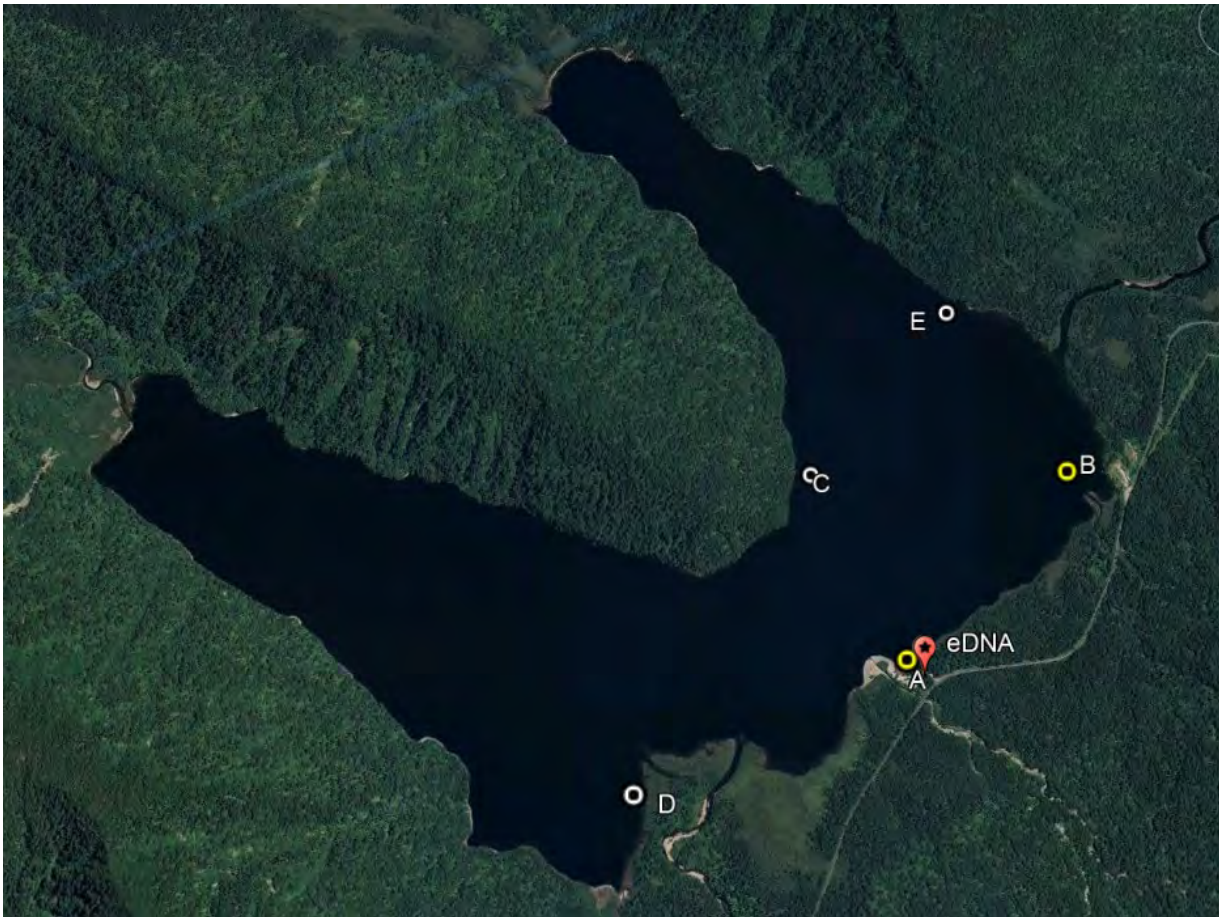
Figure 17 Lake Paringa surveillance sites (yellow) and LakeSPI sites (A-E).

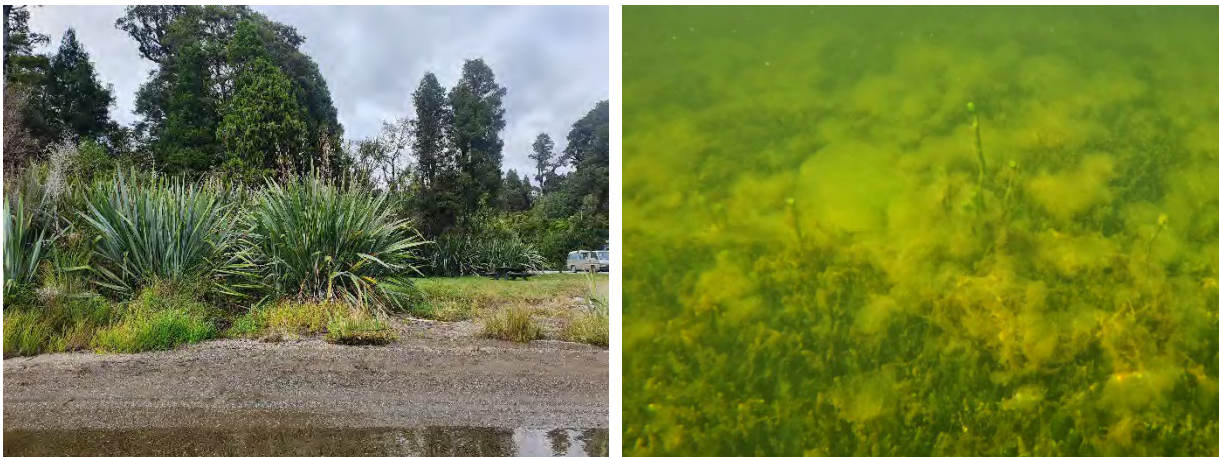
Figure 18 Lake Paringa showing topside near main ramp (left) and underwater near Paringa lodge jetty (right)

A large shallow platform extended over 100m out from the lodge jetty before eventually dropping away. *Lagarosiphon major* was dense at the site reaching 2.1m height and 4m depth. It largely accounted for 76-95% of the observed vegetation with *E. canadensis* and *L. palustris* also present to a lesser extent. Emergents, turf, charophyte and milfoils were among the native vegetation observed on the transect at a 6-25% ratio. Charophytes extended down to 6.6m depth. Closer to the jetty, a green filamentous algae was observed blanketing the bottom.

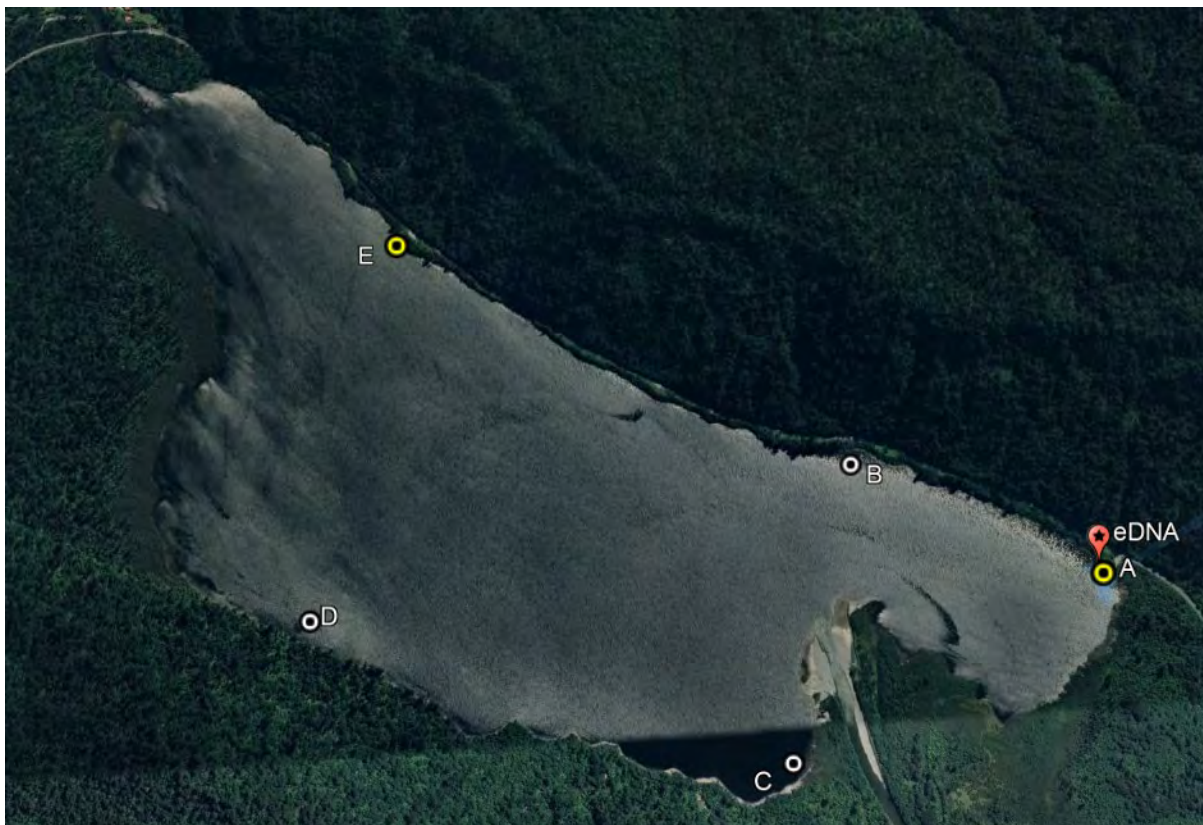
Figure 19 Lake Moeraki surveillance sites (yellow) and LakeSPI sites (A-E).

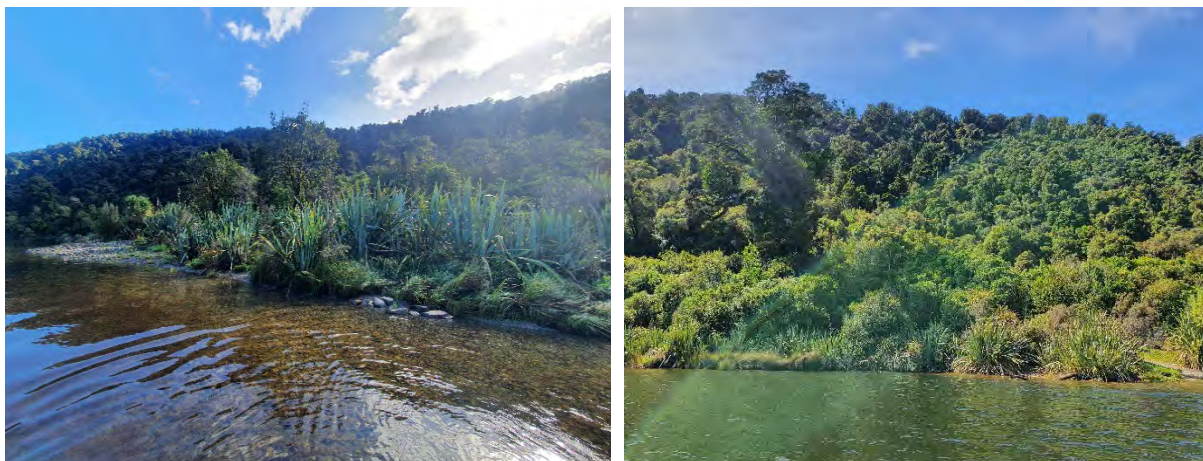
Figure 20 South Ramp area (left) and North Ramp area (right), Lake Moeraki.

Dense *E. canadensis* was recorded at the southern ramp site in Lake Moeraki down to 5.3m depth and 3.1m height. Native emergents, turf, charophytes, milfoils and pondweeds were present at a 6-25% ratio compared to 76-95% invasives. No other invasive species were observed.

The northern ramp site was also dominated by dense *E. canadensis* at 1.6m height and down to 4.8m depth. Invasive ratio was > 95% compared to natives. Native emergents, turf, pondweeds and charophytes were present down to 5.9m depth.
