WEST COAST  
REGIONAL COUNCIL

# West Coast Lakes Aquatic Weed Surveillance 2024

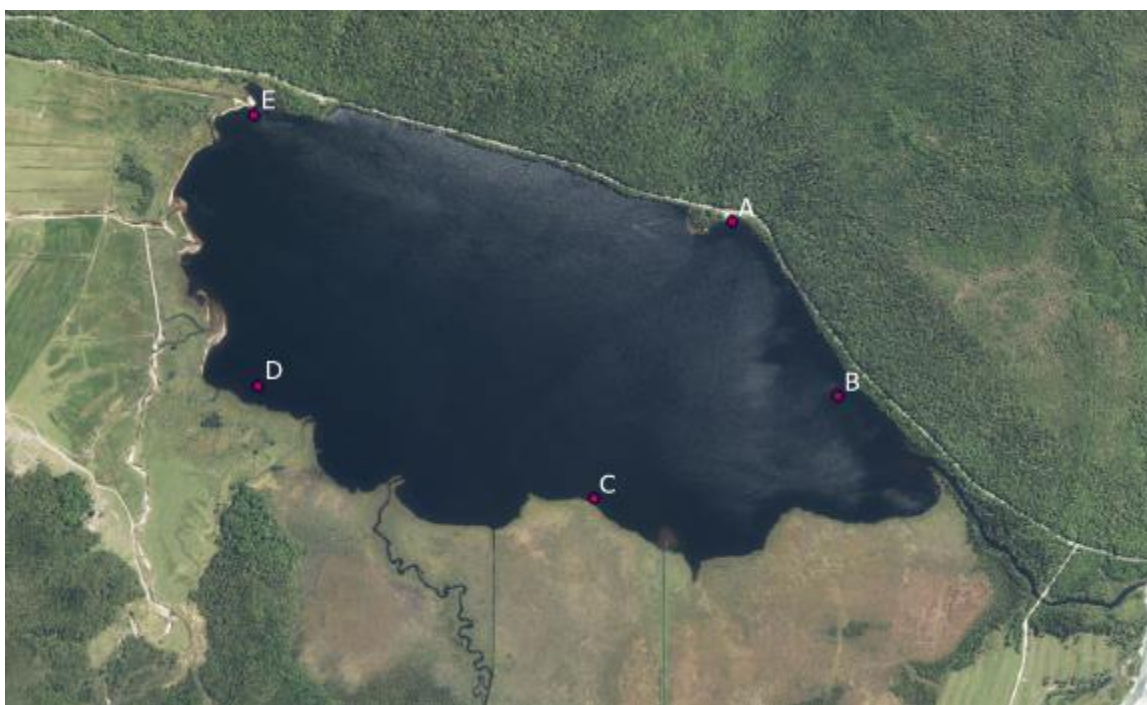
Figure 2: Locations of surveillance, Lake Haupiri. Main ramp (A), additional LakeSPI transects (B-E).

The surveillance area at Lake Haupiri was directly adjacent to the boat ramp and was very shallow across the whole survey area, with dark, tannin-stained water. An additional four LakeSPI transects were completed (Table 3 & figure 2).

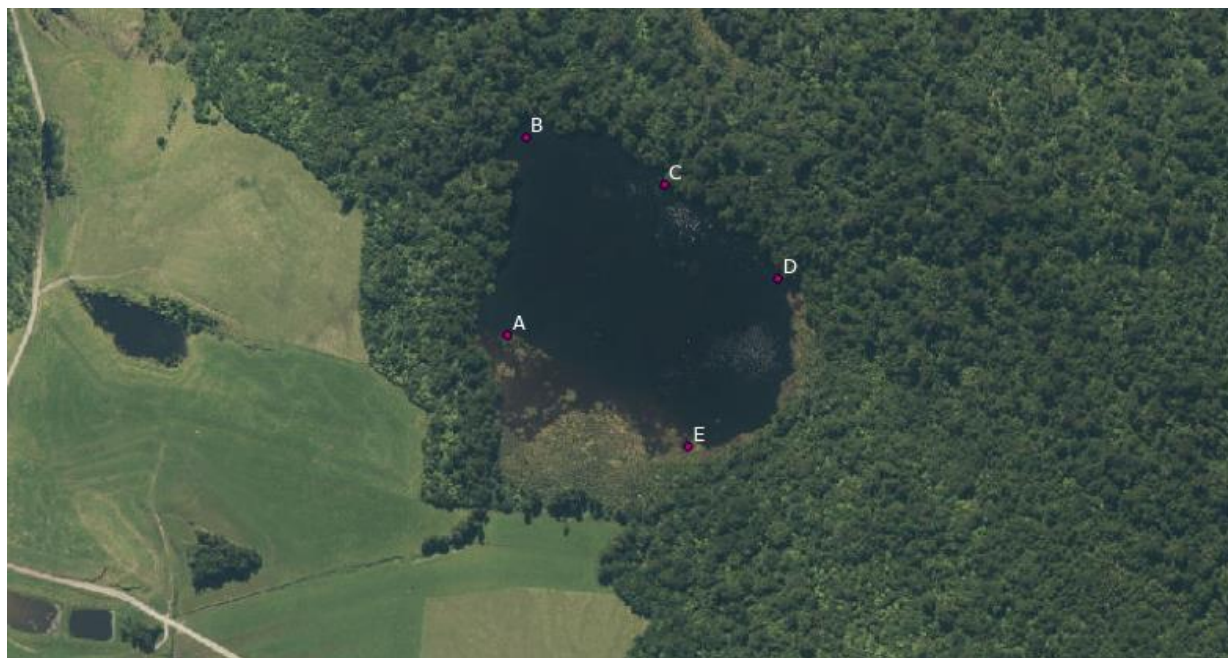
Figure 7: Locations of the LakeSPI transects, Lake Arthur.

Lake Arthur was more difficult to access, as it's surrounded by native forest vegetation (figure 7). The divers were able to get a kayak through the vegetation to carry gear during the surveillance. Lake Arthur was shallow throughout the entire lake reaching depths of 2.6m, this meant there was no end to the vegetation. Native vegetation included emergents, turf, milfoils and pondweeds at a ratio of 51-75% in the southwestern side of the lake and 76-95% at the other sites (table 7). While native milfoils were abundant, so were introduced species *J. bulbosus* and *Utricularia geminiscapa*.

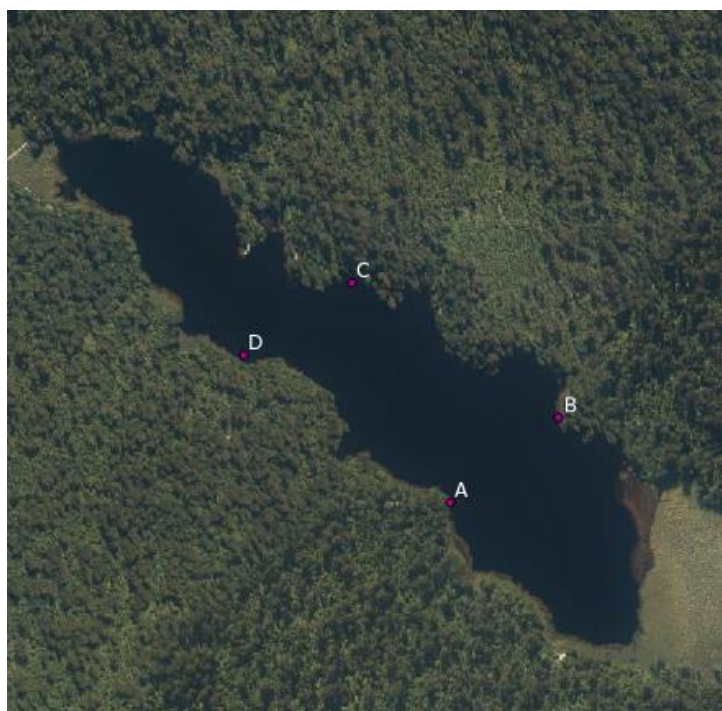
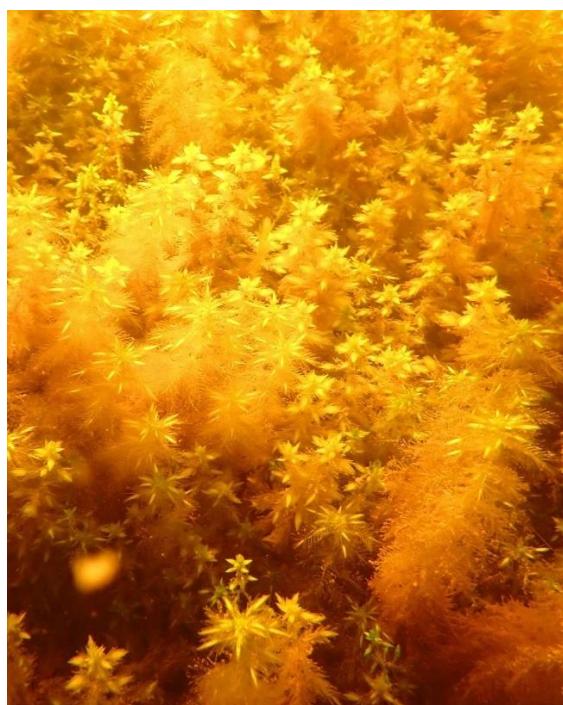
Figure 9: Locations of LakeSPI transects (left) and photo of Bryophytes (right) in Lake Matheson.

Only four LakeSPI transects were conducted in Lake Matheson due to its small size and access (figure 9). Vegetation in the lake was largely characterised by a very narrow band of bryophytes (not accounted for in LakeSPI) along with emergents, turf plants and milfoils. The only invasive species recorded was *Juncus bulbous*, which was observed occasionally at two of the transects, located surrounding the jetty area, and in nearby streams walking into the lake. Invasive vegetation ratio was <5% compared to >95% native (table 8). Another LakeSPI site at the western end could possibly be added in future.

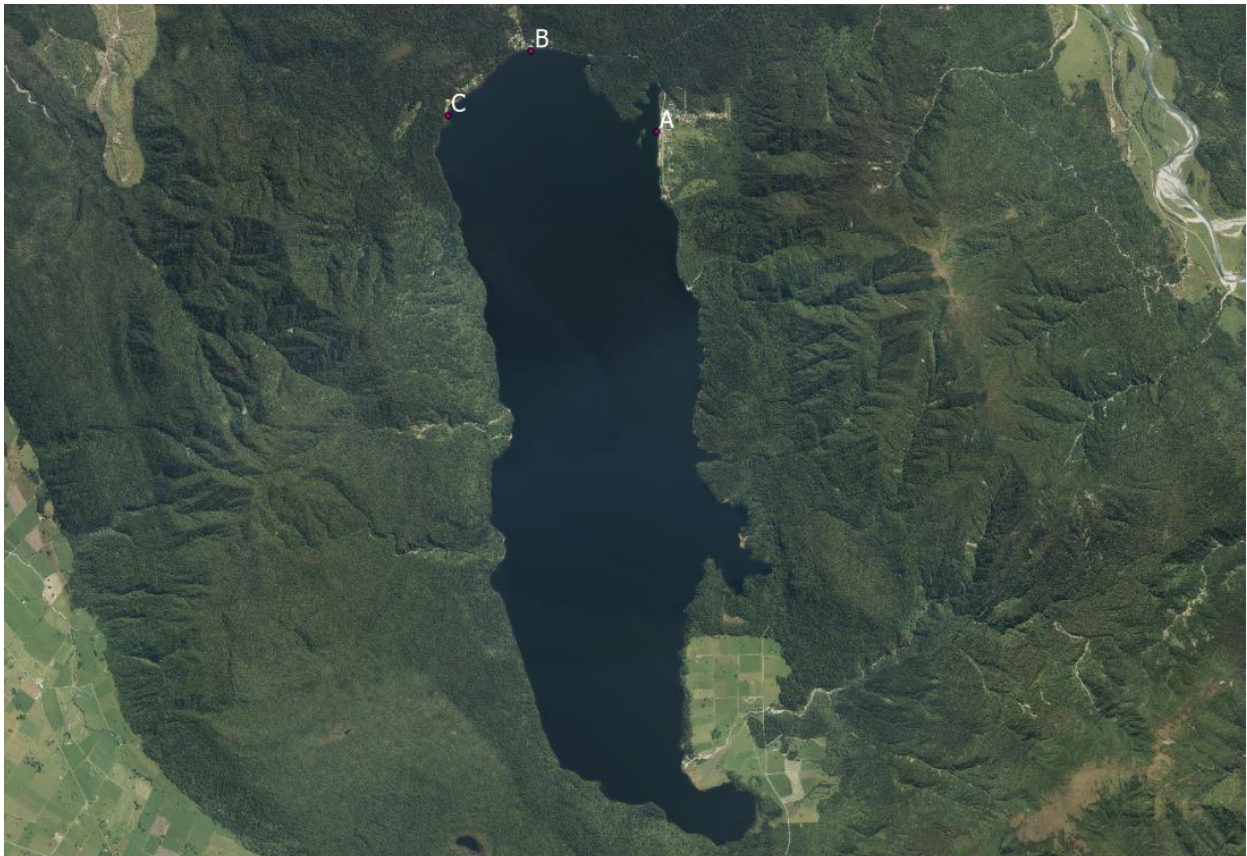
Figure 11: Locations of surveillance, Lake Kaniere. Hans Bay (A), Canoe Cove (B), and Sunny Bight (C).

Canoe Cove surveillance included the area around the outlet and walkway. Native vegetation was recorded to a depth of 6.7m and included turf, charophytes, isoetes, and milfoils at a ratio of 95% native to 5% invasive species. *Elodea canadensis* was the only invasive species recorded with occasional cover. Introduced species *Juncus bulbosus* was also present.

Sunny Bight surveillance included a shallow shelf area which sloped off to the edge of the charophytes at 6.3m. Native vegetation was diverse and included emergents, turf, charophytes, isoetes, milfoils and pondweeds at 51-75% ratio compared to 26-50% invasives. Invasive species included dense areas of *E. canadensis* down to 5.2m and 1m in height. *Ludwigia palustris* was also recorded at the surveillance site.

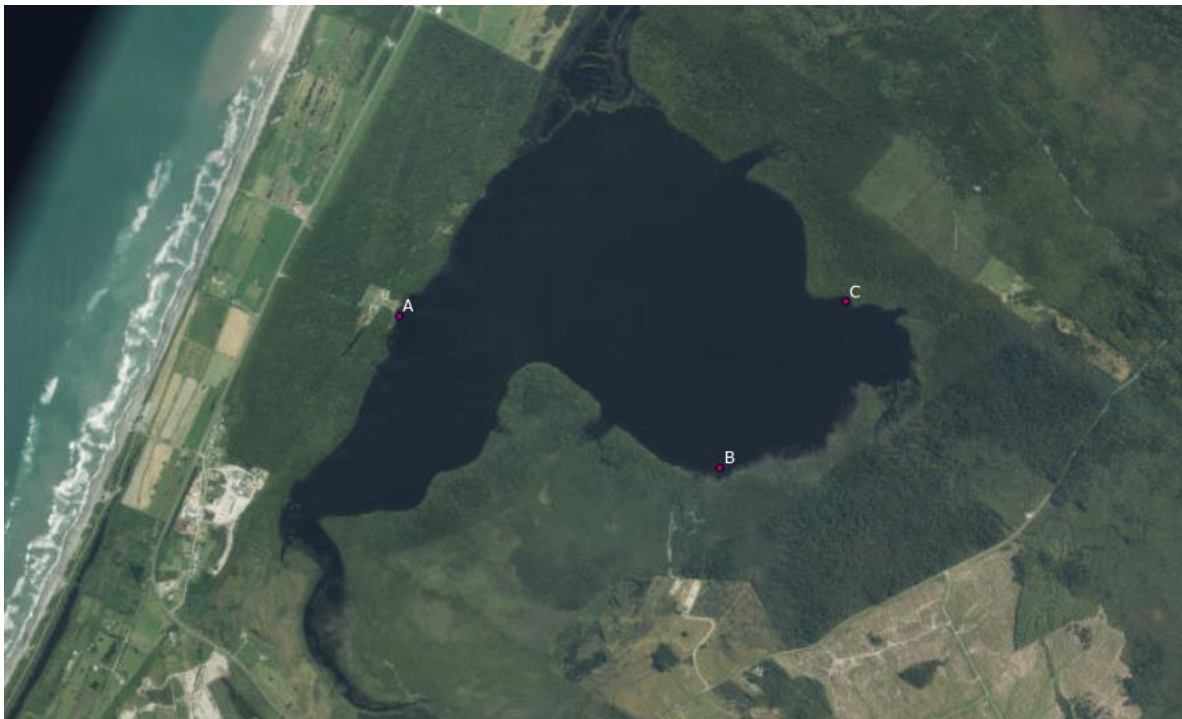
Figure 12: Locations of surveillance, Lake Mahinapua. Main ramp (A), Daylight bight (B), and Picnic Bay (C).

Daylight Bight was also very shallow (<1.5m) across the entire survey site, directly out from Johnnies Creek and the treetop walkway. Native vegetation included emergents, turfing, charophytes, isoetes, and milfoils at 51-75% ratio. The invasive vegetation cover increased on previous years with a ratio of 26-50% due to an increased abundance of *J. bulbosus*. Other introduced species recorded include *E. canadensis*, *U. geminiscapa* and *L. palustris*.

Picnic Bay surveillance was conducted at the end of Picnic Point Track. The majority of the area was shallow (<1m), with a drop-off to 3m offshore. Native emergents, turf, charophytes, isoetes, and milfoils were all present at 95% ratio compared to 5% invasives. The main invasive present was occasional specimens of *E. canadensis* and less often, *U. geminiscapa*. Introduced *L. palustris* and *J. bulbosus* were also present along the margins with the *J. bulbosus* cover reaching a maximum depth of 1m.

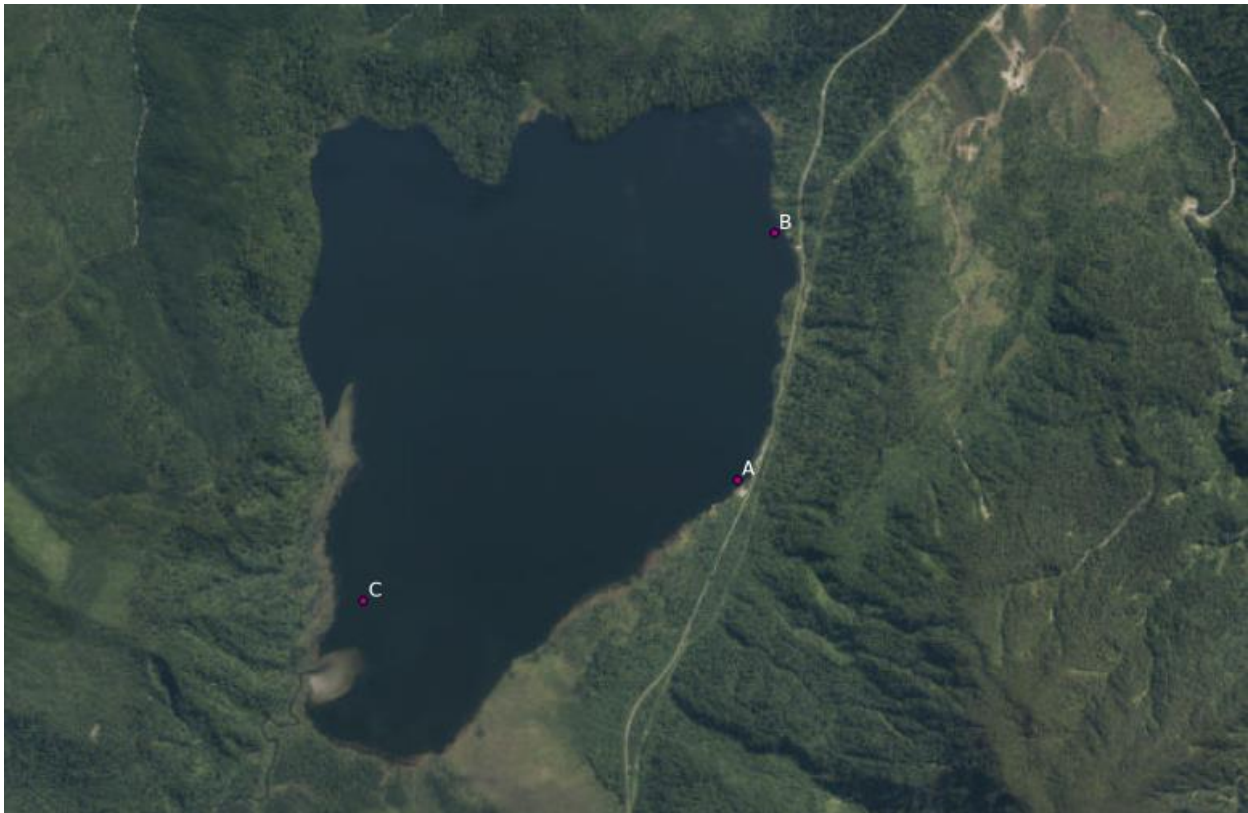
Figure 14: Locations of surveillance, Lake lanthe. Main Ramp (A), The Landing (B), and lanthe Creek Outlet (C).

The native vegetation observed adjacent to the main ramp at Lake lanthe included emergents, turf, charophytes, isoetes, pondweeds and milfoils reaching depths of 5.3m. The ratio of natives was >95% compared to <5% invasive. *Lagarosiphon major* was present at lower abundance than previous years, however new shoots were observed starting to come through. *L. palustris* was also present at this site.

Native vegetation out from the landing extended to 5.9m, with emergents, turf, charophytes, isoetes, milfoils and pondweeds present to depths of 5.9m. The ratio of natives on the transect was >95% compared to <5% invasives. Large areas of *L. major* were seen clearly having died off, although new shoots were observed growing amongst these areas.

The shallow area surrounding lanthe Creek Outlet had a ratio of 26-50% natives to 51-75% invasives. The invasive present was *L. major* in dense patches, 2.1 m high, among charophytes and other natives. Native emergents, turfing species, charophytes, isoetes, milfoils and pondweeds were present. The surveillance area was expansive and shallow, the maximum depths for both native and invasive vegetation was >2.4 m. Occasional specimens of *E. canadensis* were also present.

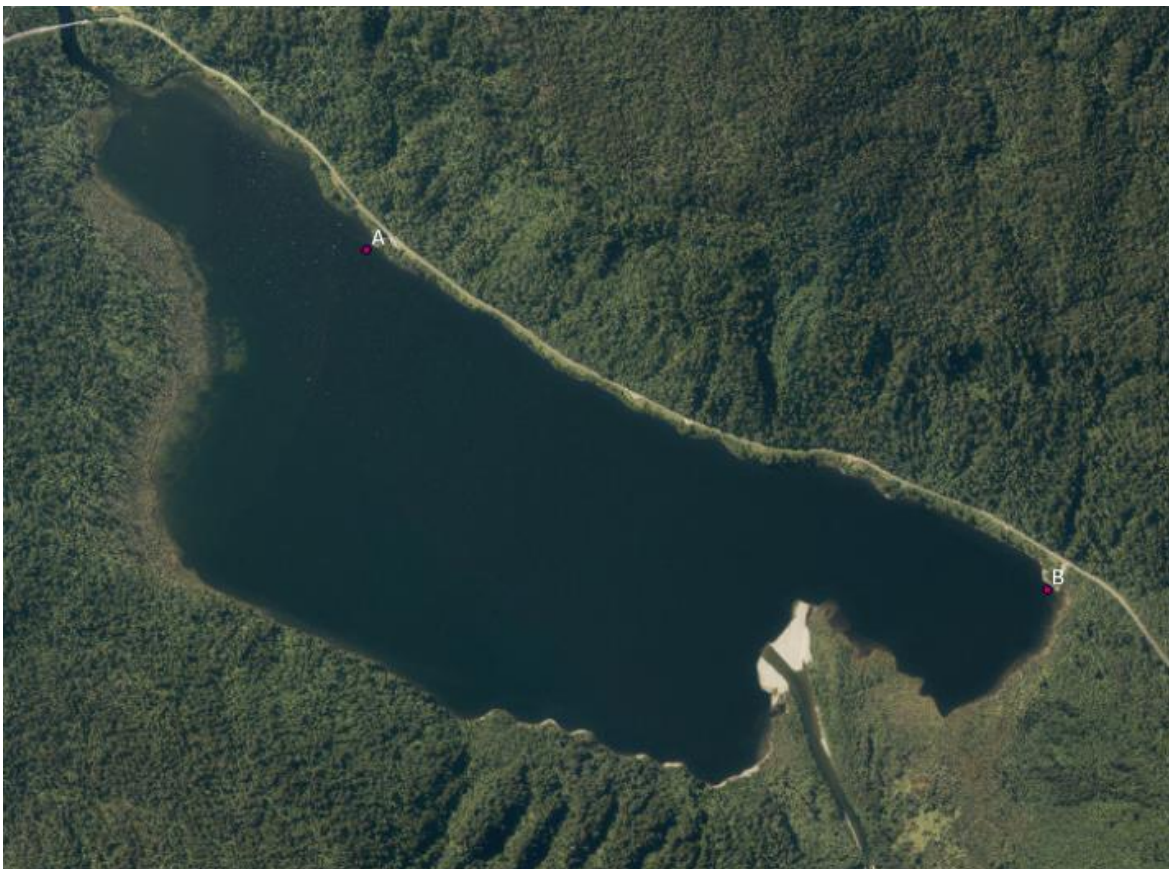
Figure 17: Locations of surveillance, Lake Moeraki. Southern ramp (B) and Northern ramp (A).

The northern ramp site was also dominated by dense *E. canadensis* at 1.8m height and down to 4.8m depth. Invasive ratio was > 95% compared to natives. Native emergents, turf, charophytes, milfoils and pondweeds and were present down to 6.5m depth.

Dense *E. canadensis* was recorded at the southern ramp site in Lake Moeraki down to 4.8m depth and 2.85m height. Native emergents, charophytes, and pondweeds were present at a 6-25% ratio compared to 76-95% invasives. *J. bulbosus* was also observed at this site.
