WEST COAST  
REGIONAL COUNCIL

## Franz Josef Joint Committee Rating District Asset Management Plan 2023-2026

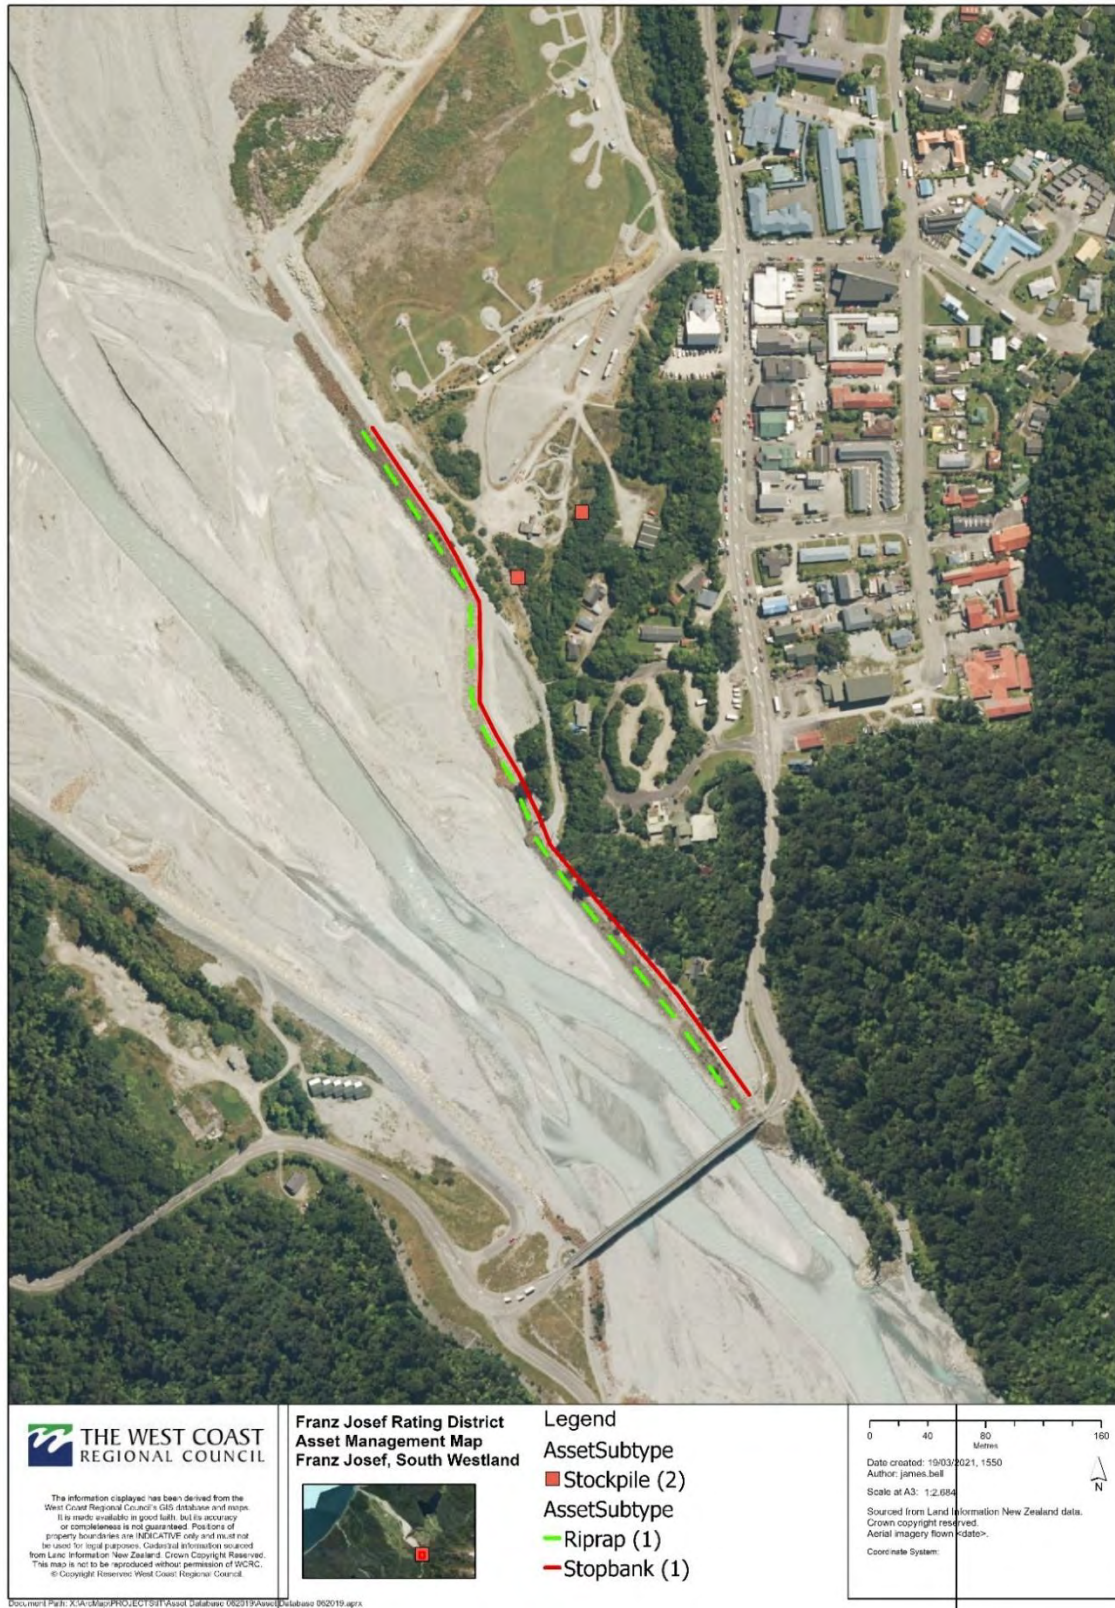
### 5.3 Asset Map Franz Josef

The Franz Josef Joint Committee Rating District manages a total of 0.55 km of stopbank on the true right bank. These stopbanks are protected by a total of 0.55 km of rock rip rap. Community infrastructure such as roads, power and telephone lines all derive benefit from the river control system as well as recreational facilities and industrial properties.

**Note: Not all assets have been added to the asset map due to having no spatial data to represent them.**

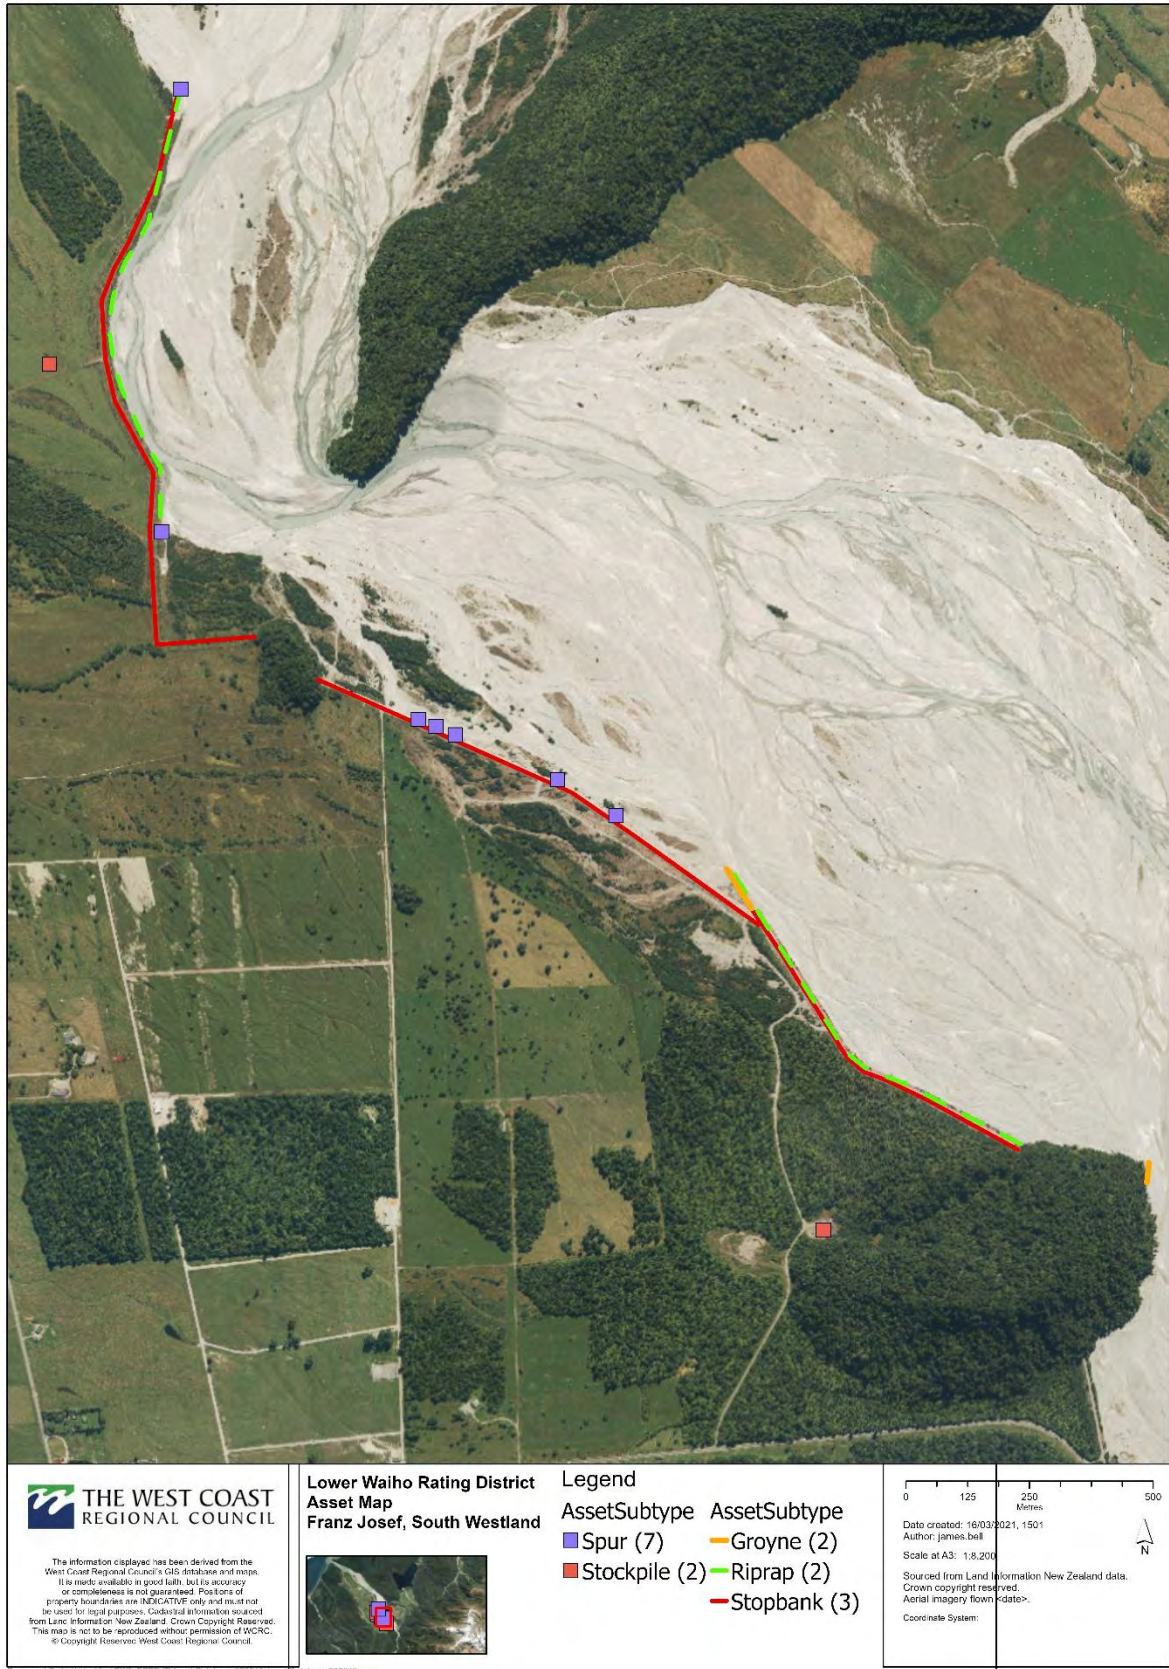
## 5.6 Asset Map Lower Waiho

<b>Asset</b>	<b>Quantity</b>	<b>Unit</b>	<b>Rate</b>
Fill	243,800	m <sup>3</sup>	\$26.00
Rock	109,968	Tonne	\$65.54
Stockpiled rock	0	Tonne	\$65.54
<b>Asset Value</b>			<b>\$13,546,102.72</b>
<i>On-costs (15%)</i>			<i>\$2,031,915.41</i>
<i>Resource Consents (2%)</i>			<i>\$311,560.36</i>
<b>Replacement Cost</b>			<b>\$15,889,578.49</b>

**Note: Not all assets have been added to the asset map due to having no spatial data to represent them.**
