WANGANUI RIVER

Flood Modelling

Report

Client: West Coast Regional Council

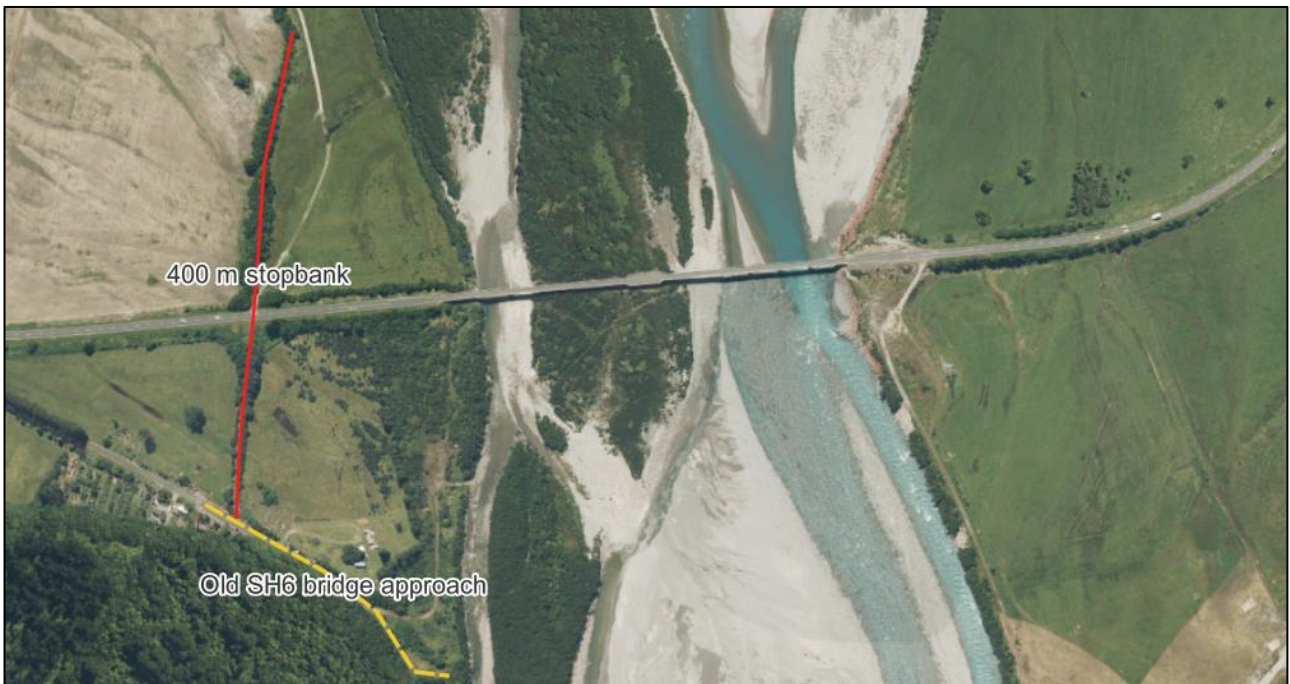
Figure 3-1 – The 400 m long true left stopbank immediately downstream of the old SH6 bridge.

- The first protection works on the Wanganui River were instigated by severe flooding of the Hari Hari Flat in 1913, resulting in a 400 m stopbank immediately downstream from the old SH6 bridge abutment on the true left (Figure 3-1). There is earlier mention of a rock groyne in 1905 near where the ferry used to operate before the old bridge was built (Benn, 1990).

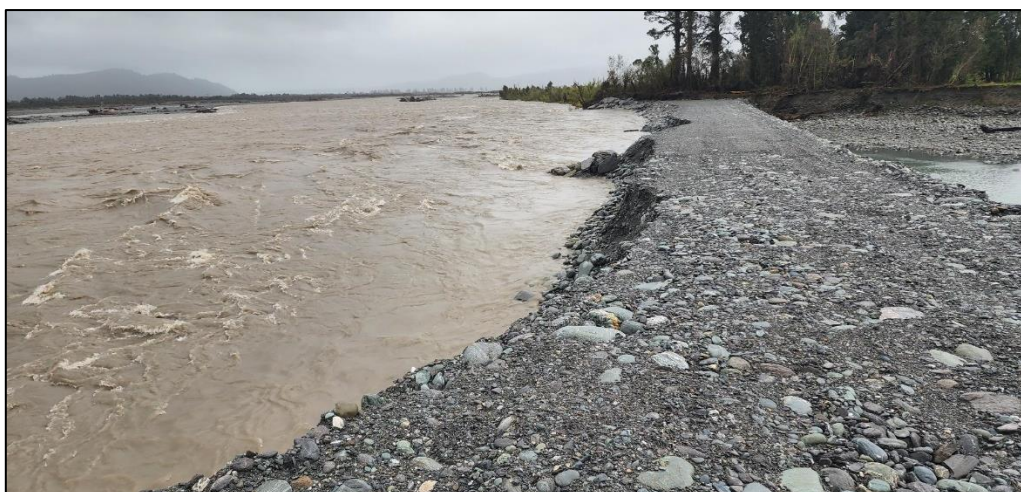
Figure 3-11: Raymond's stopbank during the 2022 July 18th/19th flood.

The main channel then remains on the true right before connecting with the downstream Raymond's stopbank. In 2022, this stopbank was damaged by two separate events. In February the stopbank was washed away, and then after being repaired it was again damaged in another flood in July (Figure 3-11), a repeating pattern it seems, as this area also experienced similar damage in the 1980s.

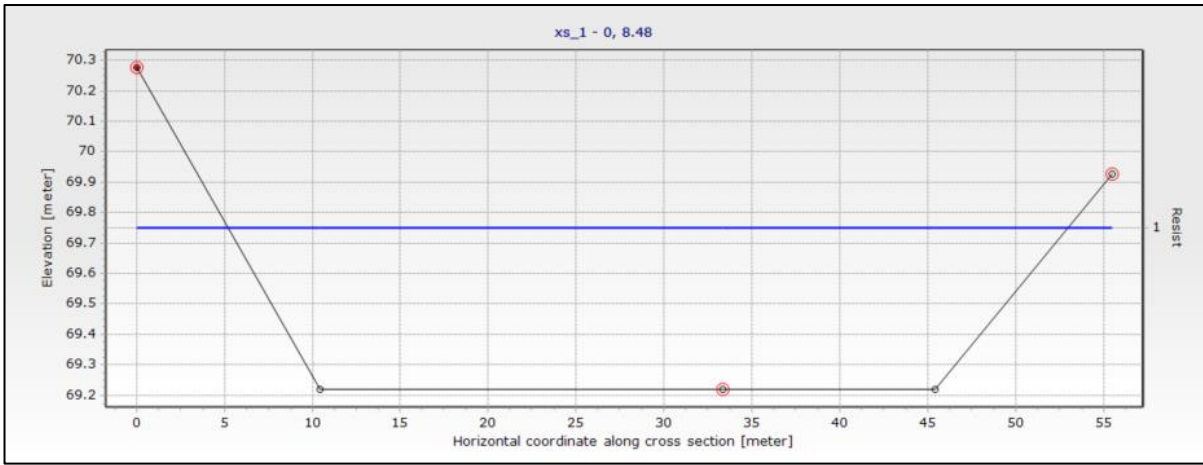
Figure 6-3: Example of the typical trapezoidal channel shape in MIKE Hydro River.

In order to allow the full river to be modelled in 2D, it has been necessary to interpolate a detailed river bathymetry. To do this, we have interpolated the bathymetry using points generated at a 1.0 m grid resolution from the LiDAR DEM. However, because the river channel changed after the LiDAR image was captured, it became necessary to burn in a 1.0 m trapezoidal main channel and two 0.5 m rectangular subsidiary channels (La Fontaine Stm and Adamson Ck) (Figure 6-3, Figure 6-4). The channel edges were designed to tie in with the DEM elevations. The model was then run with the inserted channel for all the design and sensitivity runs.

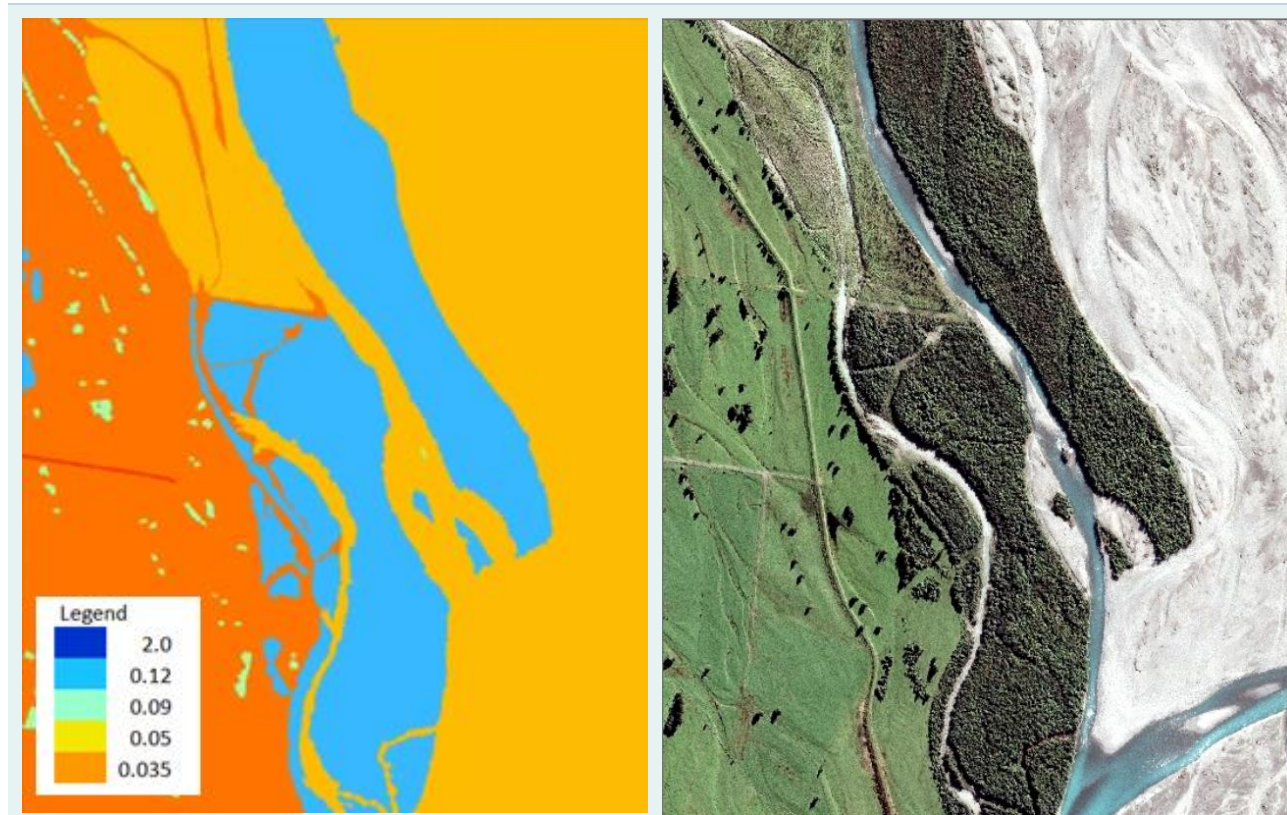
Figure 6-6 – Visualisation of Manning's 'n' roughness representation

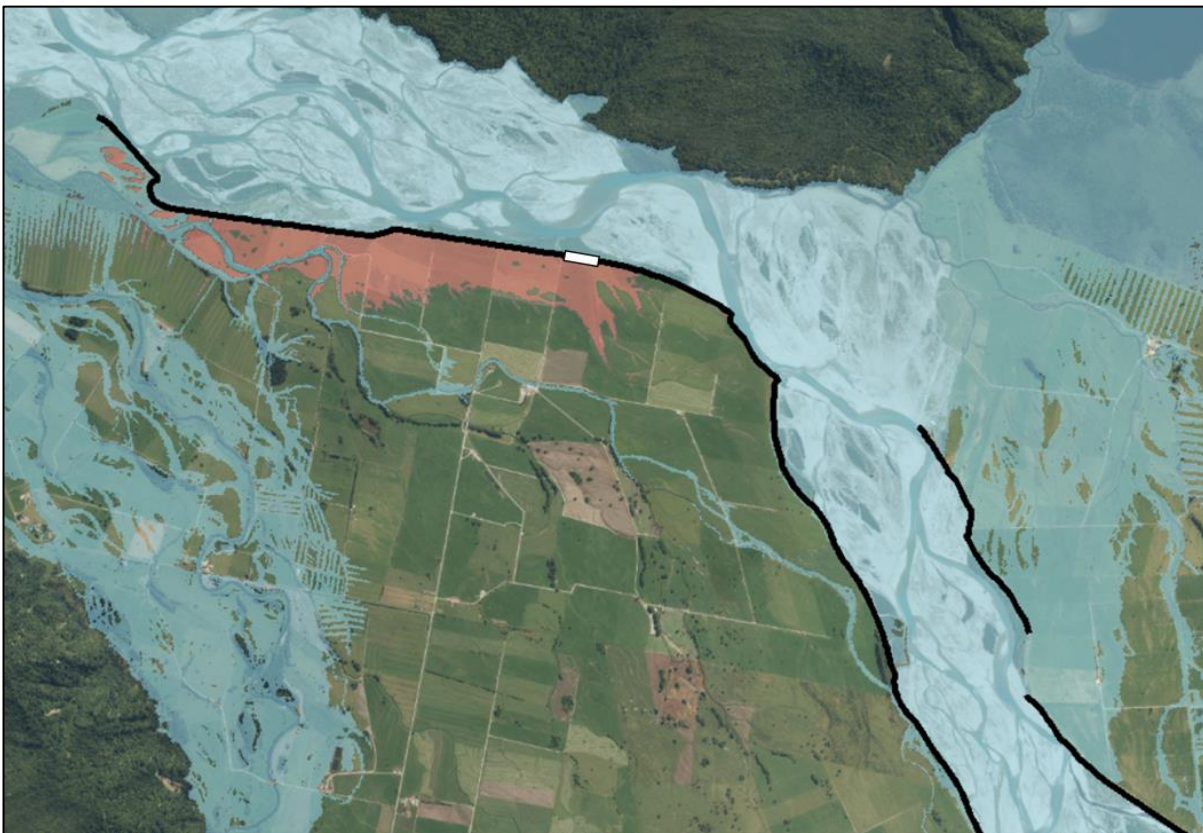
Figure 7-22: Flood extents for a 1% AEP flow with and without the left bank scour breach 3. The orange shaded area shows the additional flood extent with breach 3.
