Hokitika Rating District 2023-2026 Asset Management Plan

West Coast Regional Council

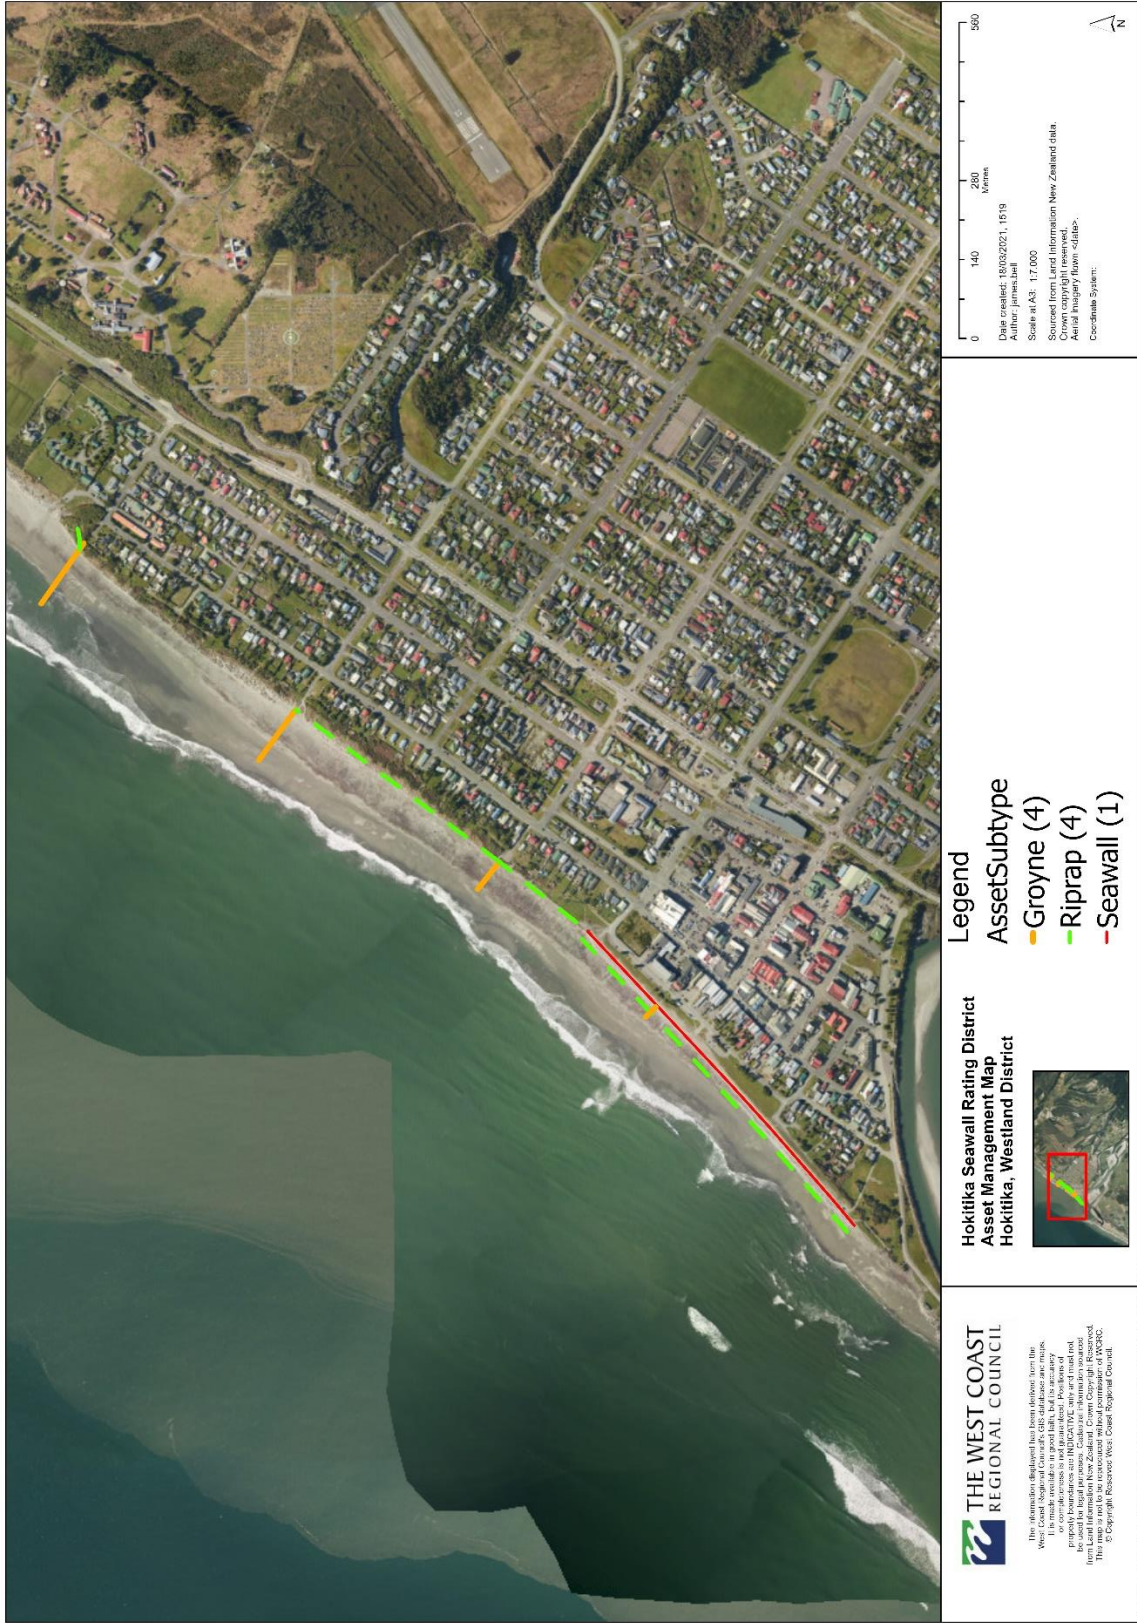
5.3 Asset Map

Asset	Quantity	Unit	Rate
Rock	63,313	Tonne	\$50.45
Quarry Waste	13,126	Tonne	\$23.45
Rock Large	3,156	Tonne	\$77.45
Fill	12,593		\$32.00
Running course	500	m ³	\$35.01
Bedding gravel	3,250		\$19.64
Filter fabric	21,800	m ²	\$12.68
Asset Value			\$4,538,621.75
<i>On-costs (15%)</i>			<i>\$680,793.26</i>
<i>Resource Consents (2%)</i>			<i>\$104,388.30</i>
Replacement Cost			\$5,323,803.31
Depreciating Assets			
Culverts			\$102,270.94
All Assets Replacement Cost			\$5,426,074.25
As at 1 July 2023

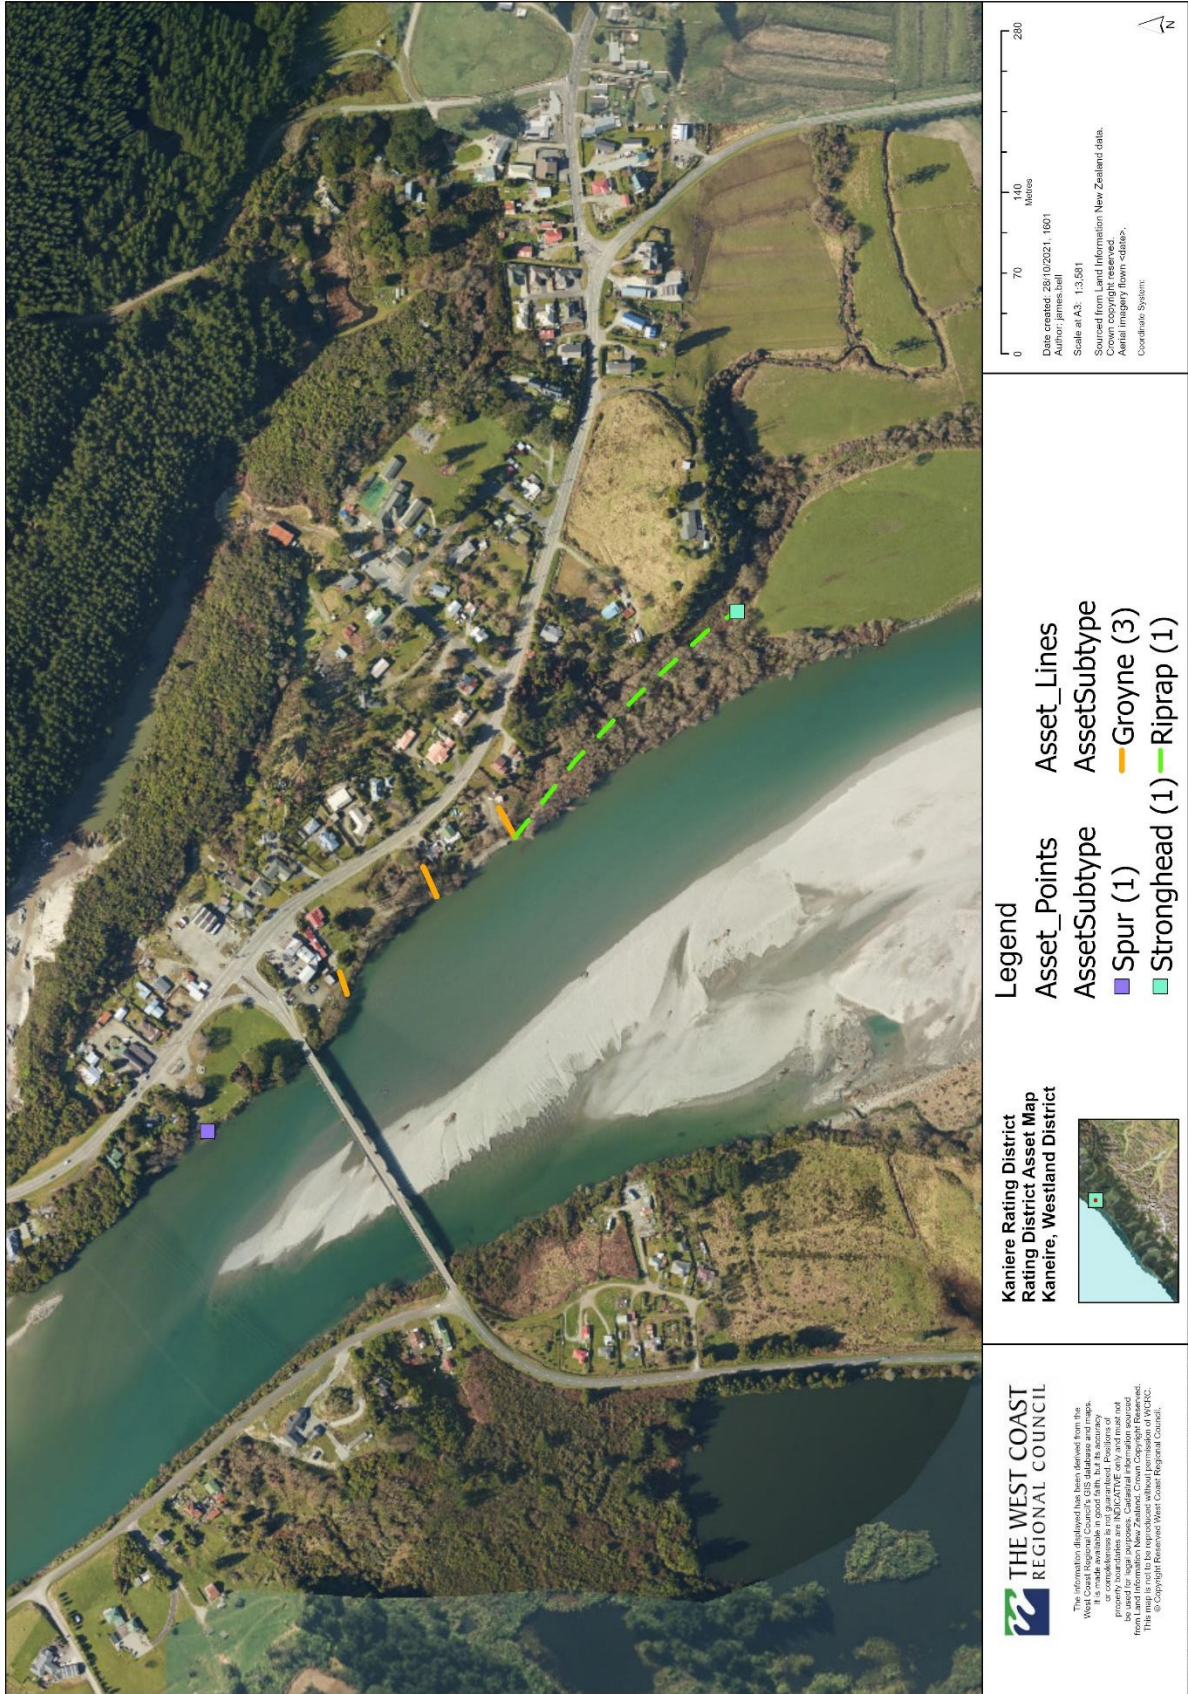
5.6 Asset Map

Asset	Quantity	Unit	Rate
Rock	17120	Tonne	\$48.50
Rubble	2,890	Tonne	\$21.50
Fill	2,890	m ³	\$32.00
Asset Value			\$984,935.00
<i>Contingencies</i>			<i>\$147,740.25</i>
<i>Resource Consents</i>			<i>\$22,653.51</i>
All Assets Replacement Cost			\$1,155,328.76
