COMPANY NAME	West Coast Regional Council
ATTENTION	Rachel Clark, Rebecca Inwood
SUBJECT	Mananui Mineral Sands Project – Hydrological Review

1. INTRODUCTION

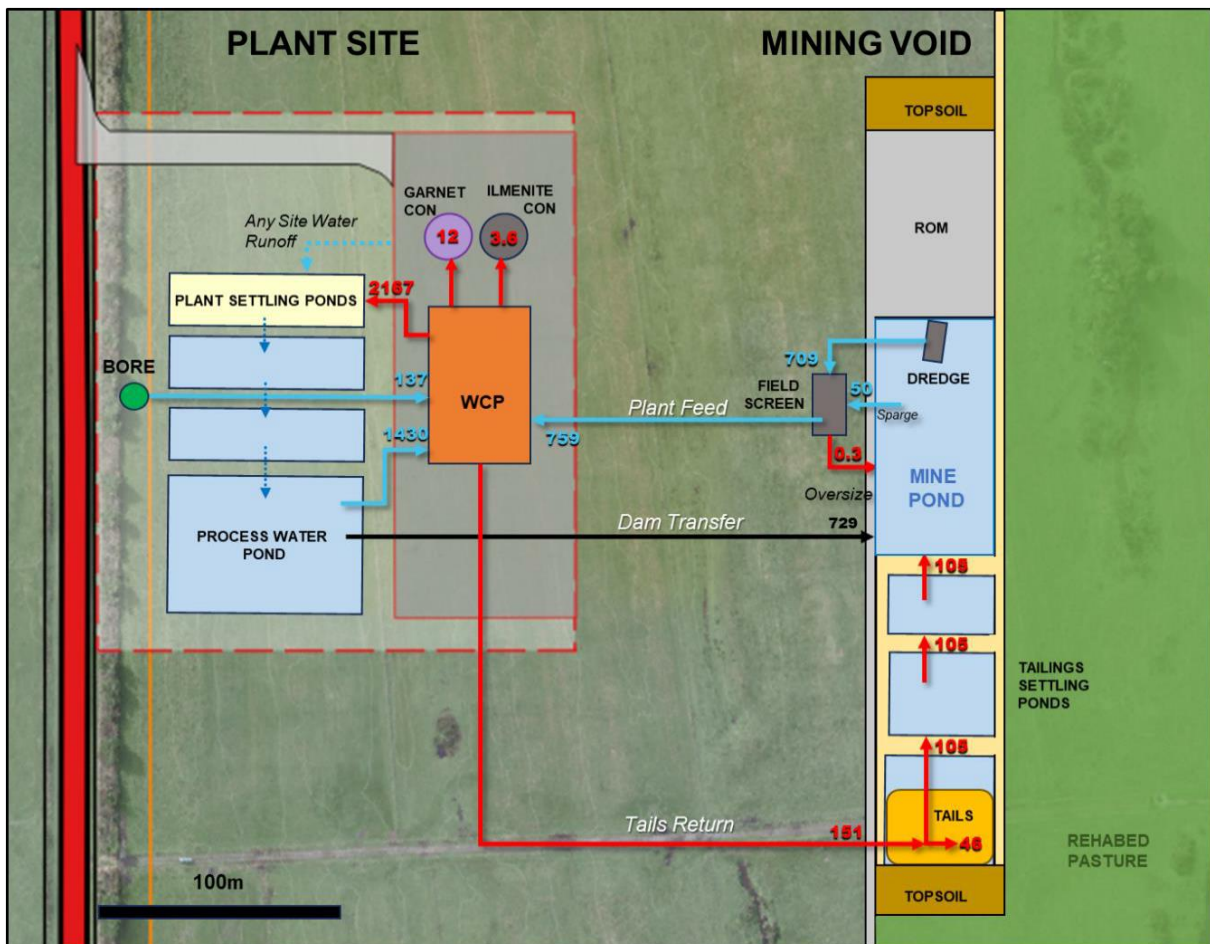
Figure 2. Site water balance diagram with flows in m³/hour (from Kōmanawa 2023a)

- The water balance for the site is summarised in Figure 2, with the following notes.
 - Any additional water required for the processing plant is to be abstracted from a new bore to be installed.

- The net flow to the dredge pond is to be about -11 m³/hour in order to maintain positive groundwater flows toward the excavation (Kōmanawa 2023a).
 - Excess water is to be discharged to an infiltration basin along the southern edge of the site.

- The water balance for the site can be managed through monitoring and adjusting the above three pumping rates.
- The land is to be progressively rehabilitated to pasture, and an ecological restoration area is to be created along the Māhinapua Wetland and Creek (presumably Tūwharewhare). The ecological area is to consist of approximately 2.37 ha of wetland and 4.75 ha of new vegetation.

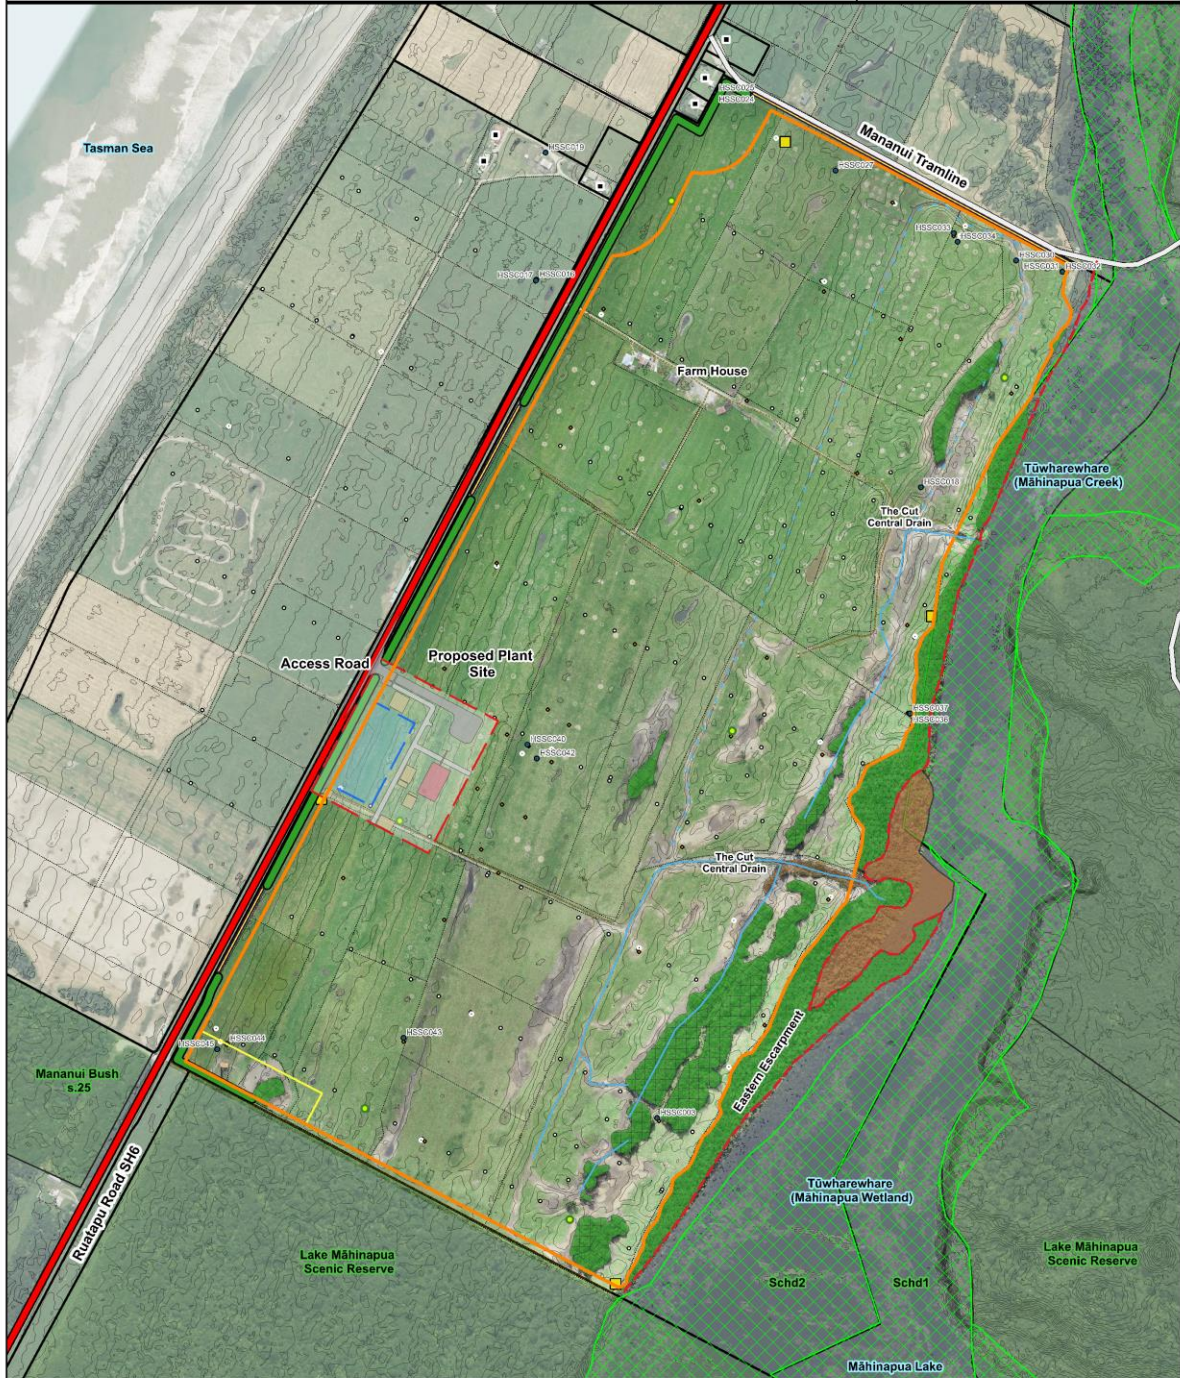
MANANUI CONSENT BRIEF MAP

<ul style="list-style-type: none"> Mining Area 112Ha Starter Pit Land Parcels Bunds Fences Farm Tracks SH6 Walkway Dwellings 	<ul style="list-style-type: none"> Drill Holes Air Core Sonic CPT Pizos Rad Samples DDG Existing Runoff Path Existing Drainage 	<ul style="list-style-type: none"> Vegetation Shrub / Weed Hinau Kamahi Rimu Kahikatea, Kamahi, Rimu Kahikatea wetland Kamahi broadleaf Wetland Bound Schd Wetlands DOC Land 	<ul style="list-style-type: none"> Plant Site WCP Road Access Road Buildings Water Treatment 	<p>LOCATION</p> <p>MANANUI, SOUTH ISLAND, NZ</p> <p>MAP VERSION V 2.0</p>	<p>0 100 200 300 m</p> <p>Coordinate Reference System: GD2000 NZTM (EPSG: 2193)</p> <table border="1" style="width: 100%;"> <tr> <td style="width: 50%;">DATE</td> <td>19/10/2023</td> </tr> <tr> <td>AUTHOR</td> <td>WMSC</td> </tr> </table>	DATE	19/10/2023	AUTHOR	WMSC
DATE	19/10/2023								
AUTHOR	WMSC

- 85 m setback from the NW corner near adjacent residential dwellings;
 - The edge of the vegetation and to the property boundary along the eastern boundary. For clarity, this setback has been taken as corresponding to the eastern boundary presented in the Mananui Consent Brief Map as attached in Appendix 1 to this memorandum.
